**NATIONAL
TRANSPORTATION
SAFETY
BOARD**

AIRCRAFT ACCIDENT REPORT

**ATLANTIC SOUTHEAST AIRLINES, INC., FLIGHT 2311
UNCONTROLLED COLLISION WITH TERRAIN
AN EMBRAER EMB-120, N270AS
BRUNSWICK, GEORGIA
APRIL 5, 1991**

**Adopted: April 28, 1992
Notation 5511A**

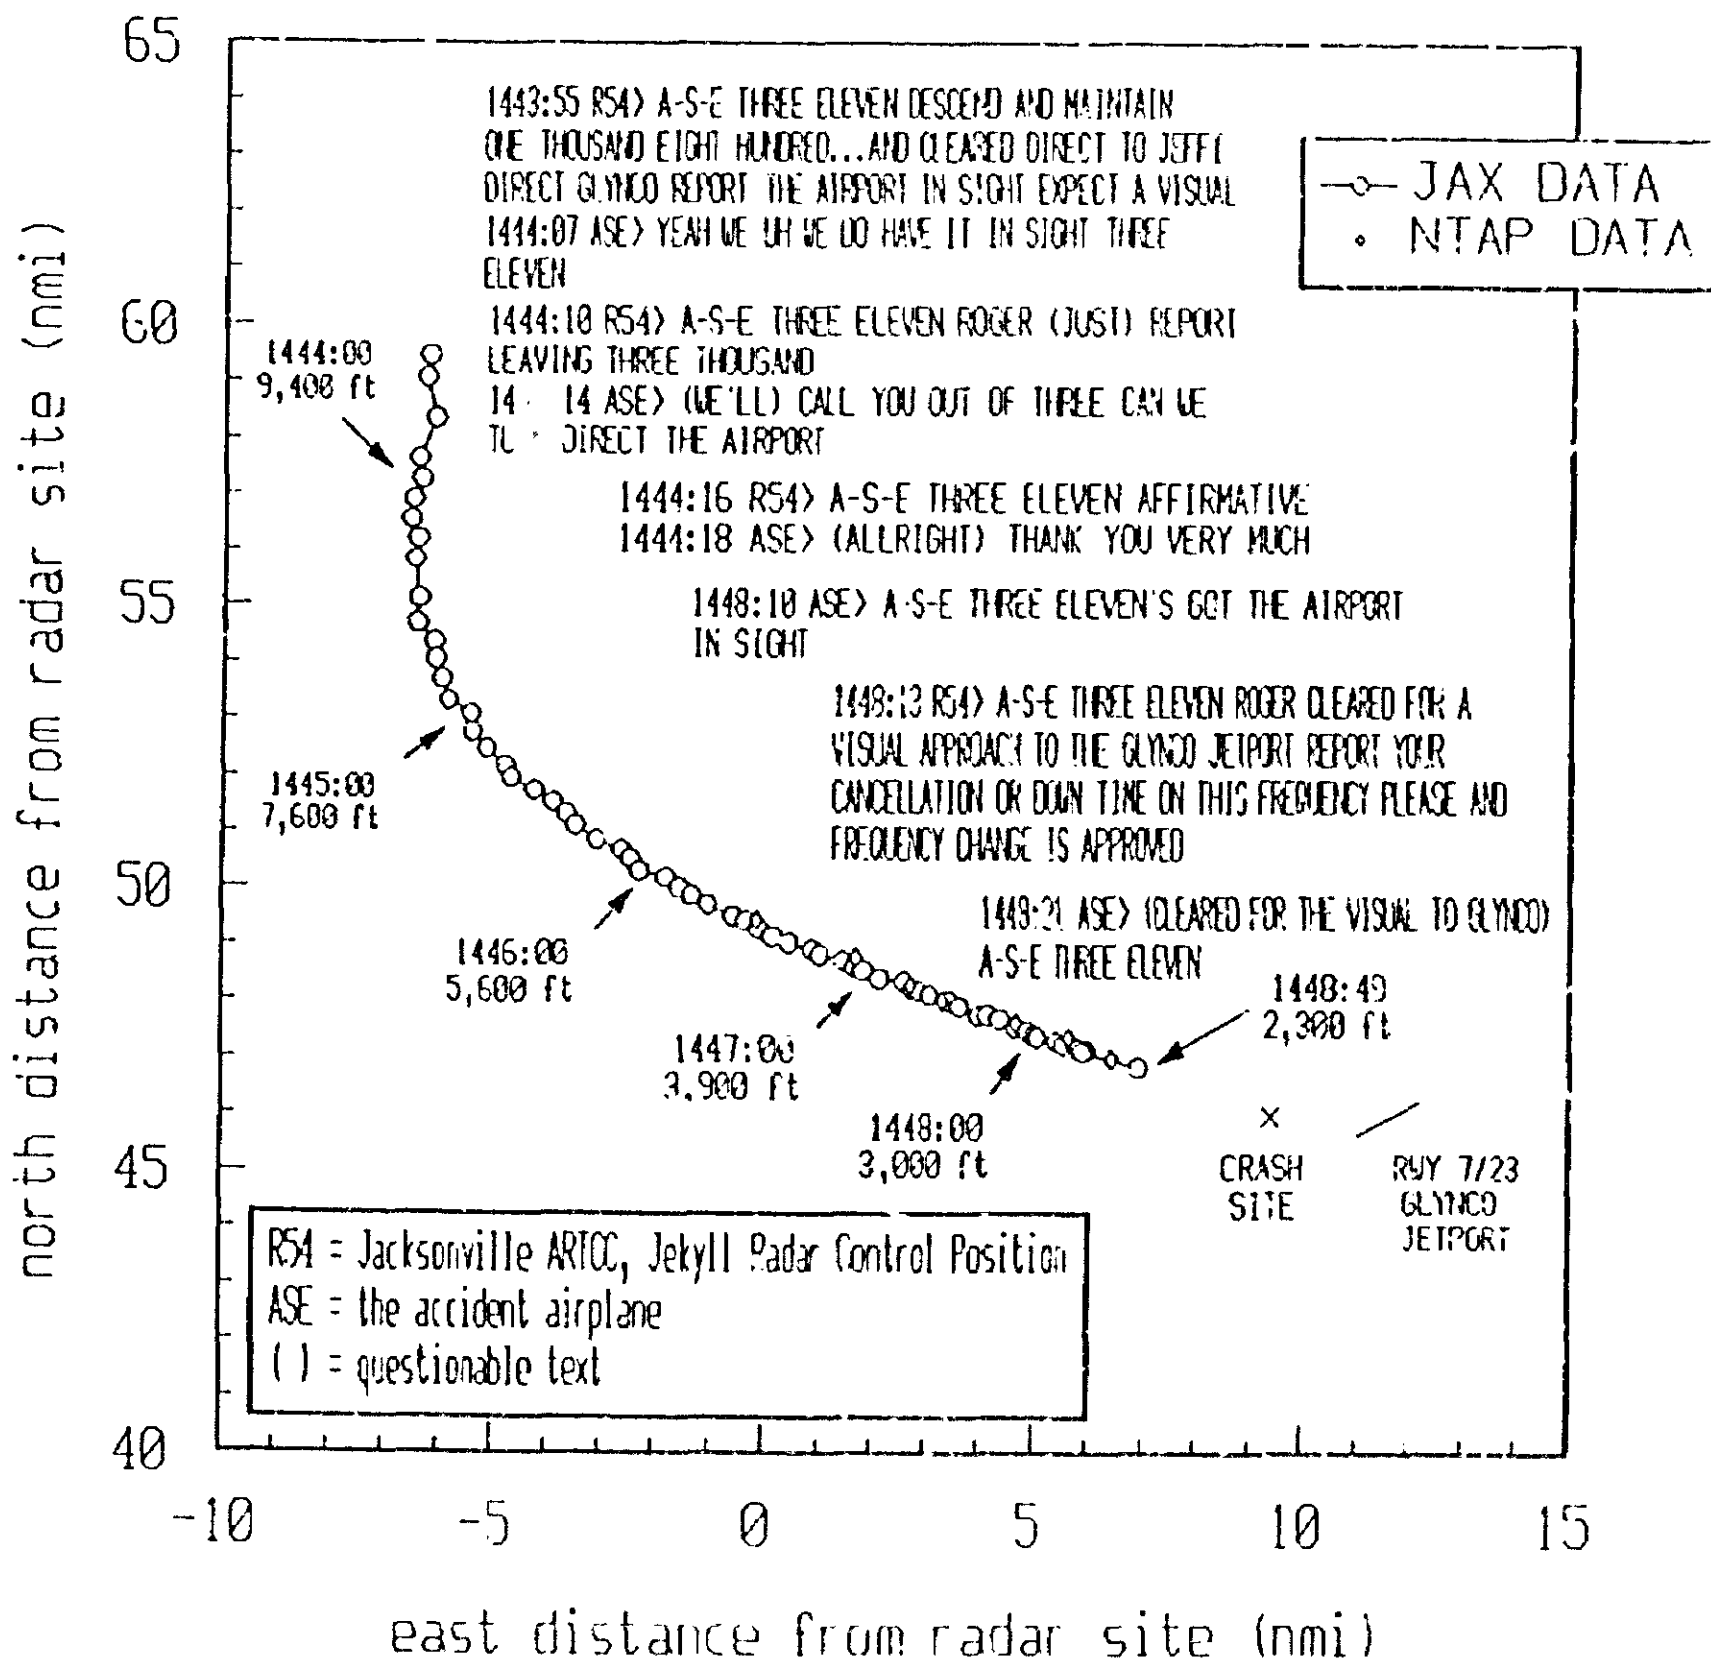
Figure 1.--EMB-120 Accident, Brunswick, Georgia, Raw Radar Data

Air traffic control radar data were plotted to show the flightpath of flight 2311 for the last 5 minutes of radar coverage. (See figure 1). The radar antenna beam is limited by line-of-sight. Therefore, because of the distance to the accident location and the geometry of the radar antenna coverage, the last recorded and lowest possible radar data in the accident area is about 2,300 feet above the ground. The interpretation of the radar data, using the anticipated winds aloft, indicates that at the time of the last radar return the airplane's indicated airspeed had decreased to 150 knots and that the airplane was on a heading of about 117 degrees magnetic.

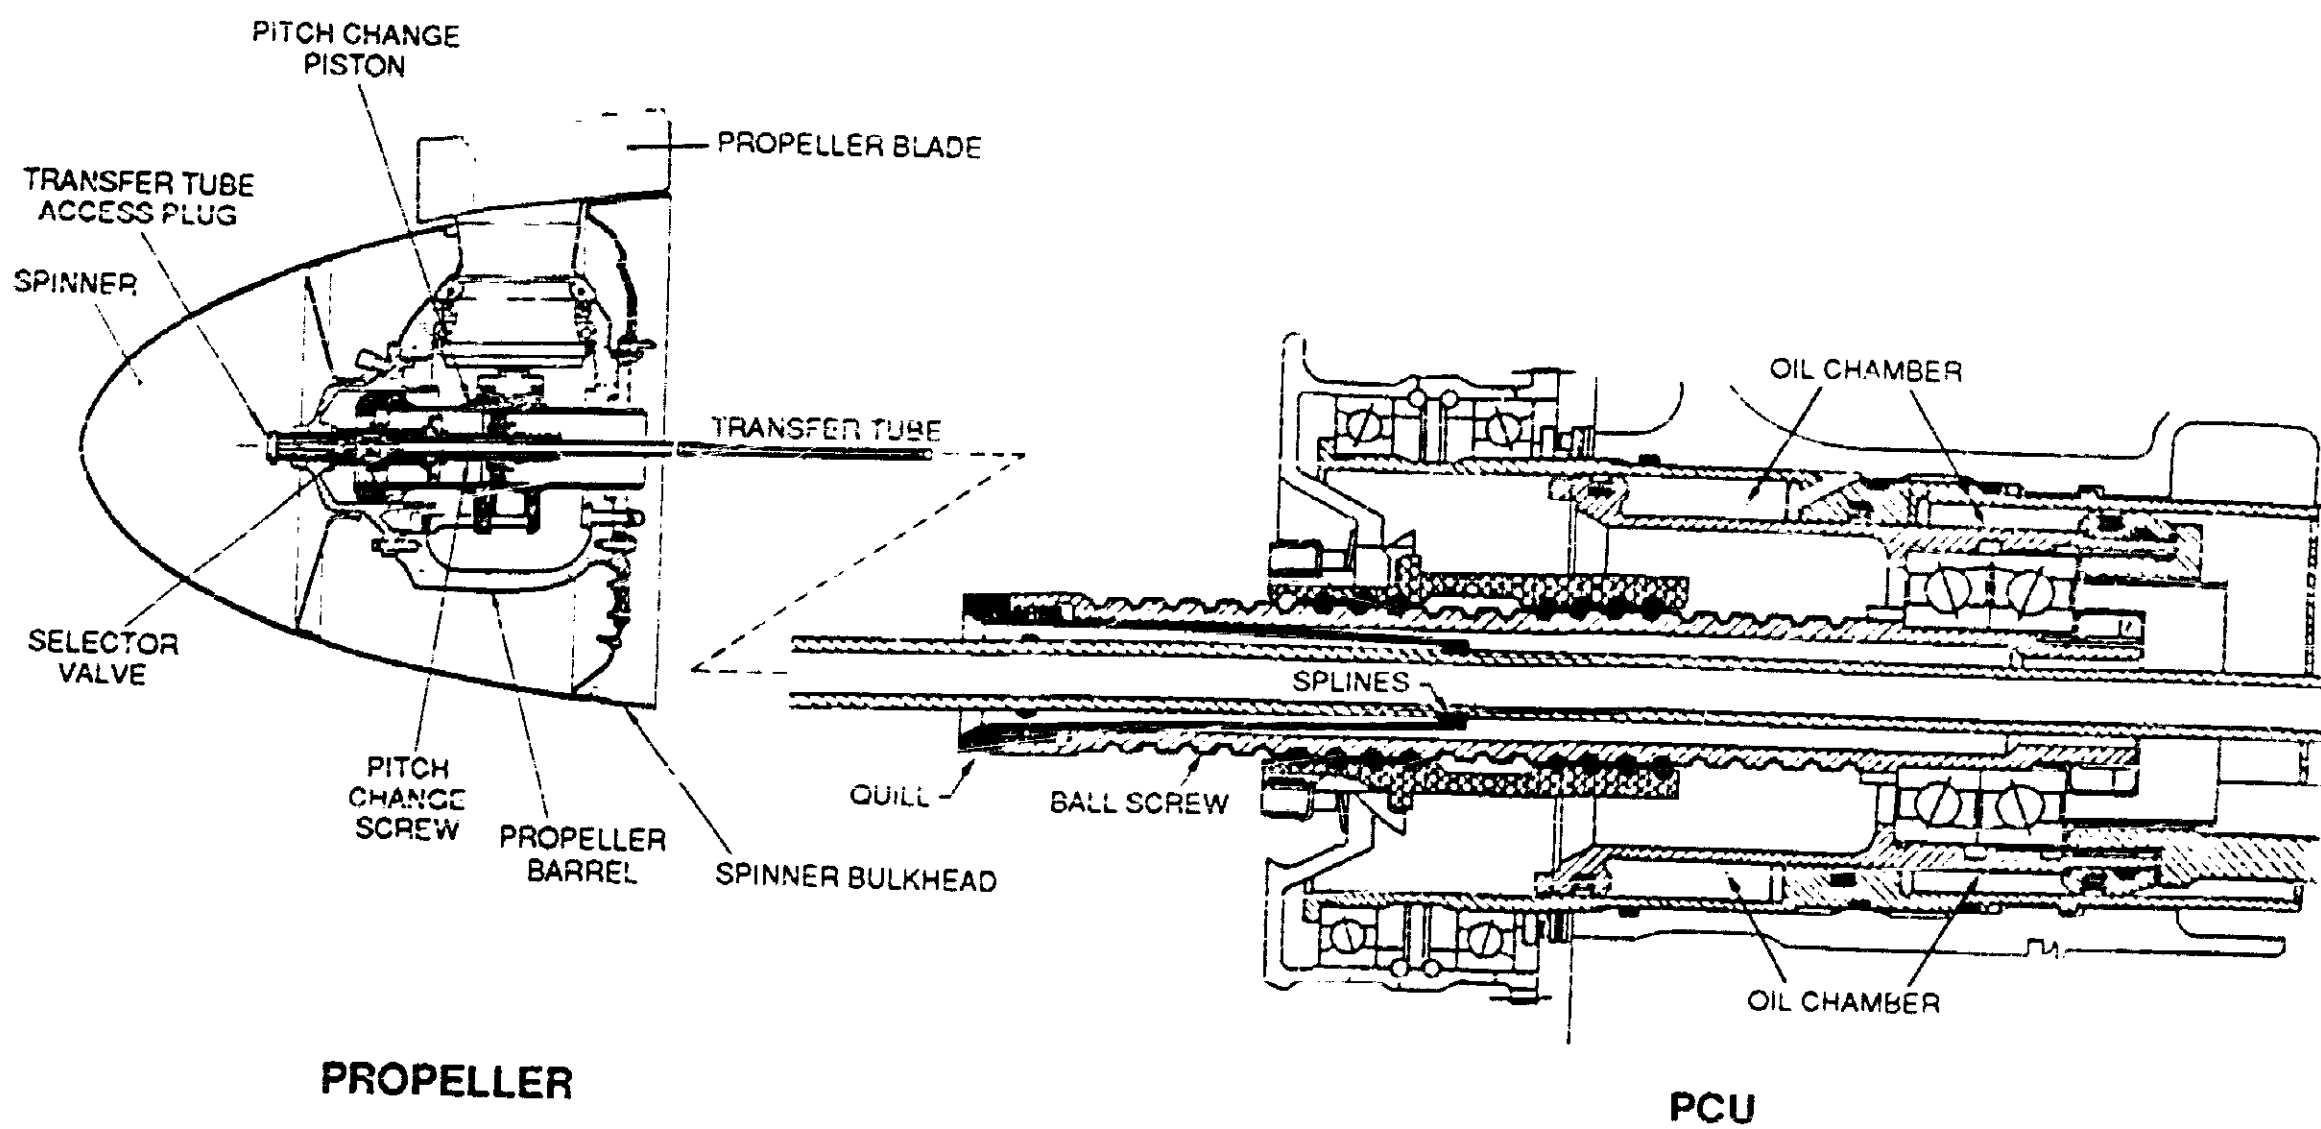
Figure 2.--Hamilton Standard propeller system Model 14RF.

The Hamilton Standard 14RF-9 propeller is a flange mounted, controllable pitch, dual acting, full feathering, reversible, four blade propeller with composite blades. The propeller and PCU are mounted on a common centerline and connected through the propeller shaft by the oil transfer tube. The transfer tube provides high pressure oil from the gearbox-mounted main oil pump to the propeller hub. The PCU governor provides metered oil pressure to operate a ballscrew drive which imparts rotary motion to the transfer tube by means of a splined quill. The transfer tube turns an acme screw in the pitch change assembly. The acme screw positions the pitch change selector valve, which directs oil to the "increase pitch" or "decrease pitch" side of the piston. (See figure 2).

Both PCU oil transfer tubes had the newer titanium-nitrided surface coating on the splines that engage the quill rather than the originally certificated nitrided surface finish. The spline surfaces on both tubes had a "matted" or dull finish appearance. The manufacturer's engineers stated that the matted appearance was the result of a relatively rough surface and that a smoother surface would have

more of a gloss or shiny appearance. They further stated that the matted finish was within the allowable surface finish specifications for the transfer tube splines.
