PB95-910401  
NTSB/AAR-95/01

## AIRCRAFT ACCIDENT REPORT

RUNWAY OVERRUN FOLLOWING REJECTED TAKEOFF  
CONTINENTAL AIRLINES FLIGHT 795  
McDONNELL DOUGLAS MD-82, N18835  
LaGUARDIA AIRPORT  
FLUSHING, NEW YORK  
MARCH 2, 1994

**Abstract:** This report explains the accident involving Continental Airlines flight 795, an MD-82 airplane, which experienced a runway overrun following a rejected takeoff from runway 13 at LaGuardia Airport, Flushing, New York, on March 2, 1994. Safety issues discussed in the report include the availability of takeoff performance data for flightcrews, the proper functioning of pitot/static heat systems, the duration of cockpit voice recordings, and problems associated with passenger evacuations from airplanes. Safety recommendations concerning these issues were addressed to the Federal Aviation Administration and to Continental Airlines, Inc.

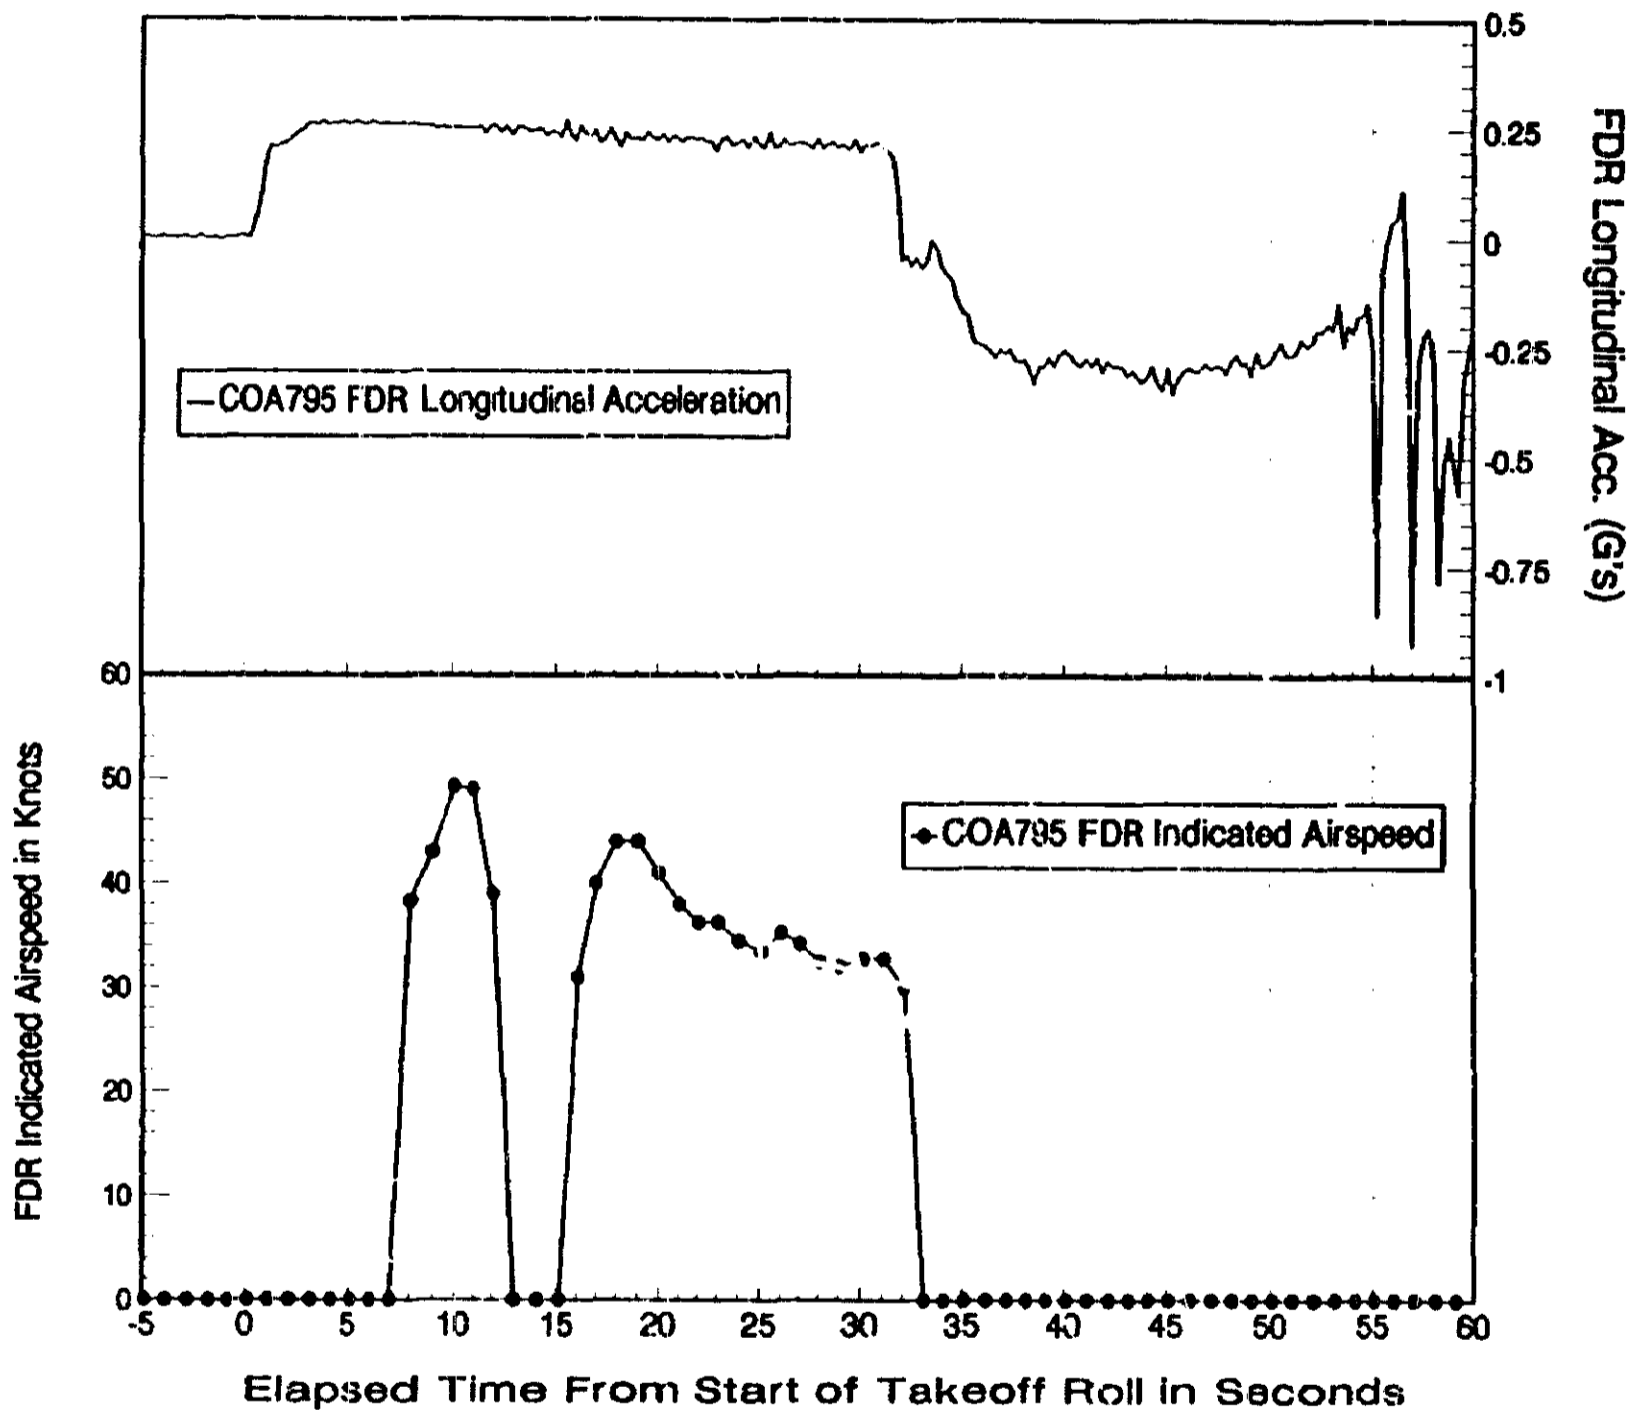
Figure 4.--FDR data.

The FDR indicated airspeed data were determined to be erroneous. Therefore, an airplane performance study was accomplished to determine groundspeed and time-distance histories of the airplane. Additionally, various takeoff/stop scenarios were examined. FDR longitudinal acceleration data, FDR pitch data, and prevailing winds were used to calculate indicated airspeed and distance traveled during the takeoff roll. (See figure 4).
