Motorcoach Collision With Combination Vehicle
After Traffic Break on Interstate 10
Palm Springs, California
October 23, 2016

Accident Report

NTSB/HAR-17/04
PB2018-100195

National
Transportation
Safety Board

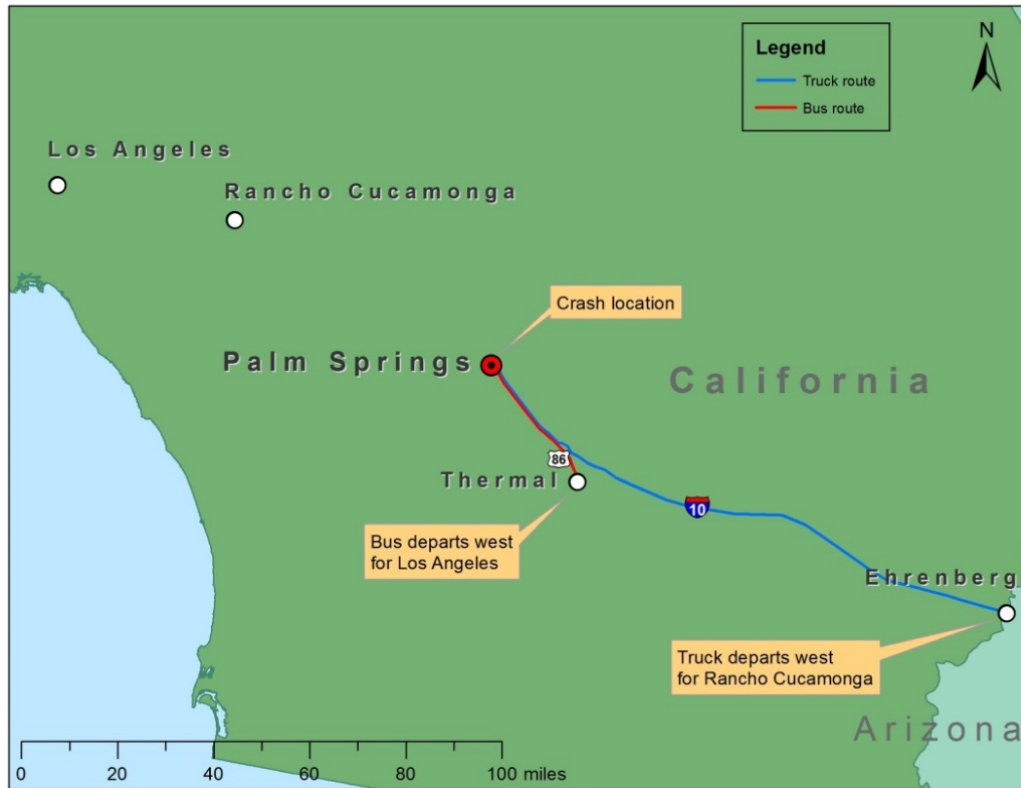
Figure 1. Map showing the bus and truck travel routes and the crash location.

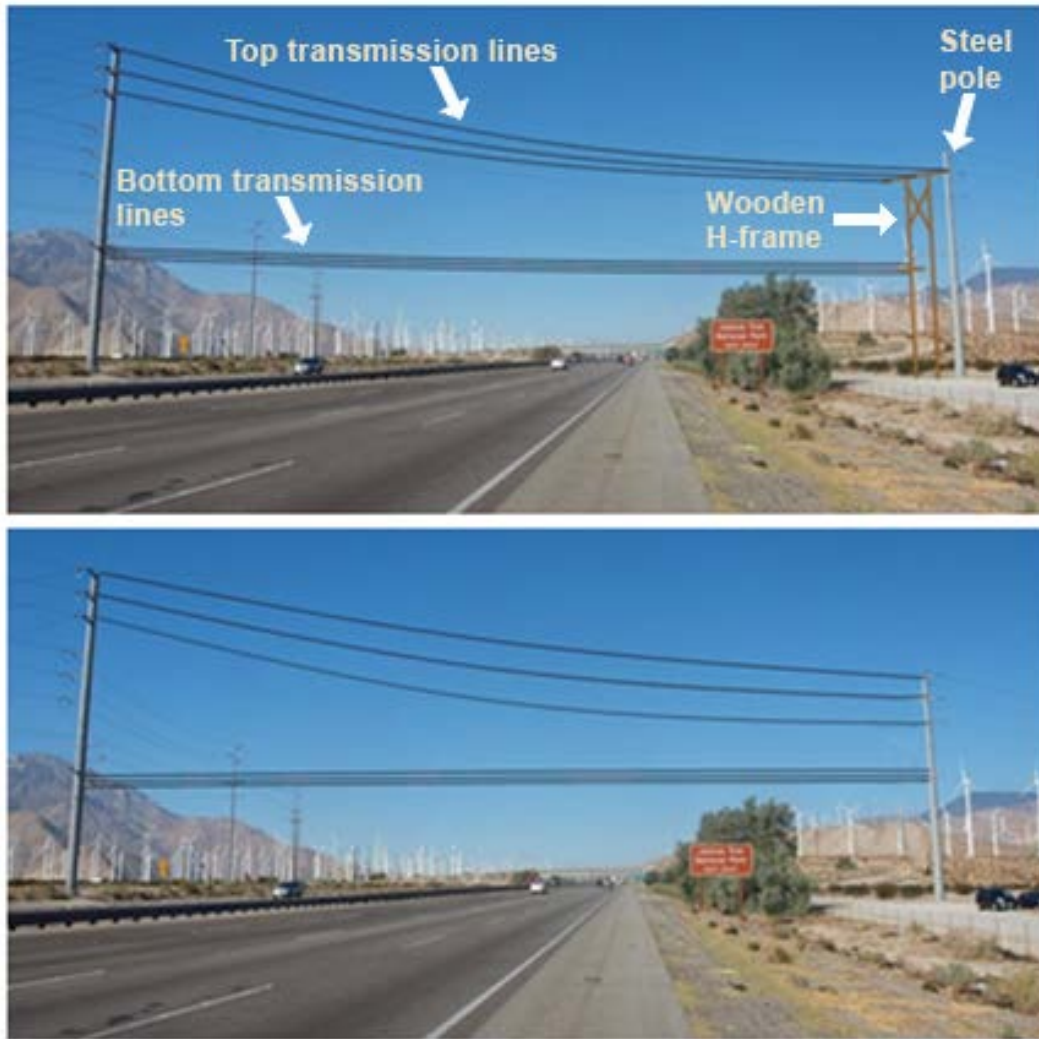
The Southern California Edison Company (SCE) was performing utility work on the day of the crash.¹⁶ The work occurred at milepost 31.1, about 1.36 miles west of the crash location. It consisted of transferring six transmission lines from an H-frame wood structure on the north side of I-10 to a new tubular steel pole, located beside the H-frame (see figure 5).

Figure 5. Utility work conducted across I-10. The top illustration depicts the conditions before the work began, and the bottom illustration shows the transferred transmission lines.

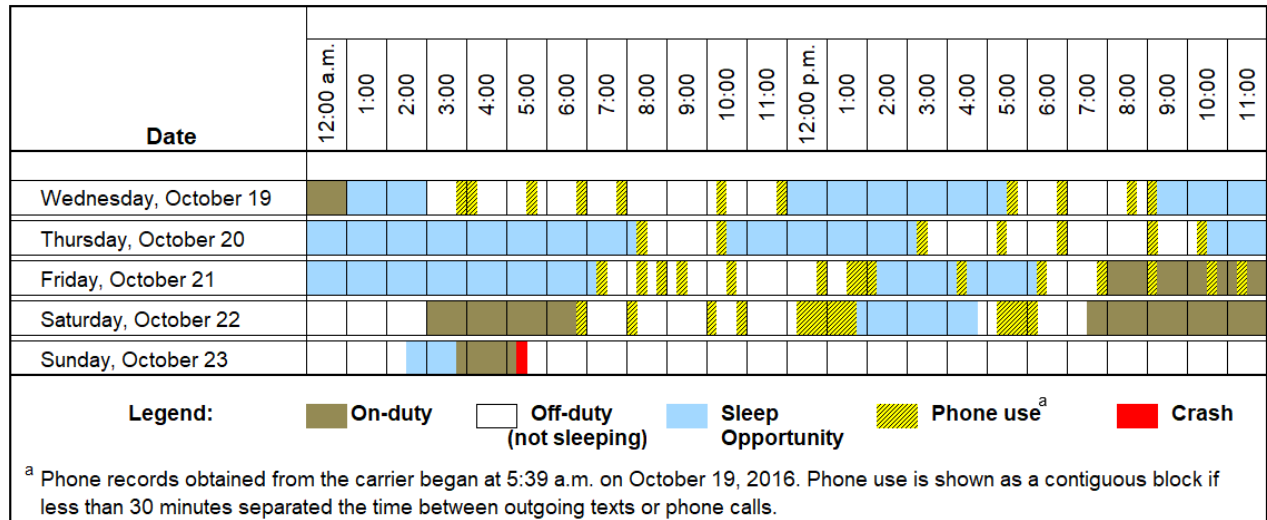
On October 22, the day before the crash, the bus driver returned home about 10:00 a.m. His family reported talking to him until about noon, at which time he went to bed. His cell phone records indicate that he engaged in phone activity until 1:33 p.m. The bus driver's son reported waking the driver at 4:45 p.m. Surveillance video from the Red Earth Casino showed the bus arriving at the casino at 11:22 p.m. on October 22, 2016. The video also showed the bus driver inside the casino until 2:32 a.m.—the early morning of October 23—at which time he left the casino and entered the bus. In interviews with NTSB investigators, several passengers reported knocking on the bus door shortly before 4:00 a.m., and they stated that they believed that the driver was asleep at the time. The video showed the bus driver moving the bus to the front of the casino at 4:03 a.m. to pick up the passengers. Figure 11 depicts the bus driver's activities on the day of the crash and for the 4 days before the crash.

Figure 11. Precrash activities of the bus driver, October 19–23, 2016. (The shortest depicted interval is 15 minutes.)
