School Bus Run-Off-Road and Fire
Oakland, Iowa
December 12, 2017

Highway Accident Report

NTSB/HAR-19/01
PB2019-100808

NTSB/HAR-19/01
PB2019-100808
Notation 58678
Adopted June 18, 2019

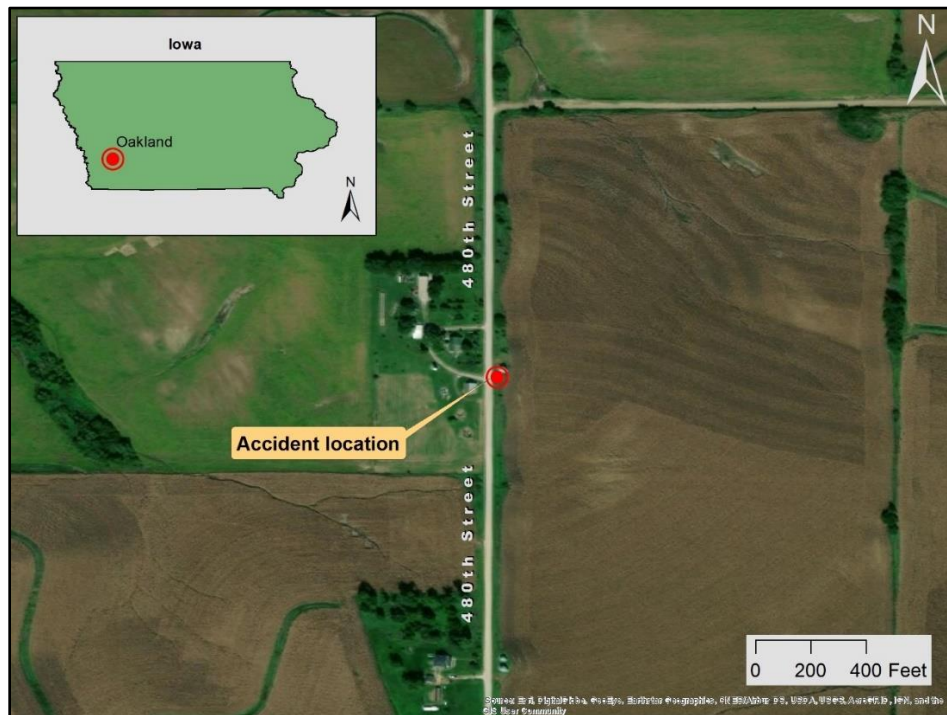
About 6:30 a.m. central standard time on December 12, 2017, a 2004 International 65-passenger school bus, operated by a 74-year-old driver for the Riverside Community School District (RCSD), left the district's bus maintenance facility and dispatch lot (known as the "bus barn") at Riverside Elementary School in Oakland, Iowa. The bus traveled south on 480th Street to its first student pickup at a residence in rural Pottawattamie County, 7 miles southeast of Oakland (figure 1).¹

Figure 1. Aerial view of school bus run-off-road location, with inset map showing Oakland on map of Iowa. (Source: Digital Globe Vivid Image)

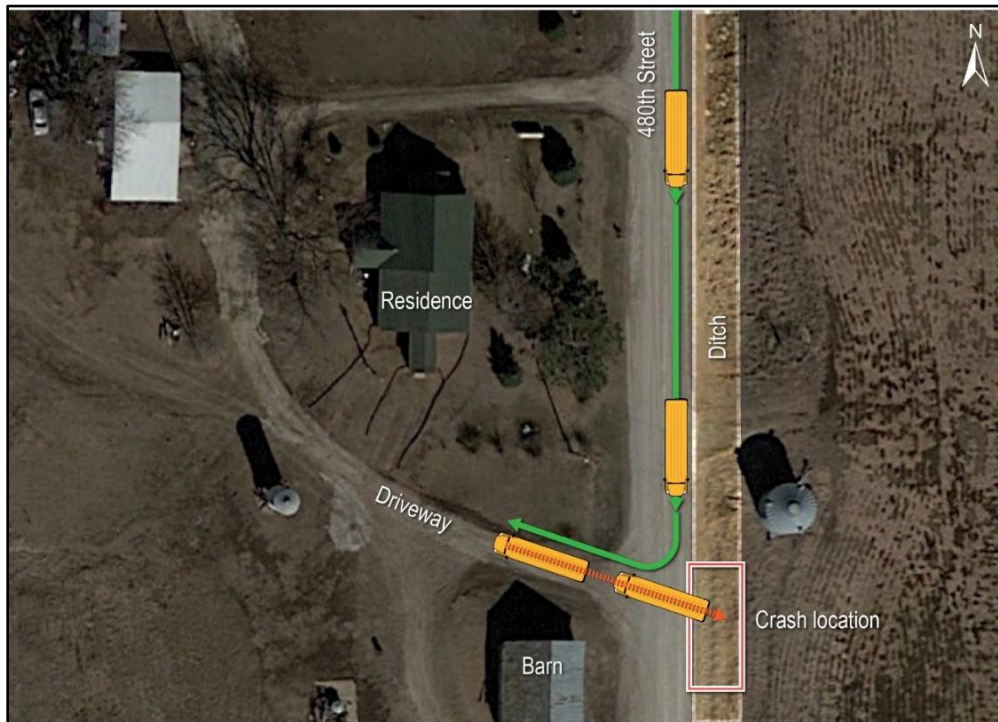
By about 6:50 a.m., the scheduled pickup time, the driver had turned right into the residence's driveway. As was his standard practice at the stop, after the student boarded the bus, the driver reversed out of the driveway so he could continue on 480th Street (a gravel road). At this location, the road is bordered on the east side by a 2.5-foot-wide earthen strip and then a 3-foot-deep drainage ditch. The driver reversed the bus out of the driveway and across 480th Street (figure 2). The bus's right rear wheels crossed the earthen strip and dropped into the ditch.

Figure 2. Aerial view showing direction school bus traveled on 480th Street, path into driveway entrance, and path in reverse to crash in roadside ditch (Source: Digital Globe Vivid Image)

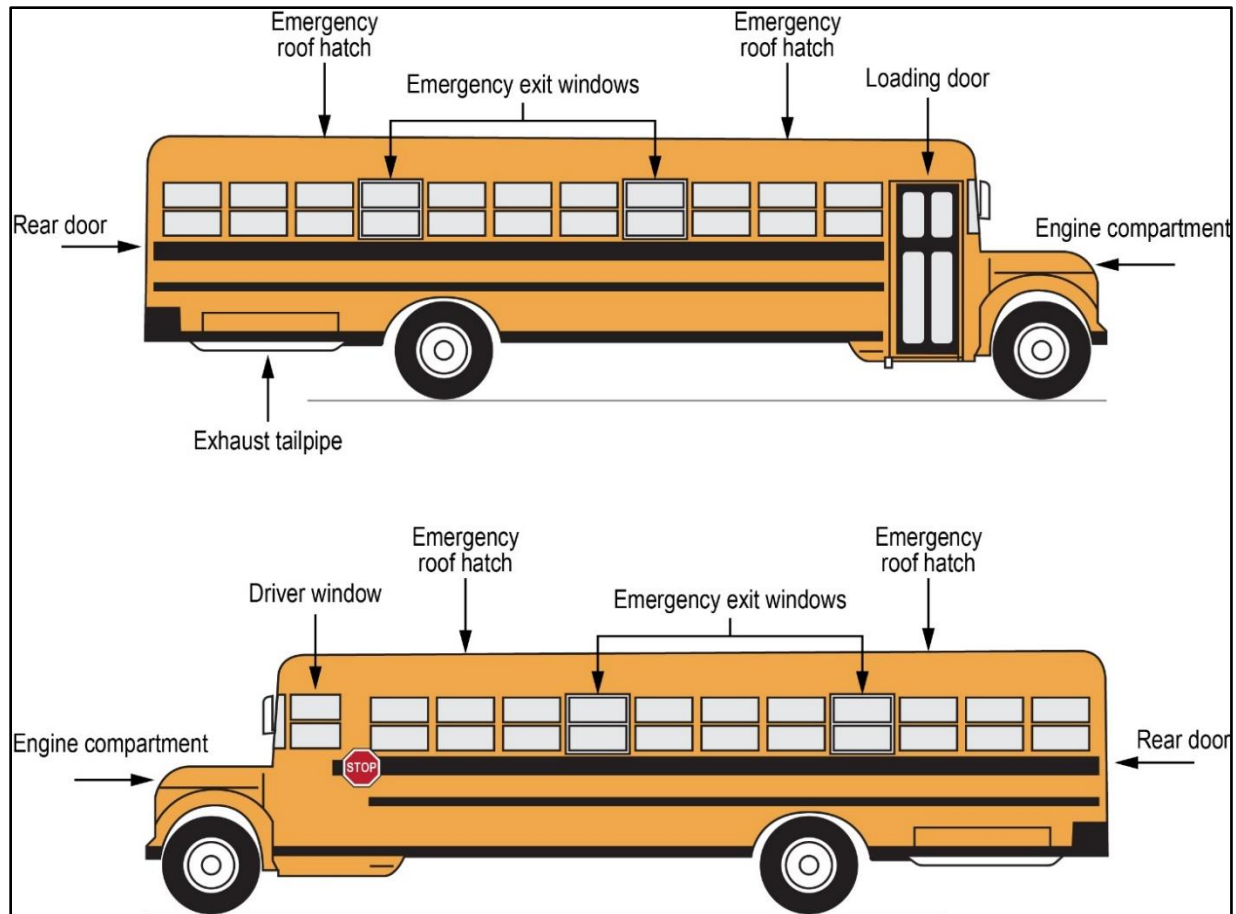
The interior of the school bus had 11 rows of bench seats on each side. A fire extinguisher was stored in a compartment above the windshield, behind the rearview mirror. The bus had a driver window and 11 windows on each side of the passenger area, 4 of which (2 on each side) were designated as emergency exits.⁴⁶ The bus also had a rear emergency door and two roof hatches above the aisle (figure 12).⁴⁷

⁴⁷ The aisle measured 18 inches wide between the seat benches, and the roof hatches were 6 feet above the floor. The emergency windows (windows 4 and 8 on both sides of the bus) were 24 inches wide and 21 inches high. The rearmost seat bench on the left was a two-person seat that allowed additional aisle clearance for accessing the rear emergency door.

Figure 12. Drawing of generic school bus showing details of both sides.

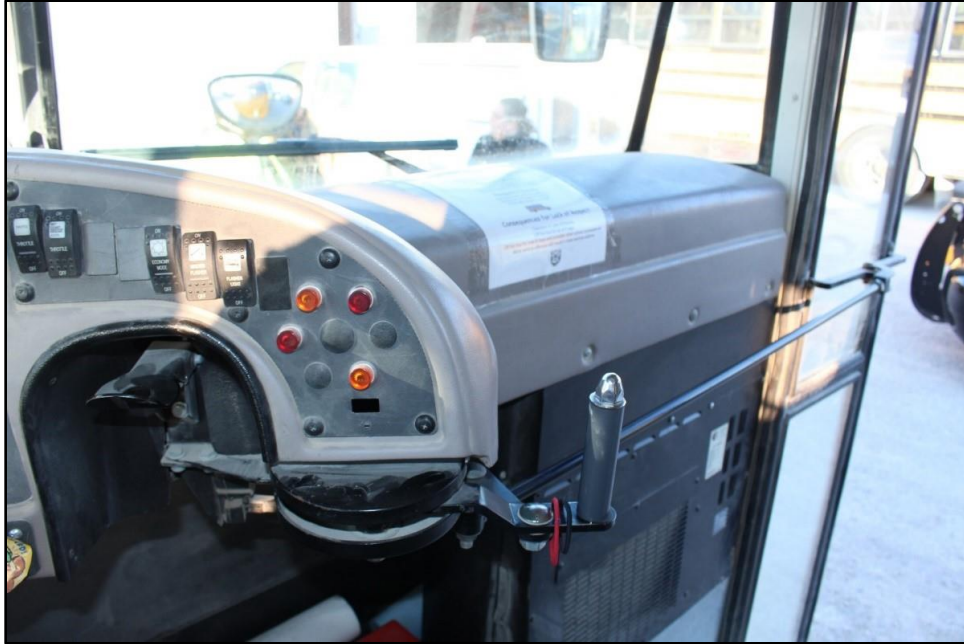
On the right front side of the bus was a manual-release loading door. In a school bus equipped with a manual-release front loading door, a seated driver can open or close the door by operating a control arm handle that acts on a lever arm to exert force against the door (figure 13). To open the door, the driver would go through the following steps:

Figure 13. Manually operated loading door at front of exemplar bus, showing hand-operated lever and connecting rod to door.

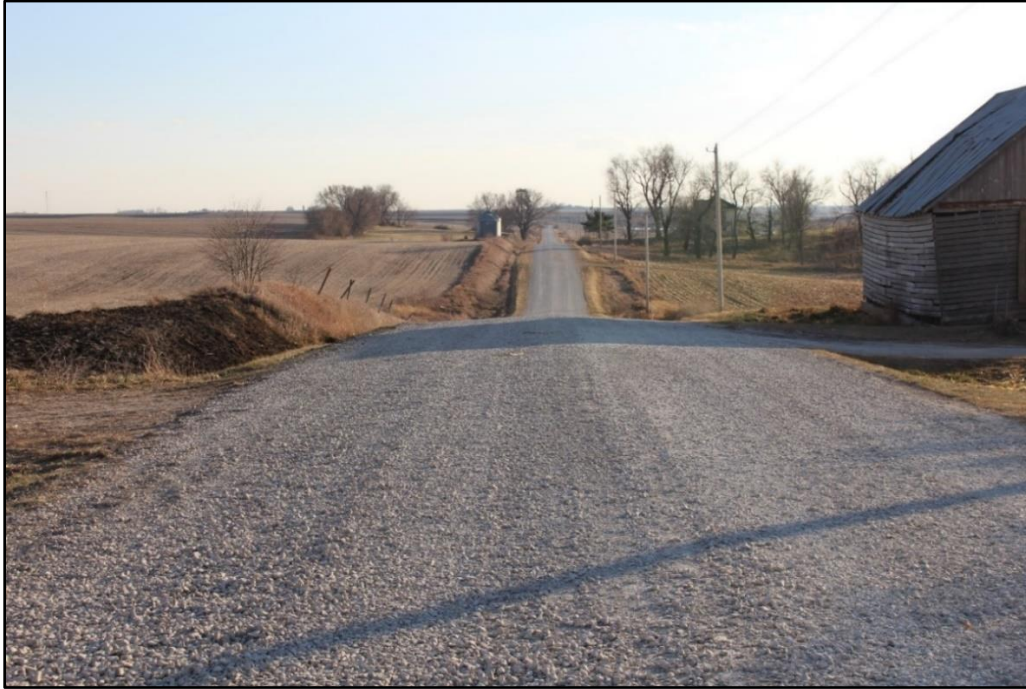
shoulder flanks the east side of the road, next to a 3-foot-deep drainage ditch parallel to the outer edge of the shoulder (figure 14). No roadside lighting is installed on 480th Street near the crash site. The speed limit is 55 mph.

Figure 14. Gravel surface of 480th Street at crash location (looking south), with embankment on left and driveway on right.

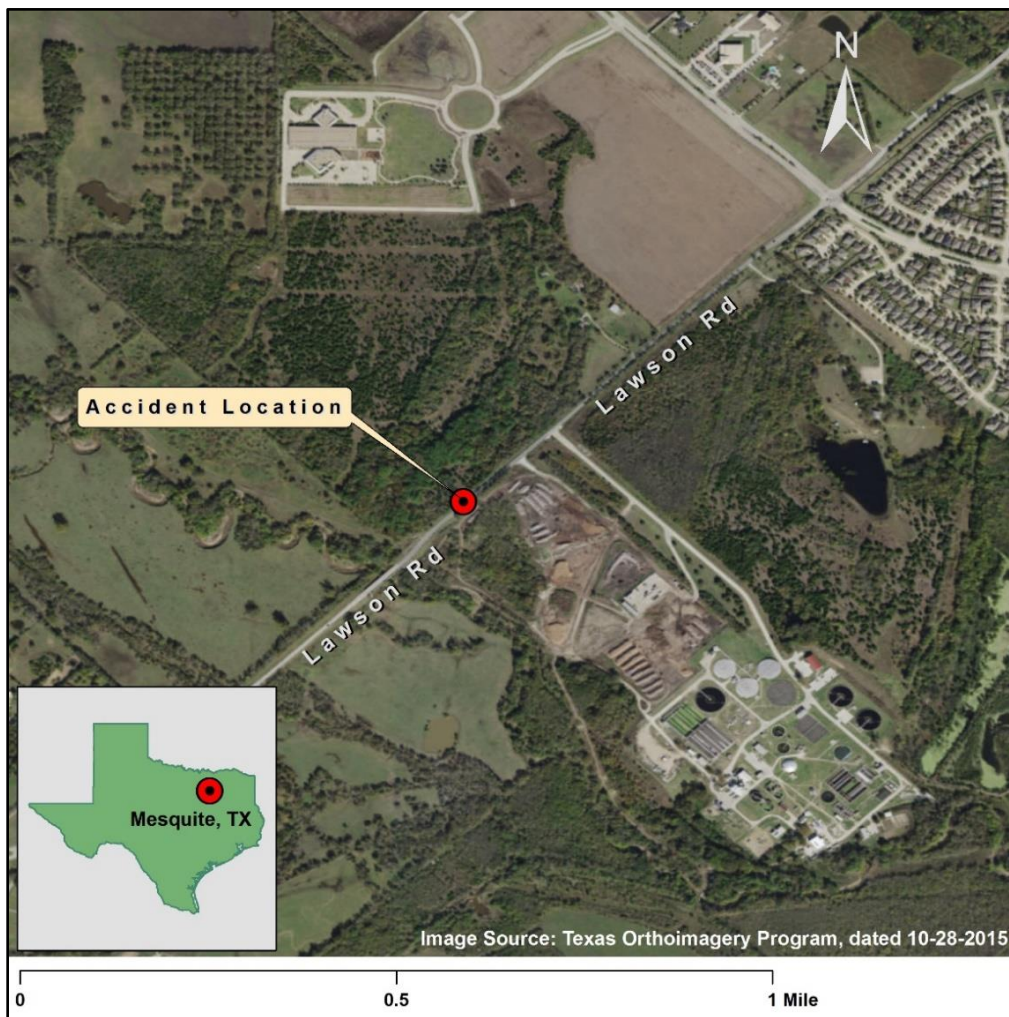
About 3:52 p.m. central daylight time on Wednesday, October 3, 2018, a 2019 IC conventional-style school bus operated by the Mesquite Independent School District was traveling south in the 3000 block of Lawson Road in Mesquite, Dallas County, Texas (figure 17). A 67-year-old driver and 54 students from Terry Middle School were on the bus. The bus was equipped with lap/shoulder belts at all seating positions, but it is not known how many occupants used them. According to the Mesquite Police Department (MPD) crash report, while the bus traveled on Lawson Road, its right rear tires dropped off the edge of the roadway. The driver steered the vehicle to the left, causing it to enter the opposing travel lane. When the driver steered the school bus back to the right, it ran off the right side of the roadway, rolled 90 degrees onto its side, and collided with a utility pole, resulting in a fire (figure 18).

Figure 17. Aerial photograph of crash site on Lawson Road, with inset map showing location of Mesquite on map of Texas. (Source: Texas Orthoimagery Program)
