NTSB/HIR-22/01

Multivehicle Crash Near Mt. Pleasant Township, Pennsylvania

January 5, 2020

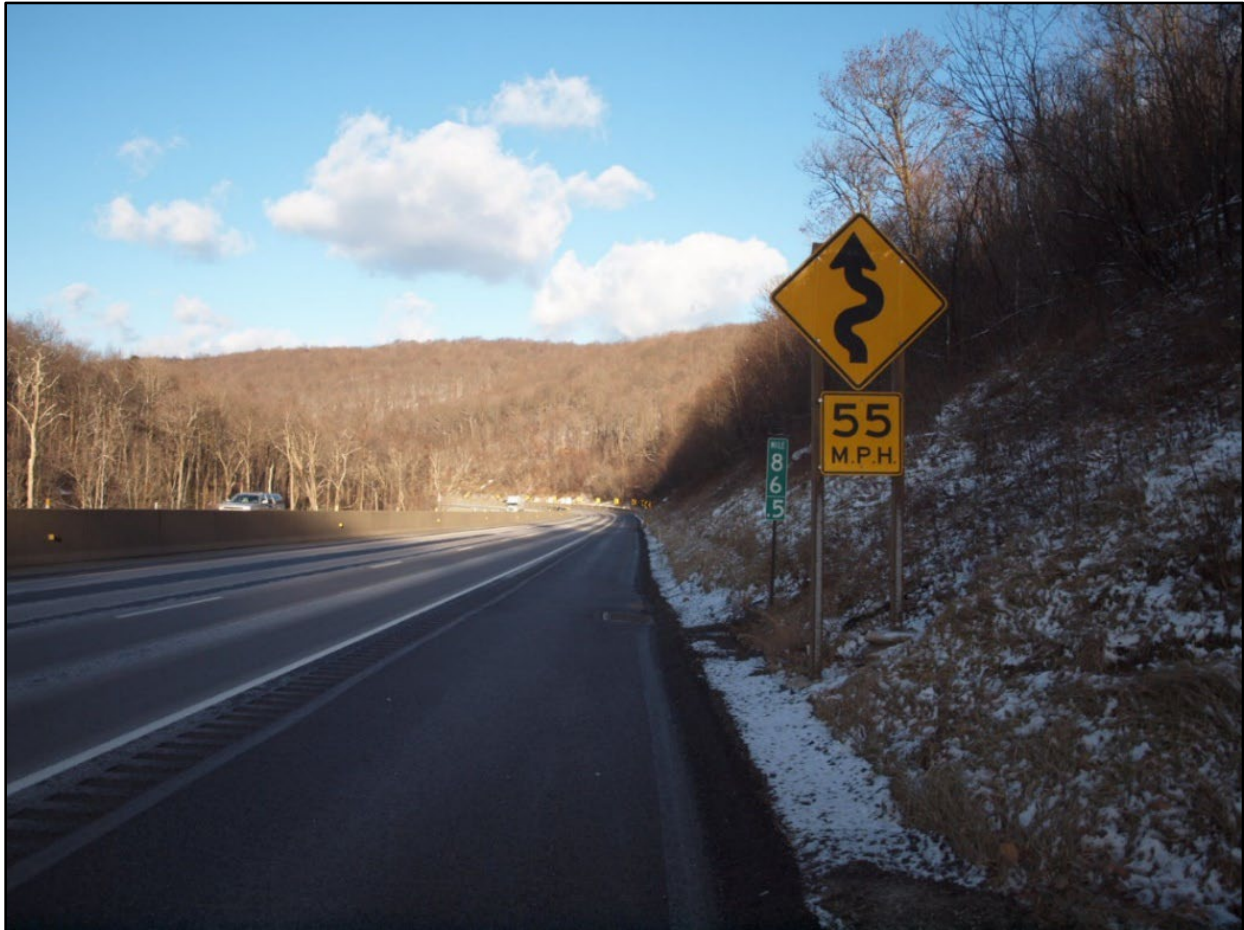
The posted regulatory speed limit for the Pennsylvania Turnpike was 70 mph. Advisory speed signs of 55 mph were posted along the turnpike, recommending that motorists reduce their speed before entering the roadway's curves.² An advisory speed sign was posted on the right side of the westbound lanes about 2,112 feet in advance of the curve where the crash occurred (see figure 2). Electronic data, including recorded speed, were retrieved from the motorcoach, the FedEx truck, and the two UPS trucks. The data indicate that the drivers of all three trucks braked before the impacts.

Figure 2. Advisory 55-mph speed sign posted in westbound lanes approaching crash site.

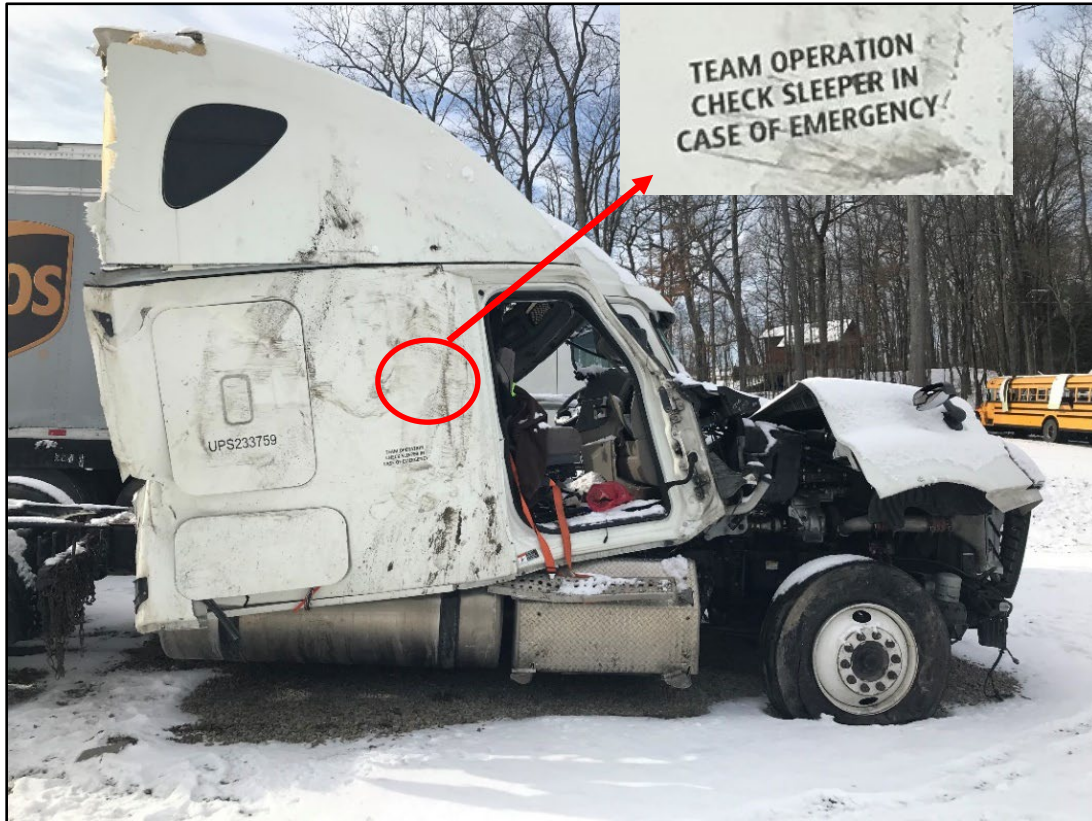
The right sides of the UPS trucks were marked with a sign reading "Team Operation Check Sleeper in Case of Emergency" (see figure 5). Emergency responders told the NTSB that the markings on the UPS trucks were useful and made them realize that they should look for two occupants in the wreckage of UPS-1.

Figure 5. Right side of UPS-1 showing sign telling emergency responders to check truck's sleeper berth.

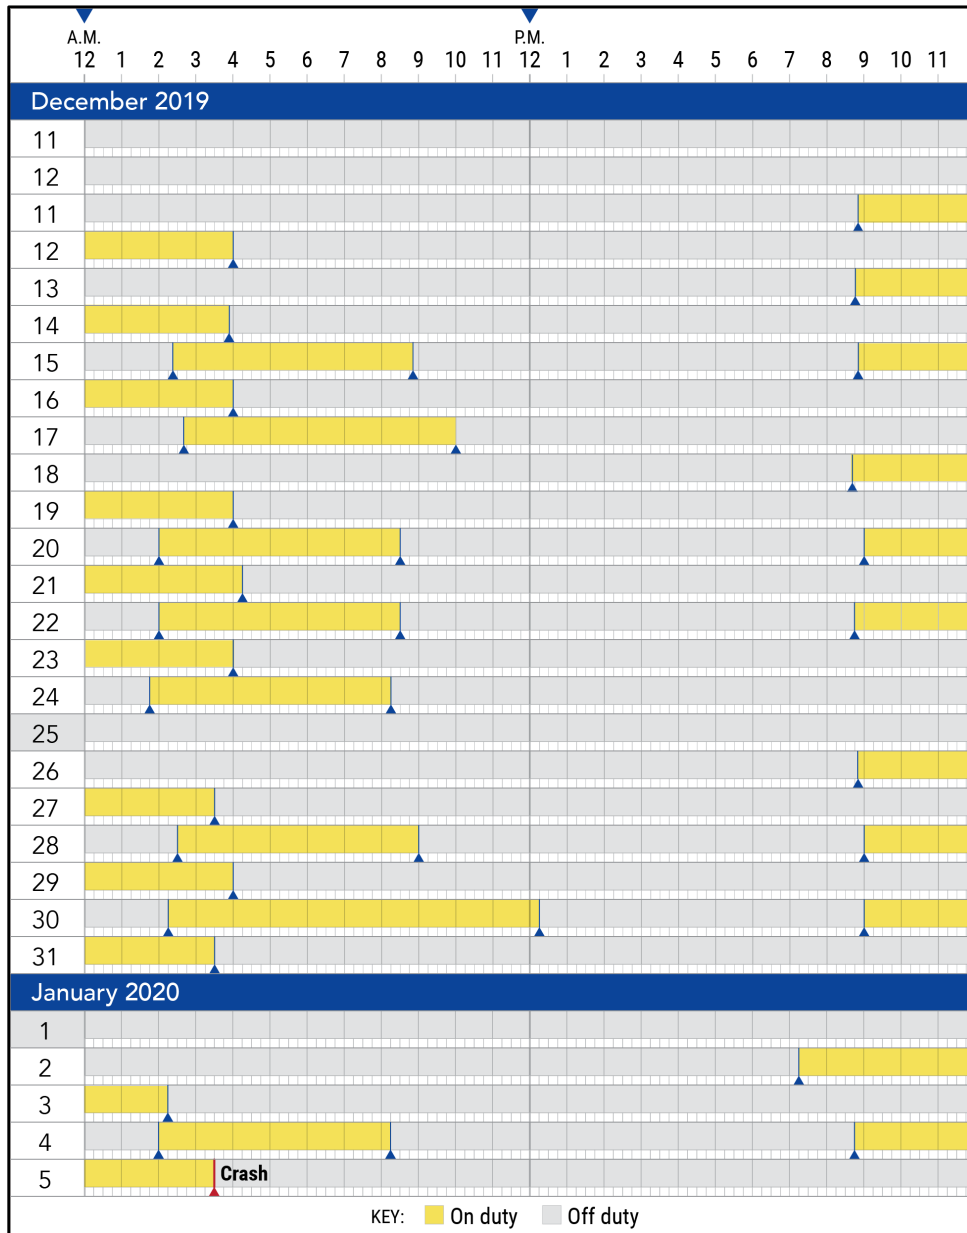
The driver worked a rotating schedule for Z&D Tour.¹³ His normal route was between New York City and New Stanton, Pennsylvania. Shifts could begin or end in either city. Shifts that began in the evening were generally followed by shifts that began in the early morning, and vice versa (see figure 6). In the 3.5 weeks before the crash, the driver worked 11 consecutive shifts, had a day off (Christmas), worked five more consecutive shifts, then had another day off (New Year's). Then, the driver worked three shifts until the crash.

Figure 6. Motorcoach driver’s schedule during month before crash.

The NTSB reviewed the motorcoach driver's work schedule and cell phone records to identify opportunities for him to sleep in the days before the crash. The schedule consisted of a dedicated route from and to the carrier's base in Queens, New York, and a driver exchange point in New Stanton, Pennsylvania. The motorcoach driver was familiar with the route and roadway. Each segment of the trip comprised a single shift of 6 or 7 hours. The start times of consecutive shifts rotated; that is, a shift that began in the evening and ended in the early morning was followed by a shift that began—after a 24-hour break for the driver—in the early morning and ended in the late morning. Then, after a 12-hour break for the driver, the cycle would begin again with an evening-to-early morning shift.⁸⁹ (For more information, refer to figure 6 in section 1.5.1.)

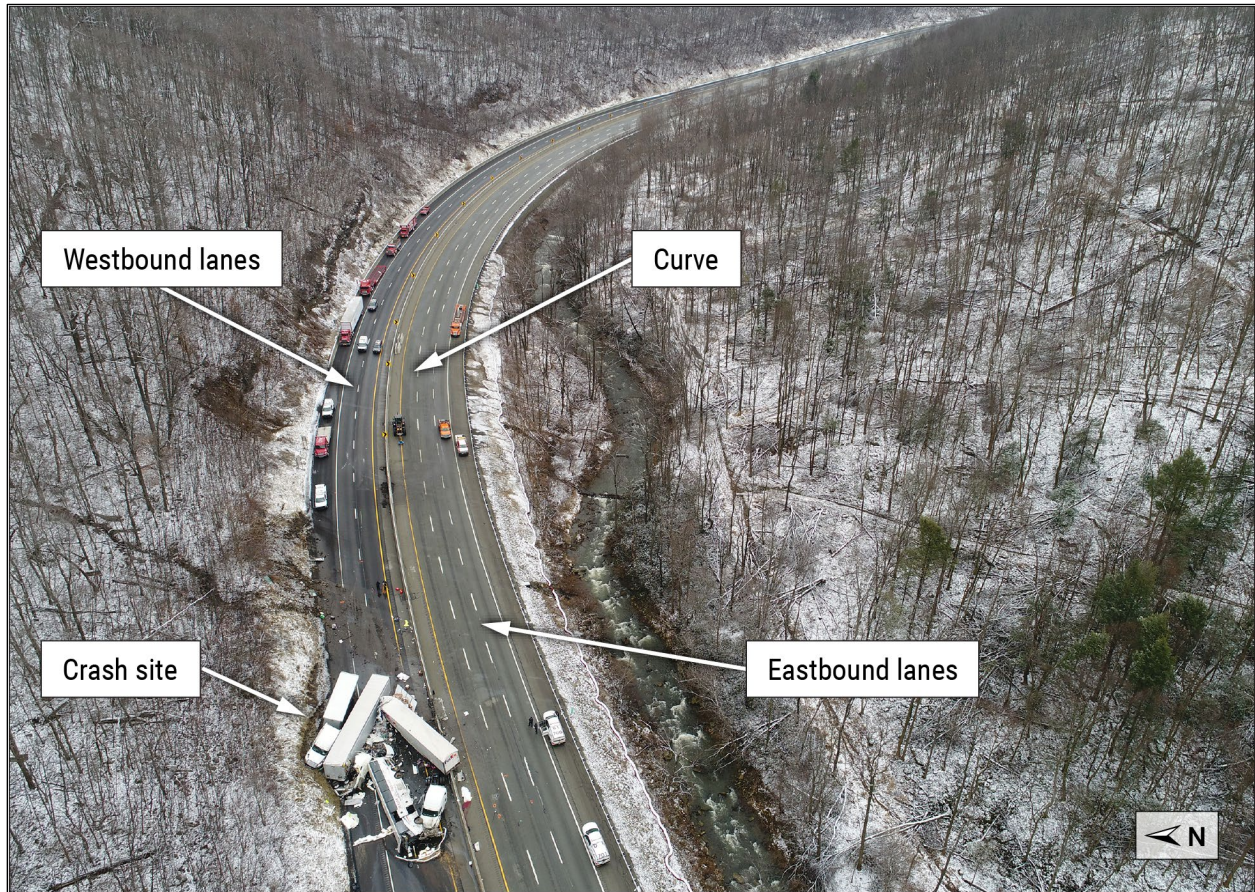
The crash occurred on the westbound Pennsylvania Turnpike, just beyond a left curve with a total length of 1,799 feet and a radius of 1,296 feet (see figure 16). The curve had a downgrade slope of 3 percent and a superelevation of 8 percent.³⁸

Figure 16. Aerial view of crash scene showing curve and west- and eastbound travel lanes. (Source: Pennsylvania State Police with NTSB overlay)
