Highway Investigation Report HIR-23/04

# Multivehicle Collision Involving a Milk Tank Combination Vehicle and Stopped Traffic Queue

Phoenix, Arizona  
June 9, 2021

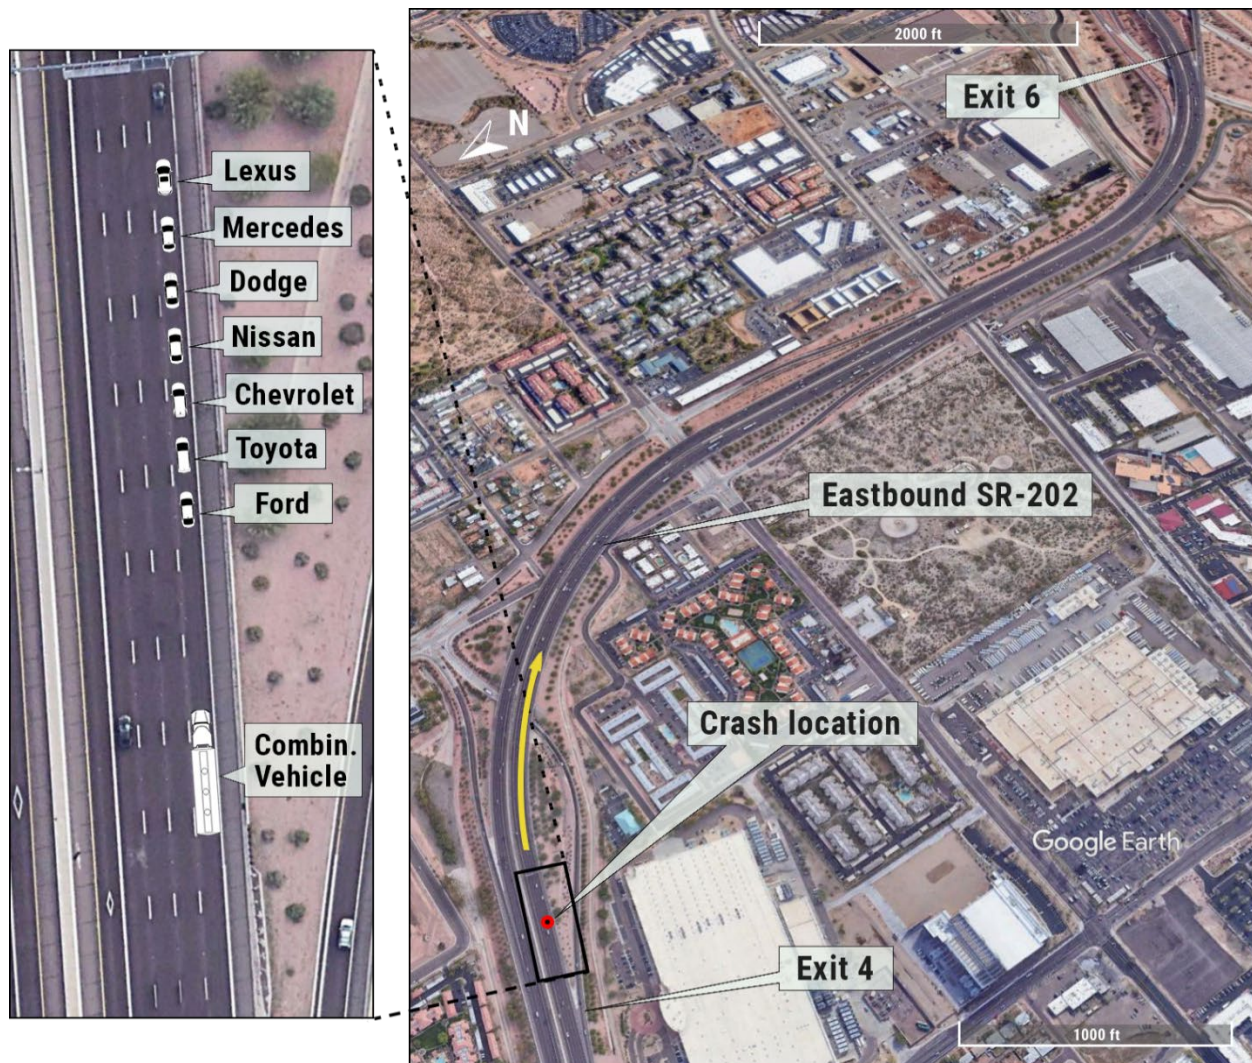
In the area of the crash, SR-202 is a divided highway with a posted speed limit of 65 mph and the eastbound and westbound lanes are separated by a concrete median barrier. The crash occurred in the far-right lane about 200 feet east of exit 4 (see figure 1).

**Figure 1.** Aerial view of the area of the crash, with an inset showing the position of the vehicles involved in the crash. (Source: Adapted from Google Earth)

The truck-tractor along with the Chevrolet came to rest in the left eastbound lane, where they were consumed by a postcrash fire (see figure 3). As shown inset in figure 1, in addition to the combination vehicle and the vehicles listed above, four other passenger vehicles, positioned in front of the traffic queue, were involved in the crash. The additional passenger vehicles—a 2015 Nissan Altima, a 2015 Dodge Charger, a 2018 Mercedes-Benz C300W, and a 2013 Lexus CT200H—were struck by the vehicles behind them and collided with each other during the crash sequence before coming to rest (the detailed crash sequence is described in section 1.5).

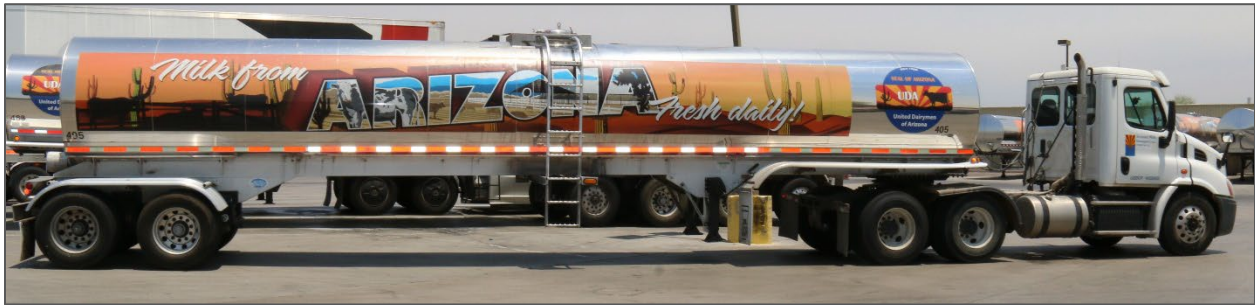
**1.4.1.1 General Description.** The combination vehicle consisted of a 2016 Freightliner Cascadia truck-tractor and a 2015 Walker Stainless Equipment tank-trailer (see figure 5 for an image of an exemplar vehicle). The truck-tractor was equipped with a Detroit Diesel 400-horsepower engine, a 12-speed automatic transmission, and Wabco pneumatic brakes. At the time of manufacture, the truck-tractor had a gross vehicle weight rating (GVWR) of 52,000 pounds; the GVWR of the semitrailer

**Figure 5.** Right-side view of an exemplar combination vehicle with AMT truck-tractor and UDA tank-trailer.

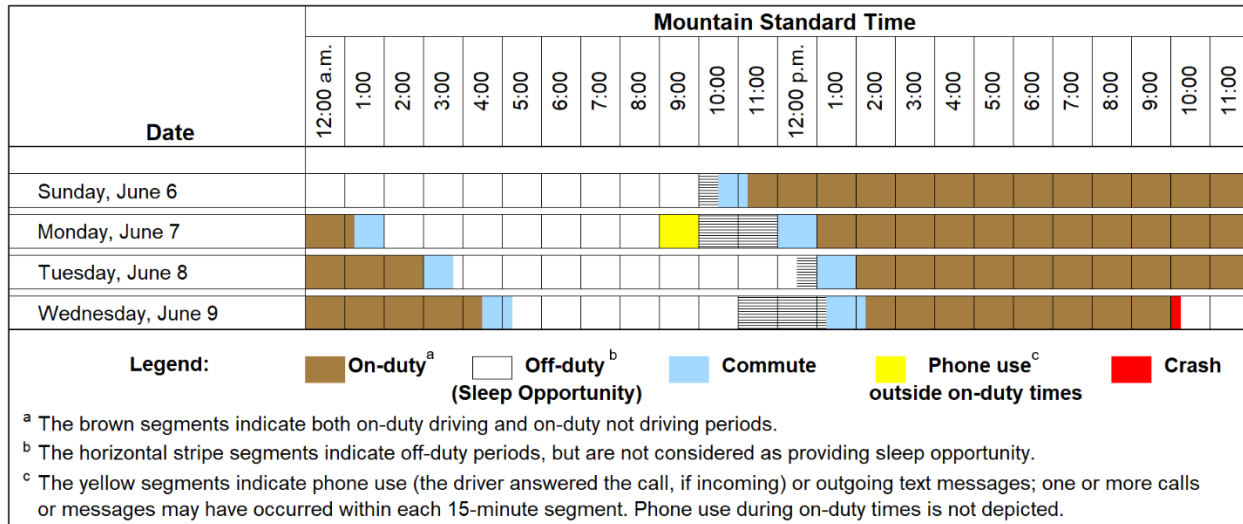
7 a.m. or 8 a.m. due to family obligations. In the postcrash interview with the AZDPS, the driver stated that on the day of the crash he woke up about 10:30 a.m.–11 a.m. His phone records for the 3 days before the crash indicate regular cell phone use—outgoing calls and text messages through short message service (SMS)—during his work hours, although it is not possible to determine whether he was driving during those times.<sup>37</sup> The phone records also indicate a 39-minute phone call that started shortly after 9 a.m. on Monday, 2 days before the crash. Figure 14 shows the truck driver’s activities in the 3 days before and on the day of the crash.

**Figure 14.** Precrash activities of truck driver, June 6–9, 2021. Phone use during duty hours is not depicted in the figure.

The truck driver did not work on June 5. On June 6, after about a 10-hour opportunity for sleep, he arrived at the AMT yard and began his shift about 11:30 a.m. He completed the shift about 1:15 a.m. on June 7, and returned home about 2 a.m. On June 7, after about a 7-hour opportunity for sleep, he arrived at the AMT yard and started his shift about 1 p.m. He completed his shift and returned home about 3:30 a.m. on June 8. On June 8, after about an 8.5-hour opportunity for sleep, he arrived at the AMT yard and started his shift about 2 p.m. He completed his shift and returned home about 5 a.m. on June 9.

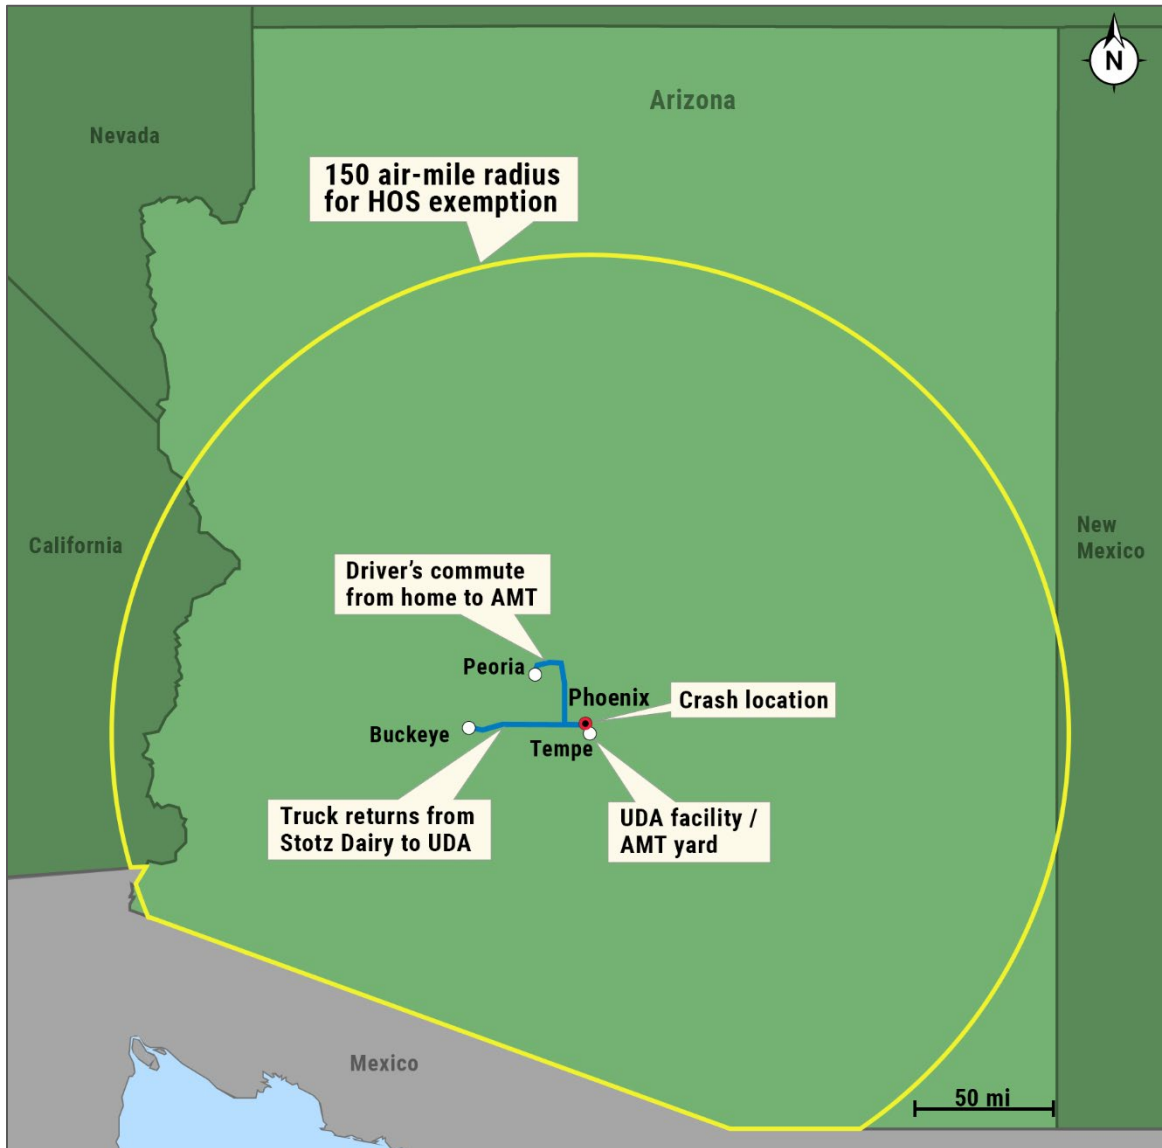
In October 2012, Congress passed the Moving Ahead for Progress in the 21st Century Act (MAP-21), which confirmed and expanded the list of commodities covered under agricultural exemption. MAP-21 also increased the operating radius eligible for the agricultural exemption from 100 to 150 air-miles (figure 15).<sup>43</sup> In November 2021, Congress passed the Infrastructure Investment and Jobs Act, which expanded the agricultural exemption to drivers transporting livestock within a 150

**Figure 15.** The 150 air-mile radius of the agricultural HOS exemption, overlaid on a map of the state of Arizona. The truck driver's route is also outlined on the map.
