HIR-23-10

Grade Crossing Collision Between Commuter Train and Box Truck

Clarendon Hills, Illinois
May 11, 2022

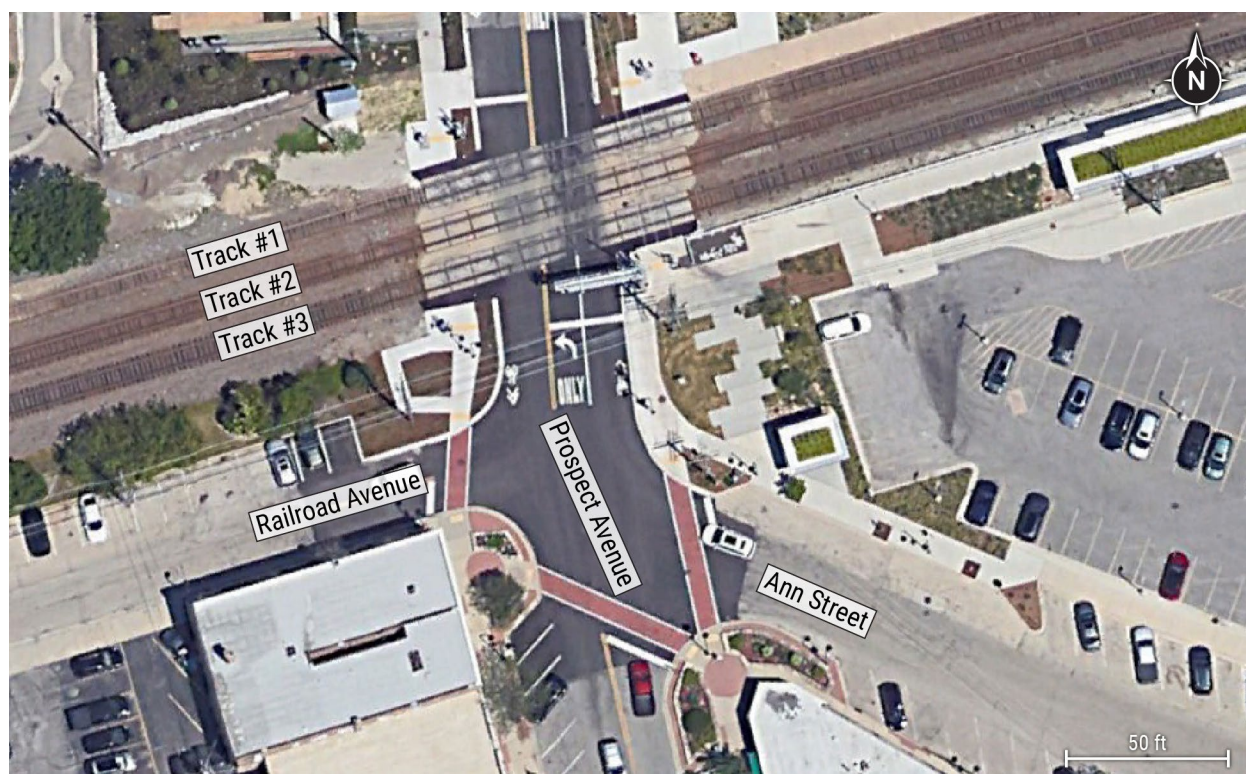
At the grade crossing, Prospect Avenue consisted of one northbound dedicated left-turn lane, one northbound through lane, and one southbound travel lane. The grade crossing consisted of three BNSF Railway (BNSF) tracks and the three lanes of Prospect Avenue (Figure 3). The roadway grade leading up to the south end of the grade crossing was approximately a 6% upward grade.

Figure 3. Overhead view of the Prospect Avenue grade crossing with side streets and track numbers annotated. (Source: Google Maps [image from 2023], annotations by NTSB)
