HIR-24/03

# Fire on Battery Electric Transit Bus

Hamden, Connecticut  
July 23, 2022

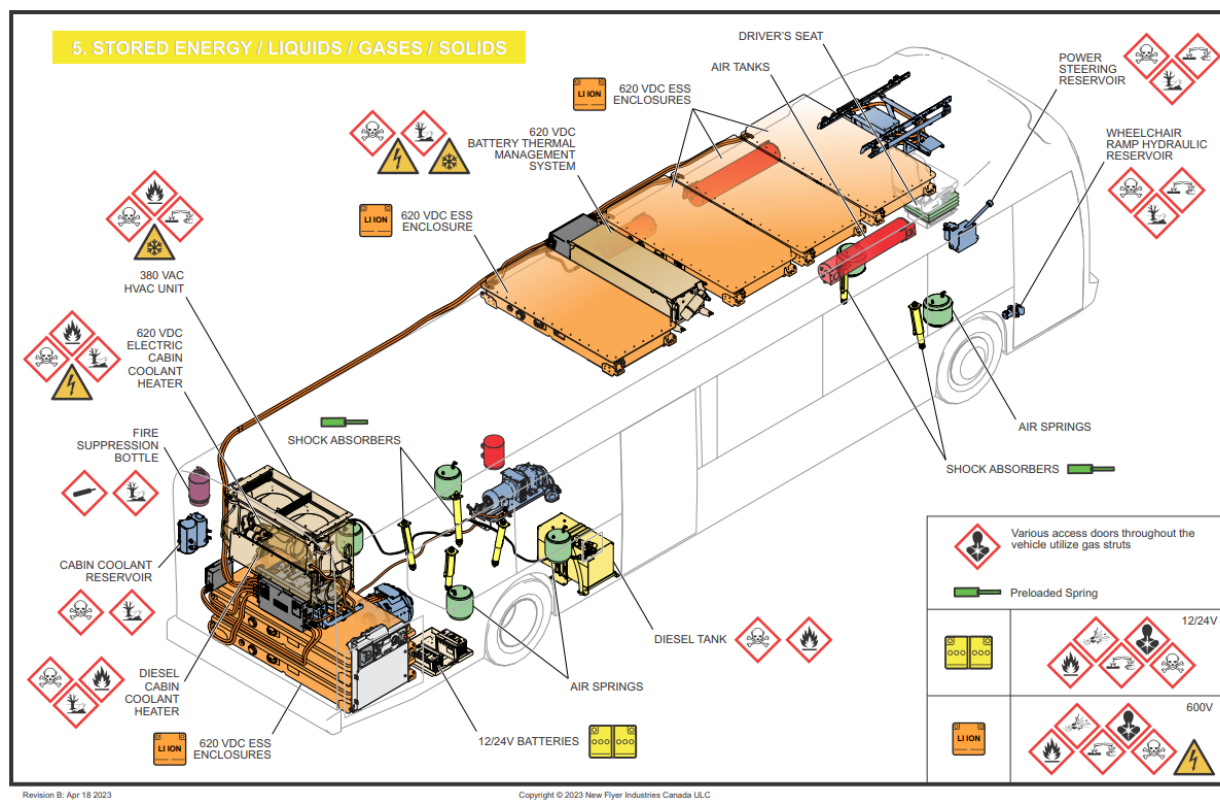
ESS also contains components used to control and monitor the batteries' voltage, conduct thermal management, and eliminate moisture. A diagram of components from the emergency response guide (ERG), including ESS locations, is shown in figure 2.

**Figure 2.** Diagram of component locations, including ESS enclosures, from the New Flyer ERG.
