Air Products and Chemicals, Inc. Tube Trailer
Module Hydrogen Release and Subsequent Fire
Diamond Bar, California
February 11, 2018

NTSB/HZM-19/02
PB2019-101398
Notation 59258
Adopted October 10, 2019

Hazardous Materials Incident Report

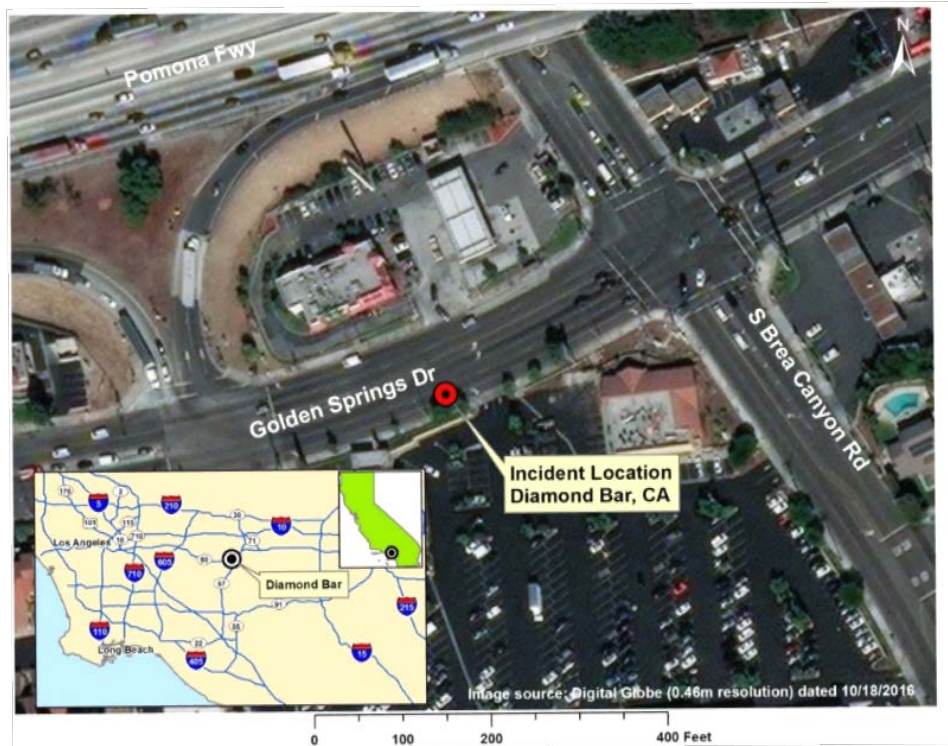
Figure 1. Aerial view of the incident location, Diamond Bar, California.

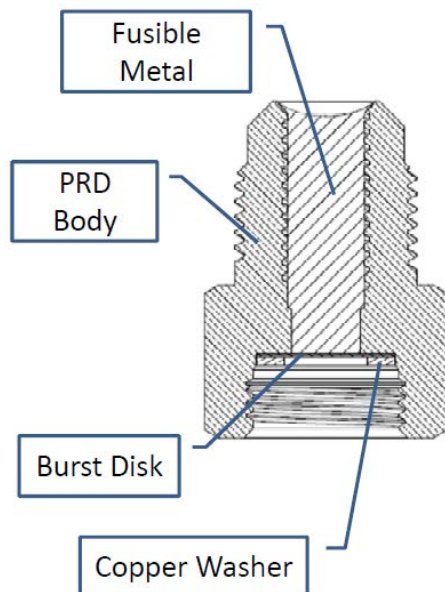
In accordance with the trailer and composite cylinder design, the PRDs were CG-5 type devices (combination rupture disk/fusible plug).⁷ The cylinder manufacturer's drawings call for Sherwood Valve, LLC (Sherwood) model 3132SB9-95 PRDs with a set pressure of 10,000 psig. These PRDs contain a copper rupture disk that is directly exposed to the internal cylinder pressure and is situated immediately upstream of a fusible metal plug in the discharge port.⁸ The design intends for the fusible metal plug to weaken from thermal exposure before the rupture disk bursts from overpressure. (See figure 2.) The CG-5 type devices require a combination of both high pressure and high temperature (212°F) to first melt the fusible metal, after which the device affords the same overpressure protection as does a type CG-1 rupture disk. The rupture disk is reinforced against rupturing by the fusible metal, and the fusible metal is reinforced against extrusion by the rupture disk. The advantage of using a CG-5 type device to protect cylinders used for flammable gases is it may provide a few minutes of extra time for personnel to evacuate a cylinder exposed to fire before its rupture disk activates, leading to greater potential for injury.

Figure 2. Sherwood valve type 3132SB PRD.

Type 3132SB PRDs are available in a range of pressures. Lower-pressure devices, such as the model 3132SBF9-55 nickel disk variant with a burst pressure of 5,833 psi, are typically used for cylinders containing compressed natural gas. The 10,000 psi PRDs are used in hydrogen carbon fiber composite cylinder service.

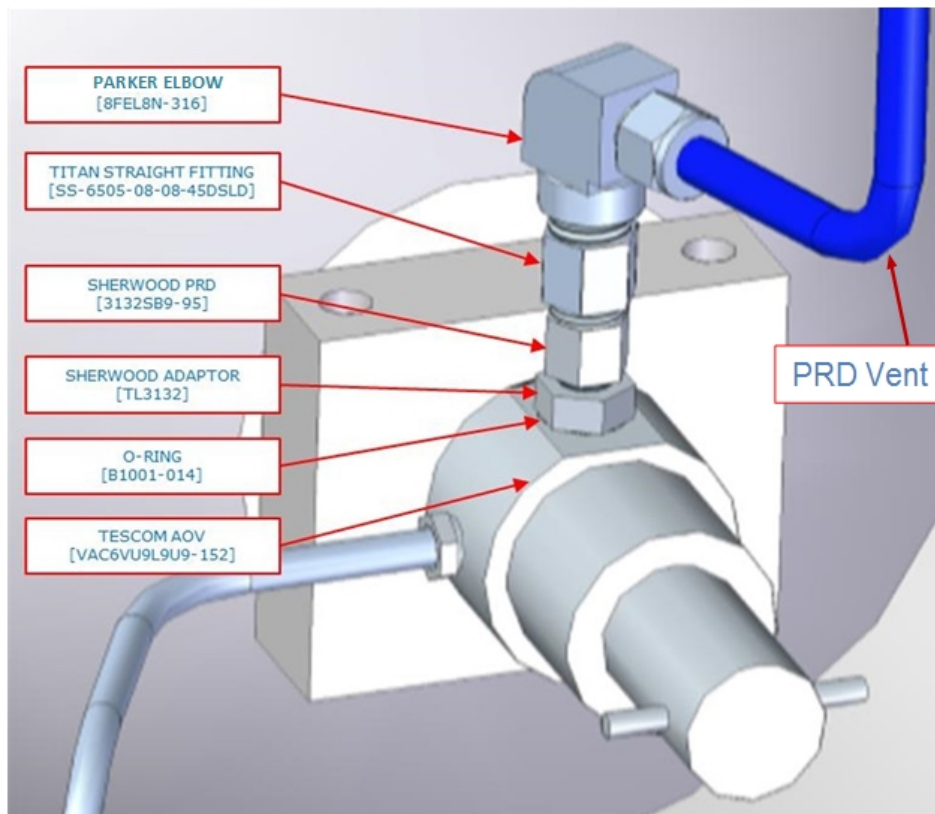
The incident module PRDs were contained in an assembly that consisted of a brass-threaded adaptor, brass-body PRD, stainless-steel straight fitting, and stainless-steel elbow. (See figure 3.) The 50 front and rear cylinder heads were each equipped with a PRD assembly and vent line. The rear heads were also fitted with Tescom shutoff valves to control discharge and filling, and tubing associated with the module's manifold system.

Figure 3. Cylinder fittings arrangement for rear heads. The PRD vent line compression fitting is attached to the Parker elbow.

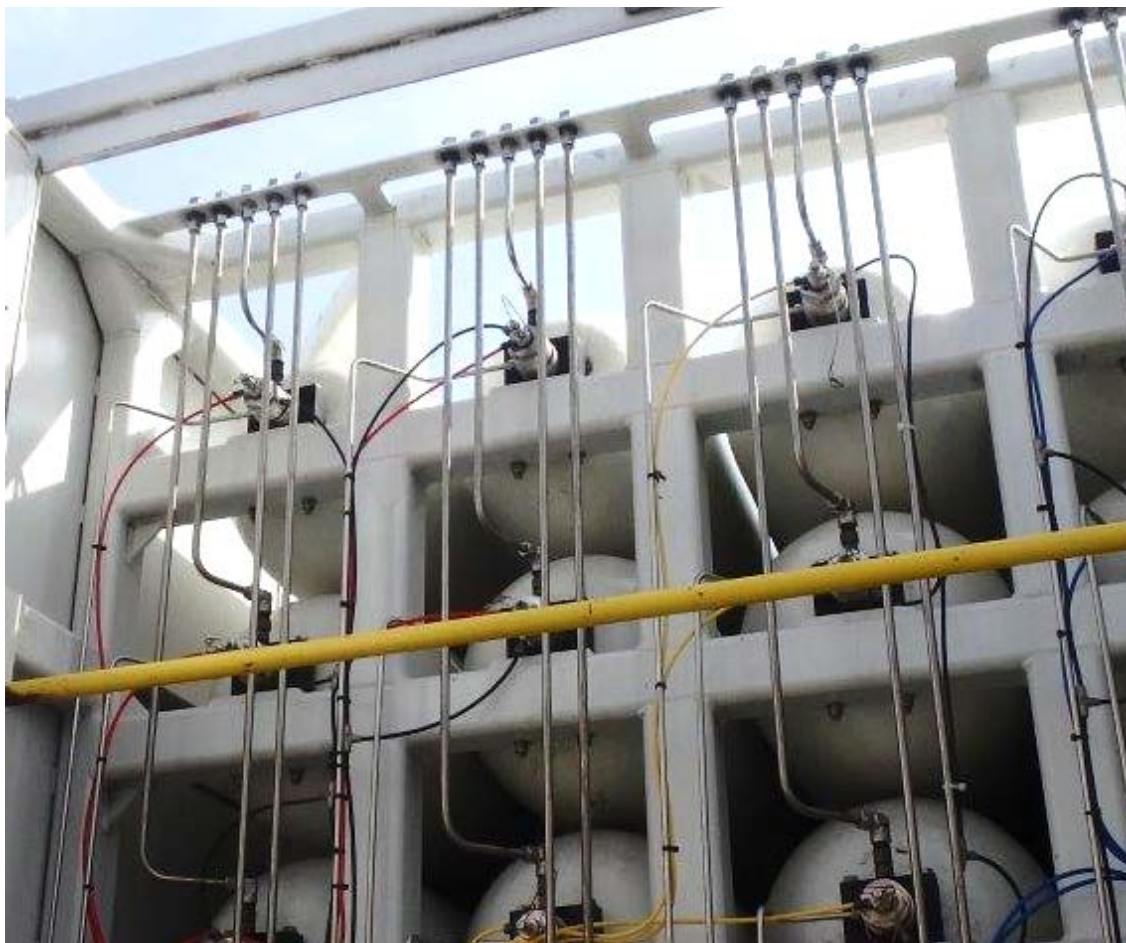
Title 49 *CFR* 173.301(g) and CGA S-1.1 (Table 3), require the PRDs to be arranged to discharge upward and unobstructed to the open air to prevent any impingement of escaping gas upon the containers or personnel. This is accomplished on the CT-250 tube trailer modules by fixing 0.5-inch outside diameter stainless steel tubing to each of the PRD discharge ports that are designed to direct any pressure-relieved gases upward and away from the module. Under normal transportation conditions, the vent tubing is under atmospheric pressure and would only convey gas if a rupture disc were to actuate. As shown in figure 4, the vent tubing downstream of each front and rear PRD assembly had a 90° bend and extended upward to a transverse horizontal bulkhead at the highest point on the module frame.

Figure 4. Hydrogen tube trailer module PRD vent lines and tubing bulkhead.
