CSX Transportation, Inc. Tank Car Release of UN1987
Denatured Ethanol
Fredericksburg, Virginia
November 2, 2016

NTSB/HZM-20/01
PB2022-100361
Notation 64530
Adopted February 14, 2020

Hazardous Materials Incident Report

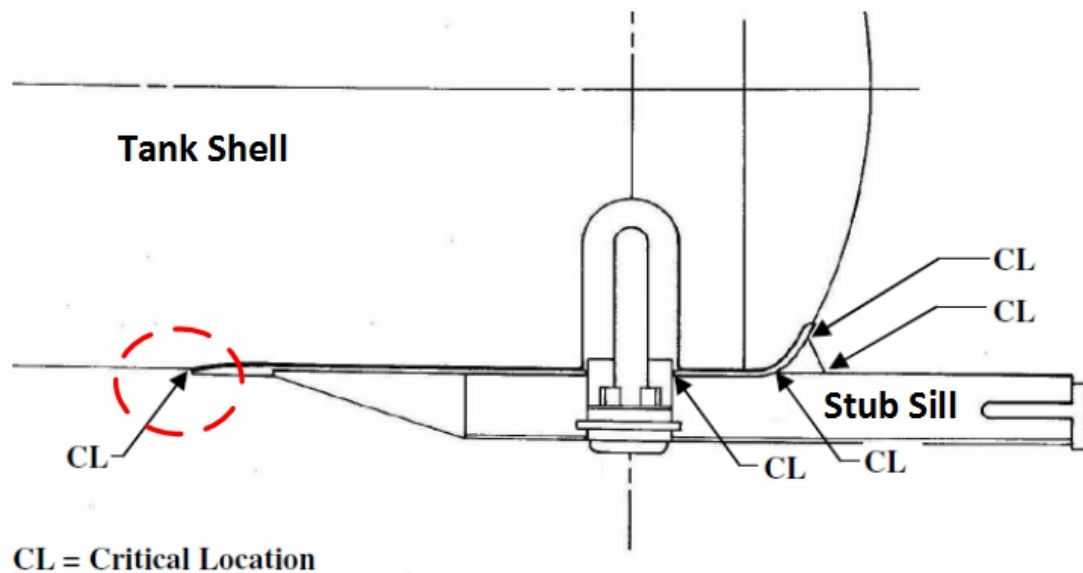
In response to an increasing number of stub sill-related defects found on tank cars during transportation, on October 1, 2010, the AAR published maintenance advisory (MA)-0123, advising tank car owners, repair shops, and railroads to intensify inspections of these structures during maintenance or other inspection events (AAR 2010). The advisory asked railroad operating and mechanical personnel to visually inspect the critical locations that could be seen during routine inspections or maintenance events. These critical locations (CL) are indicated in figure 5. The buckled and cracked shell of the incident tank car ADMX 28988 corresponded to the critical location highlighted by the dashed red circle.

Figure 5. Diagram of a tank car stub sill underframe highlighting damage-prone critical locations where weld cracks are likely to occur.
