# National Transportation Safety Board

## Marine Accident Brief

### Fire aboard Vehicle Carrier *Courage*

<b>Accident no.</b>	DCA15RM024
<b>Vessel name</b>	<i>Courage</i>
<b>Accident type</b>	Fire
<b>Location</b>	North Sea in the approaches to the English Channel, about 57 miles* east-northeast of Harwich, United Kingdom, 52°04.8' N, 002°48.0' E
<b>Date</b>	June 2, 2015
<b>Time</b>	2215 British summer time (coordinated universal time + 1)
<b>Injuries</b>	None
<b>Damage</b>	\$10 million in vessel damage, \$90 million in cargo loss
<b>Environmental damage</b>	None
<b>Weather</b>	Visibility unrestricted at night, winds 34–40 knots, seas 24 feet
<b>Waterway information</b>	The English Channel and its approaches from the east and west are some of the busiest waterways in the world, providing access to Europe's largest ports; there was significant vessel traffic on the night of the accident.

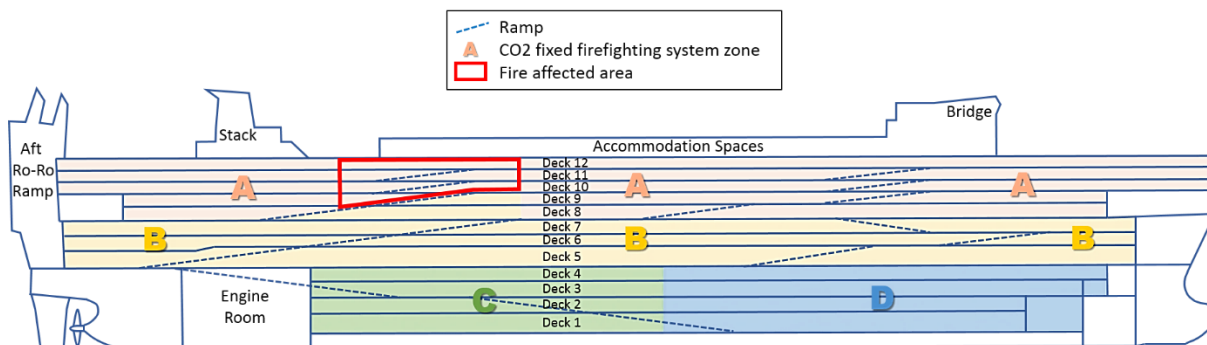
**Simplified diagram of *Courage* cargo decks with CO<sub>2</sub> fixed firefighting system zones.**

Fire investigators hired by the vessel owner and working with the US Coast Guard examined the affected spaces and identified the likely origin to be a ramp on the starboard side, aft, from Deck 8 to Deck 10 (the moveable Deck 9 was almost completely pressed up to the bottom of Deck 10). Vehicles on this ramp were completely destroyed by fire, and there was substantial damage to the ramps from Deck 10 to Deck 11 and from Deck 11 to Deck 12 that were immediately above this area.
