National Transportation Safety Board

Marine Accident Brief

Collision between *Cooperative Spirit* Tow and *RC Creppel* Tow

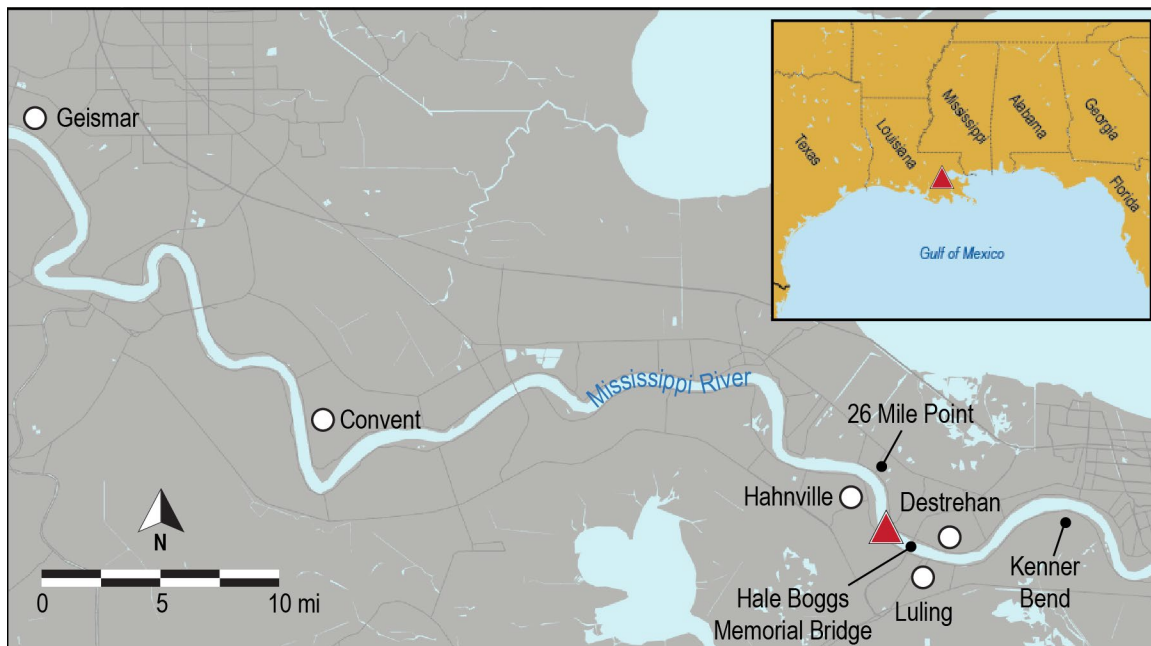
Area of accident where the *RC Creppel*'s tow collided with the *Cooperative Spirit*'s tow, as indicated by the red triangle. (Background source: Google Maps)
