Collision between Liquefied Gas Carrier
Genesis River and *Voyager* Tow
Houston Ship Channel, Upper Galveston Bay, Texas
May 10, 2019

Marine Accident Report

NTSB/MAR-21/01
PB2021-100912

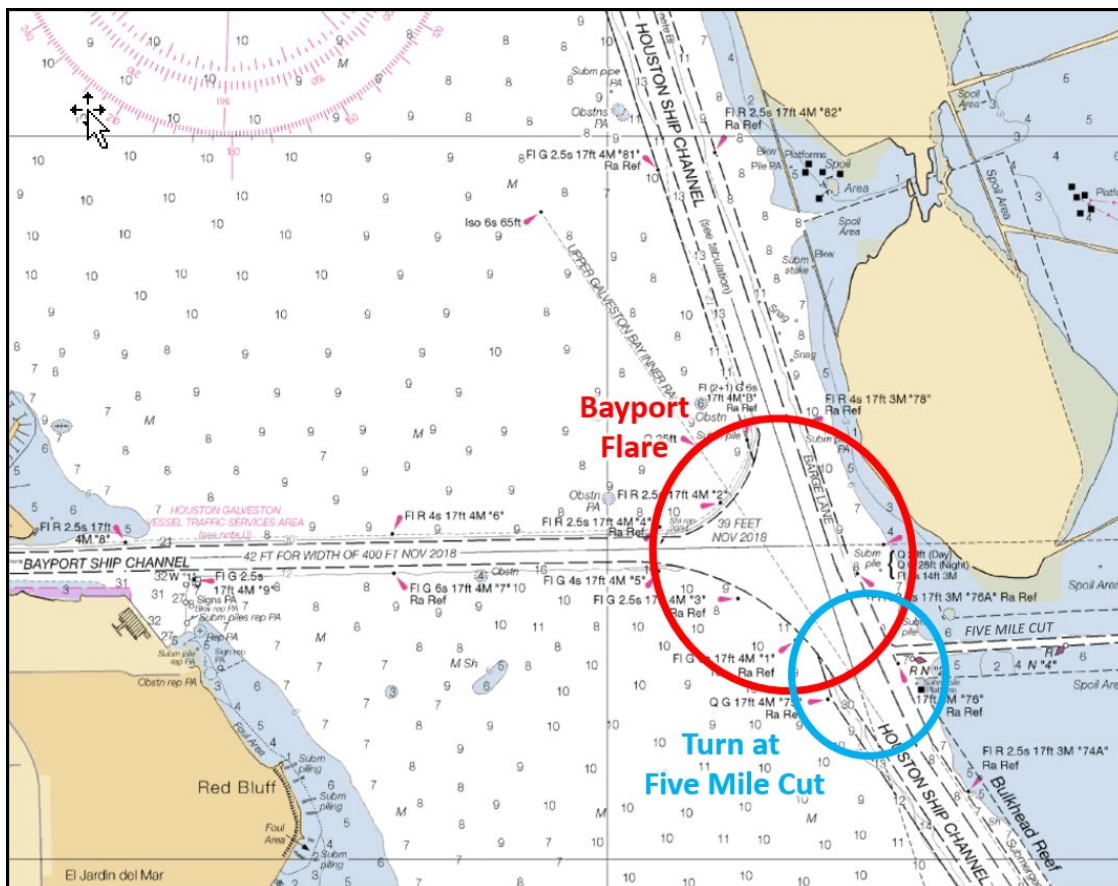
Figure 4. Bayport Flare and turn at Five Mile Cut. (Background source: National Oceanic and Atmospheric Administration [NOAA] chart 11327¹⁴)

Meeting with the *BW Oak*. In the Upper Galveston Bay, the Houston Ship Channel is intersected from the west by the Bayport Ship Channel, which provides access to container, automobile, and petrochemical terminals in Bayport, Texas. Where the two channels intersect, the Bayport channel widens into a funnel shape to allow ships to negotiate the turn from one channel to the other. This area is known as the “Bayport Flare” (see [figure 4](#)). At the southern terminus of the Bayport Flare, in the vicinity of Five Mile Cut (a shallow channel that extends to the east of the Houston Ship Channel), the Houston Ship Channel makes a 15.7-degree turn to the east.

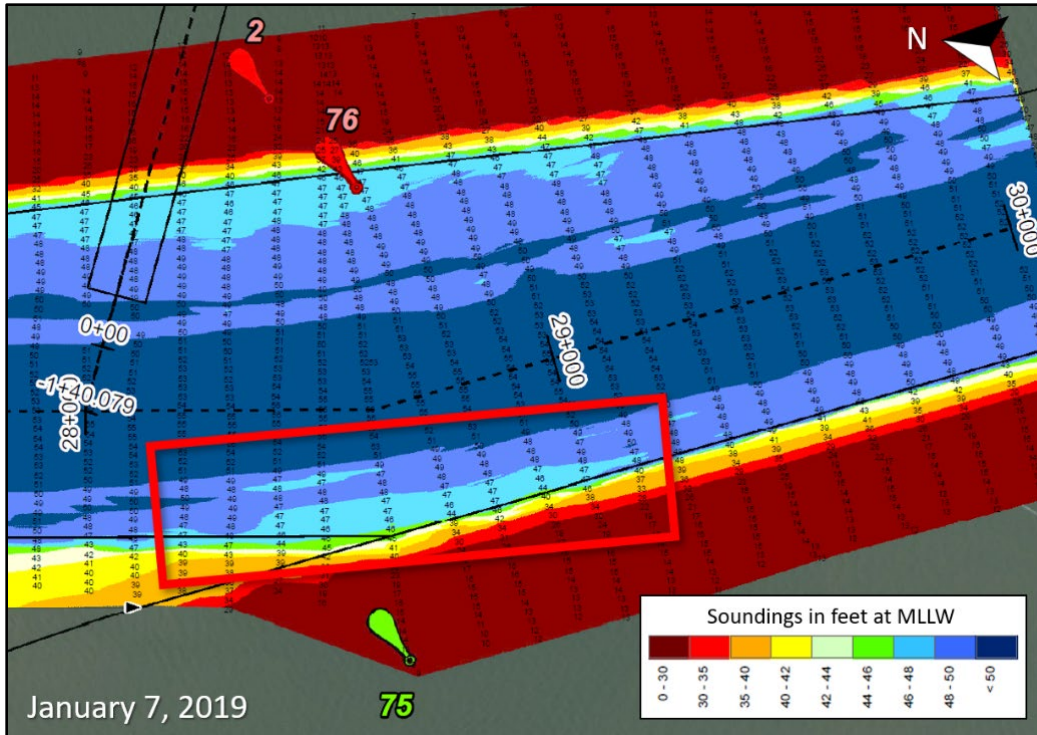
Figure 13 below shows USACE’s January 2019 periodic survey results for the turn at Five Mile Cut. Blue tones indicate deeper water, while yellow/red tones indicate shallower water. The sounding data in feet are indicated by the numbers in the image. Figure 14 shows the results of a survey that was requested by the Houston Pilots immediately following the accident in May 2019. Note the area highlighted by a red box in each figure, which shows shoaling had occurred in the turn of the channel in the 4 months between the surveys, as depicted by the change in depth contour colors.

When asked by investigators, the USACE representative confirmed that shoaling was common in turns of the channel. She also stated that the area of the channel in the vicinity of the Bayport Flare and just south of the flare was prone to shoaling, but that it was “not one that is commonly brought up as a concern.” Prior to the accident, the channel in the vicinity of the turn at Five Mile Cut had last been dredged in late 2017. In November 2019 (5.5 months after the accident), planned maintenance dredging of the Houston Ship Channel in this area commenced.

Figure 13. January 2019 sounding survey data in feet at mean lower low water (MLLW)(the average of the lower low water height of each tidal day observed over the National Tidal Datum Epoch) for the Houston Ship Channel at the turn at Five Mile Cut. The red box shows the area on the western side of the channel where shoaling would occur in the 4 months that followed. The “75” and “76” indicate the channel beacons in the vicinity of the turn. (Source: USACE)

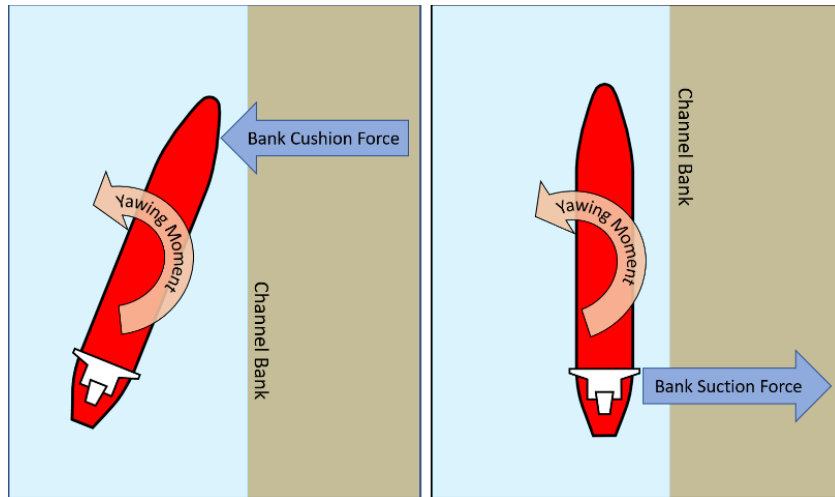
Bank Cushion and Suction. As a ship approaches the bank of a narrow channel, an area of high pressure builds near the bow, which tends to push, or sheer, the bow away from the bank, an effect known as “bank cushion.” Conversely, an area of low pressure forms near the stern and tends to pull the stern into the bank, an effect known as “bank suction” (see [figure 15](#)).

Figure 15. Bank cushion and bank suction.

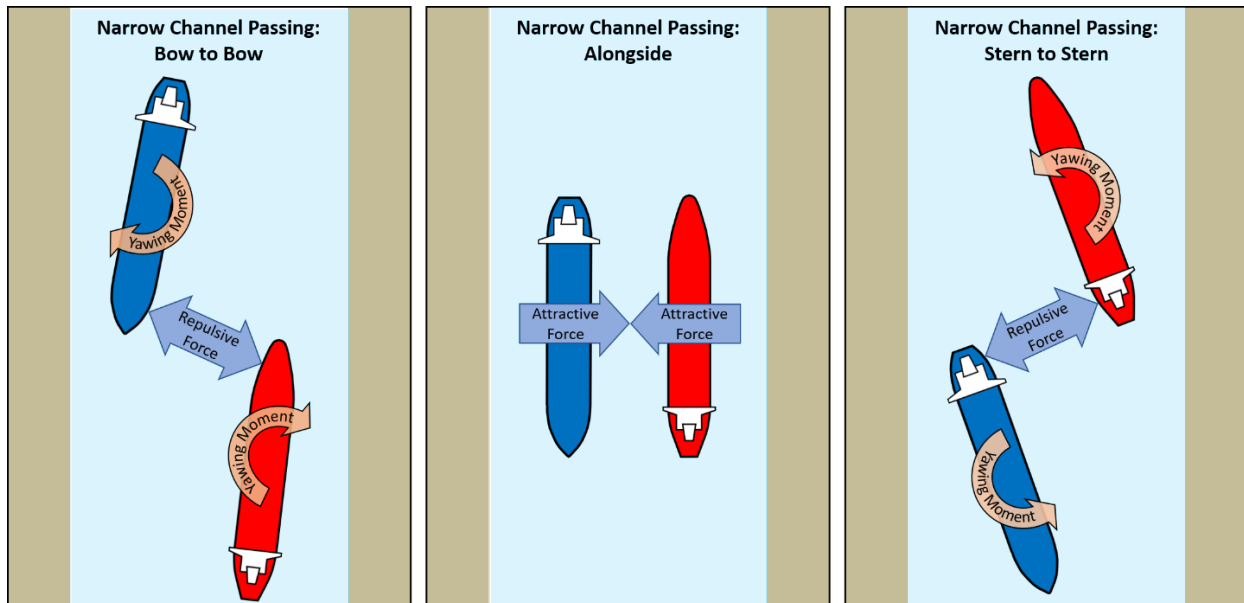
Ship-to-Ship Interaction. Two ships passing in a narrow channel introduce additional hydrodynamic effects. In the case of two vessels meeting head-on (see figure 16), the bow wave ahead of each vessel creates repulsive forces between the two vessels (toward opposite banks) as they approach. When the ships are side by side during the meeting, the interactive forces between the vessels are reversed and become attractive, tending to bring the vessels toward one another. As the vessels pass stern to stern, the forces become repulsive again, which tends to turn the vessels back toward the center of the channel.³⁵ In a straight channel with symmetrical banks, the forces of bank cushion and bank suction are also acting on the two passing vessels.

Figure 16. Forces created by vessels passing in a narrow channel. Bank cushion and suction, in effect during a vessel passing, are not shown.

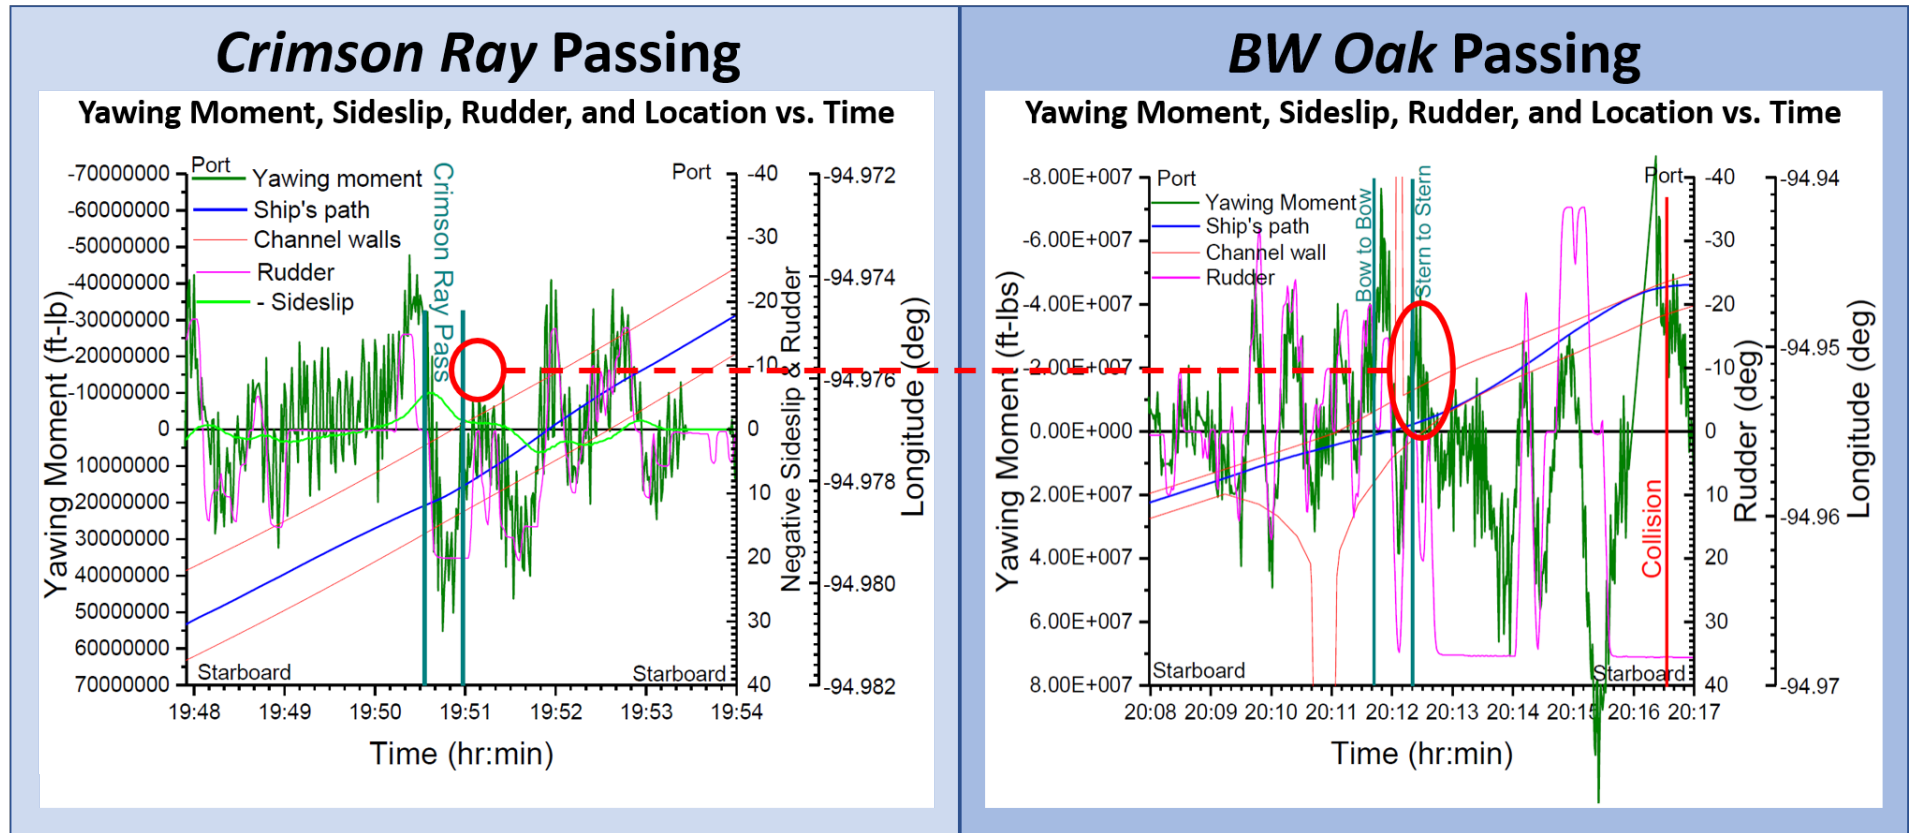
Figure 19. *Genesis River's* yawing moment, sideslip, rudder angle, and location versus time for *Crimson Ray* passing (left) and *BW Oak* passing (right). Note the difference in yawing moment (represented by the dark green plot and encircled in red) when sterns pass in each case. (Source: NTSB Kinematics Parameter Extraction Study)

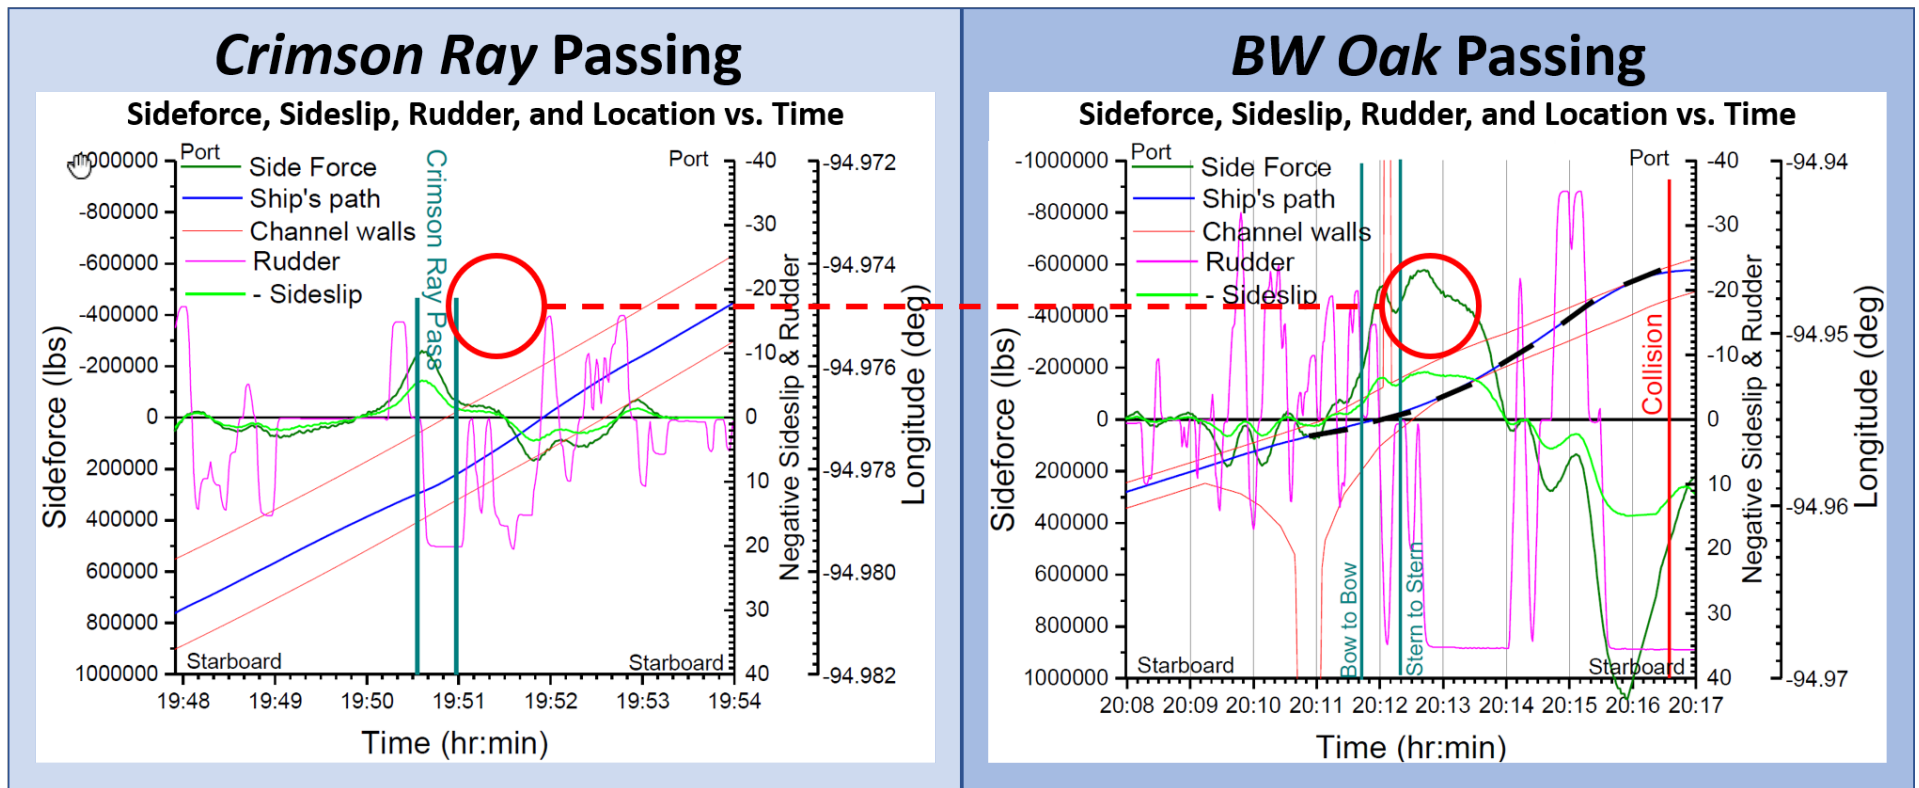
Figure 20. *Genesis River's* sideforce, sideslip, rudder angle, and location versus time for *Crimson Ray* passing (left) and *BW Oak* passing (right). Note the difference in sideforce (represented by the dark green plot and encircled in red) when sterns pass in each case. (Source: NTSB Kinematics Parameter Extraction Study)
