Issued January 13, 2022

MIR-22/01

## Contact of *Robert Cenac* Tow with CSX Railway Rigolets Bridge

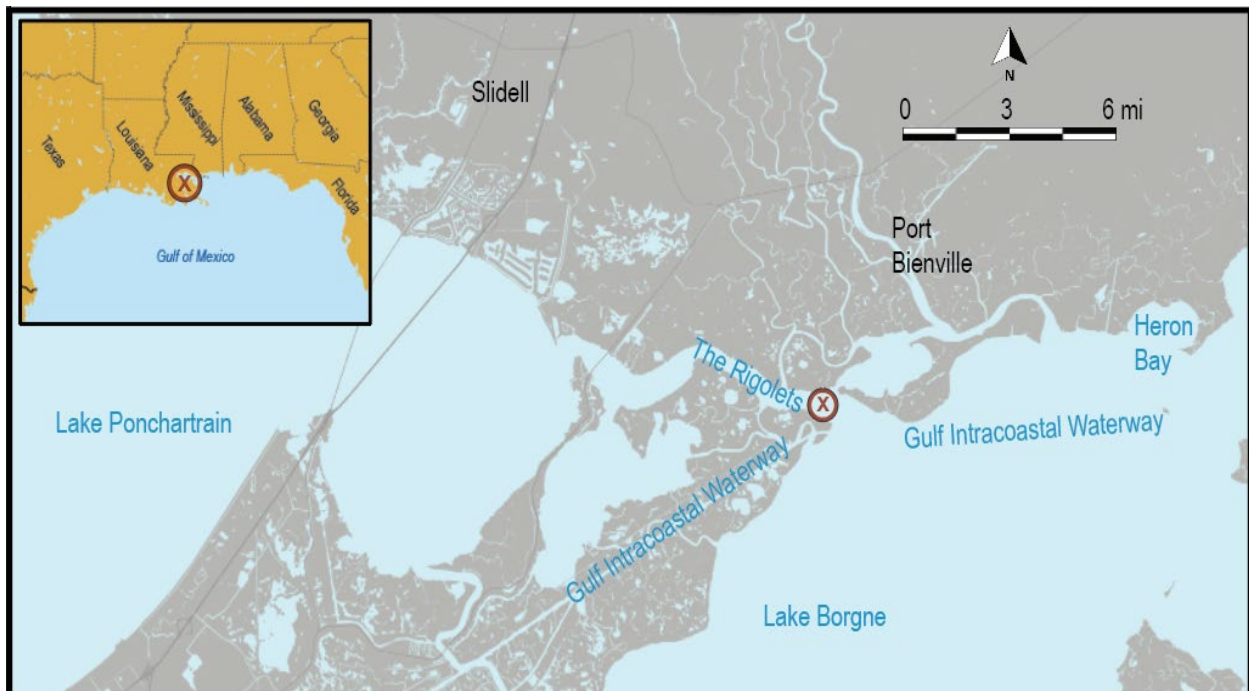
**Figure 2.** Area where the *Robert Cenac* tow struck the Rigolets Bridge, as indicated by the red X. (Background source: Google Maps)

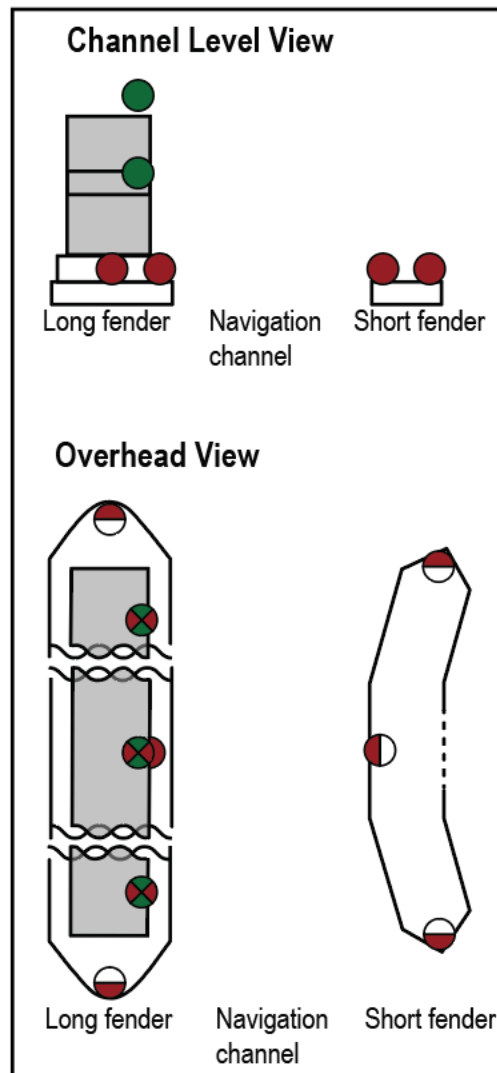
The *Robert Cenac* captain described seeing only two lights on the long fender and one on the short fender as the tow approached the channel to pass through the bridge, where there should have been three on each. Postaccident video and pictures of the Rigolets Bridge confirmed the captain's observations: there were no lights marking the south end of the short fender and long fender. The swing span was not fitted with alternate green and red navigation lights marking each end and the top center of the bridge span. No correspondence was found from the Coast Guard exempting the Rigolets Bridge from the requirements of 33 *CFR* 118.70.

**Figure 5.** Swing bridge lighting, as required by regulations, with the navigation channel passing one side of the span. Note that not all lights are visible at once at the channel level. (Source: Coast Guard)
