Issued March 21, 2022

MIR-22/09

Contact of *Ava Claire* Tow with Leland Bowman Lock Gate

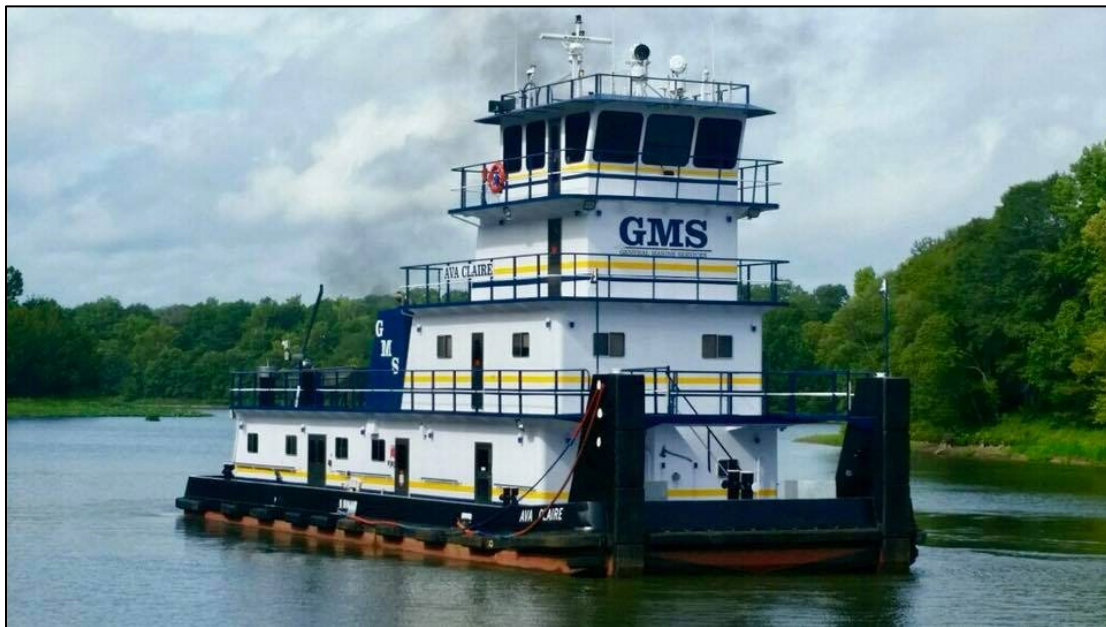
Figure 1. *Ava Claire* under way before the casualty. (Source: General Marine Services)

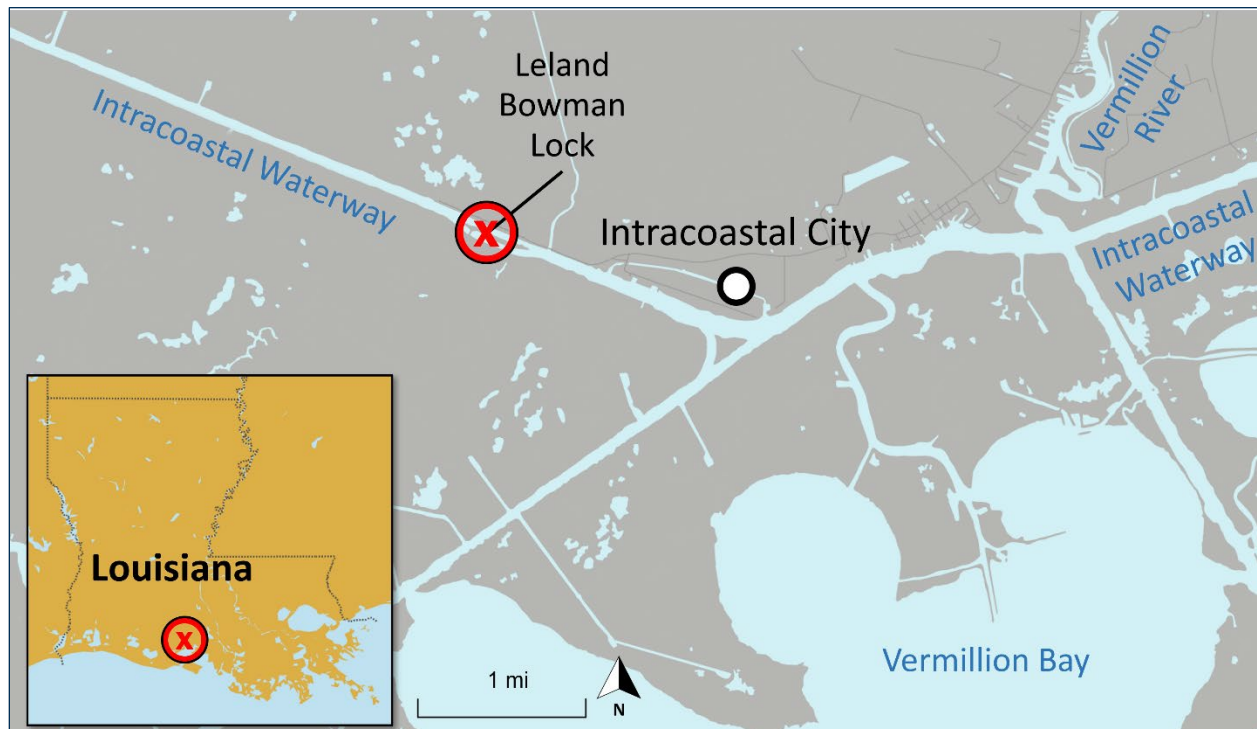
Figure 2. Area where the *Ava Claire* tow contacted the Leland Bowman Lock gate, as indicated by the red X. (Background source: Google Maps)
