Issued September 13, 2022

MIR-22/23

## Contact of Bulk Carrier *Jalma Topic* with Office Barge

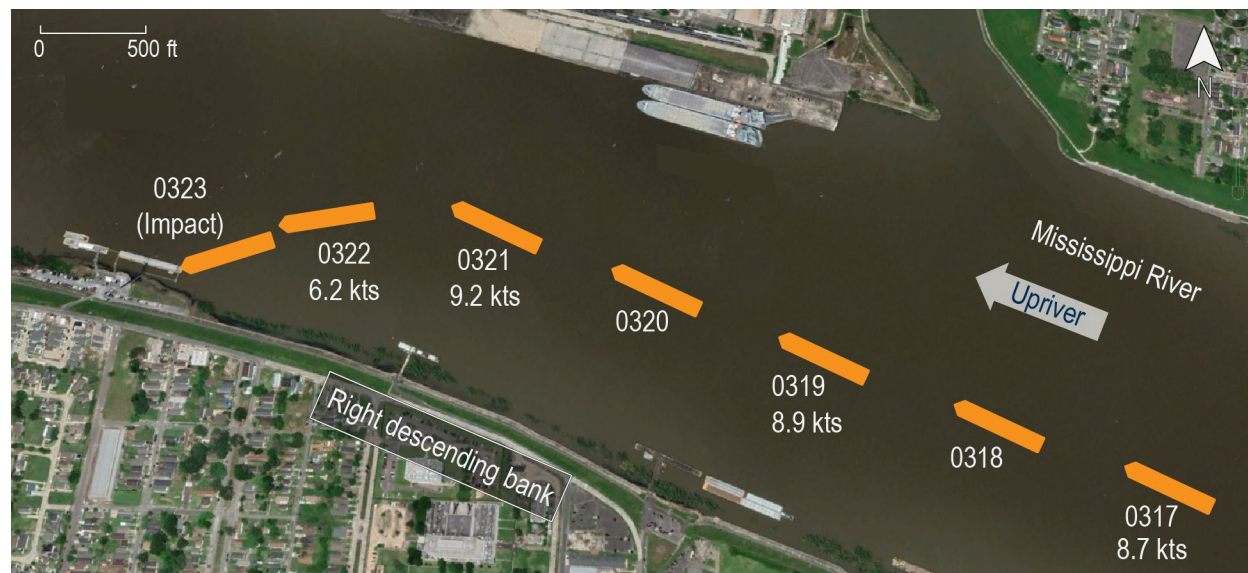
**Figure 4.** Plotted positions of the *Jalma Topic* taken from the vessel's VDR from 0317 to the time when it struck the corner of the Smith's fleet office barge. (Background source: Google Maps)

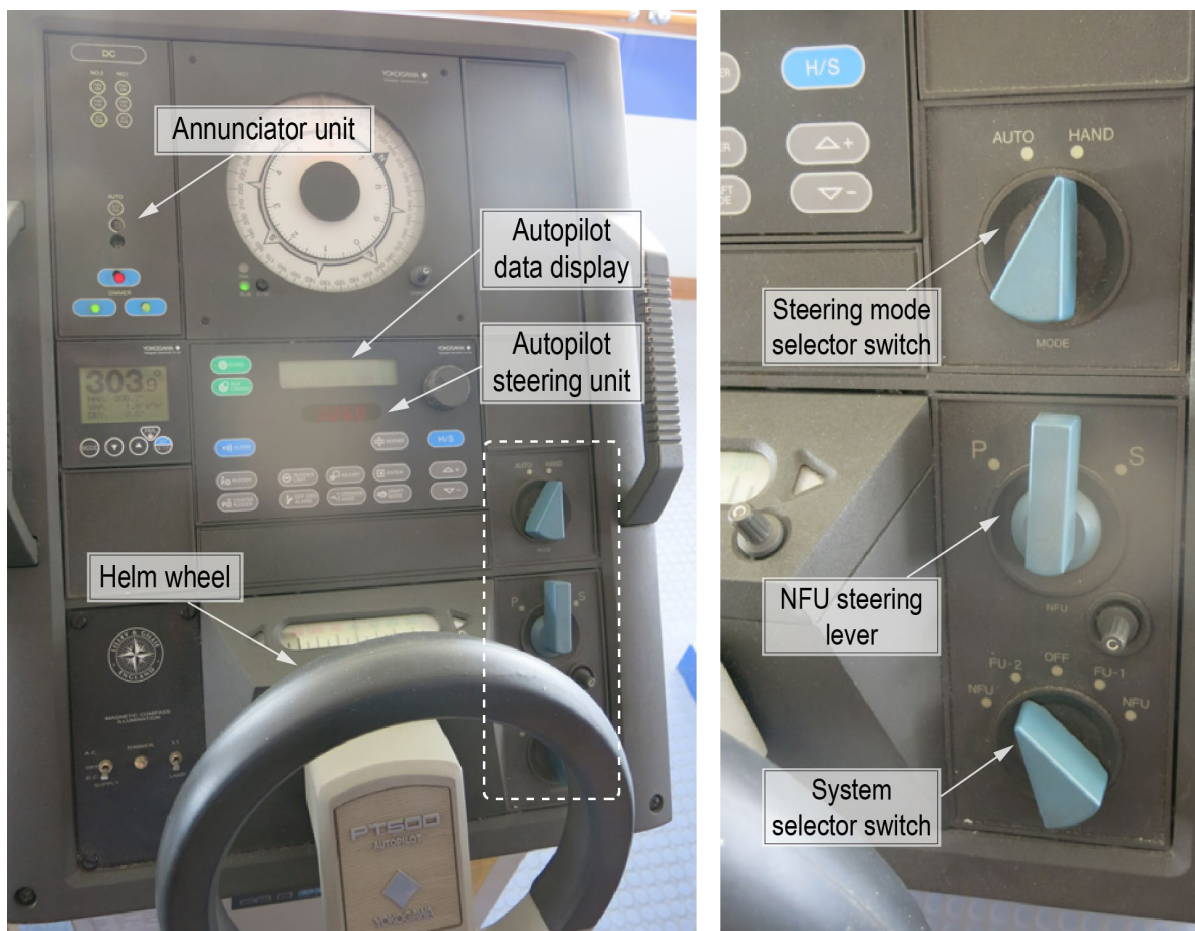
**Figure 7.** YDK (Yokogawa) main steering stand at the center of the bridge of the *Jalma Topic* (left). System selector switch and non-follow up steering lever and selector switch (right).

When helm steering (FU) mode was in use, signals from the helm wheel on the steering stand on the bridge were transmitted to the servo control board in use (either no. 1 or no. 2). Rudder feedback from the feedback ( $\mu$ ) transmitter was applied to the in-use servo control board, where the two signals were compared and an amplified output signal driven to one of two solid-state relays (SSR) on the servo control board, the port or starboard relay, which in turn sent a signal to actuate either the port or starboard solenoid valve on the selected steering pump. When NFU mode was selected, signals from the steering lever would be directed through the in-use servo control board SSRs, either port or starboard, to either the port or starboard solenoid valves on the operating pump, thus bypassing the rudder feedback.
