MIR-23-10

## Contact of Cruise Ship *Radiance of the Seas* with Sitka Sound Cruise Terminal Pier

On May 9, 2022, about 0727 local time, the cruise ship *Radiance of the Seas* was maneuvering in Sitka Sound toward the pier at the Sitka Sound Cruise Terminal near Sitka, Alaska, when the vessel struck and damaged a mooring dolphin.<sup>1</sup> No pollution or injuries were reported. Damage to the pier was estimated at \$2.1 million.

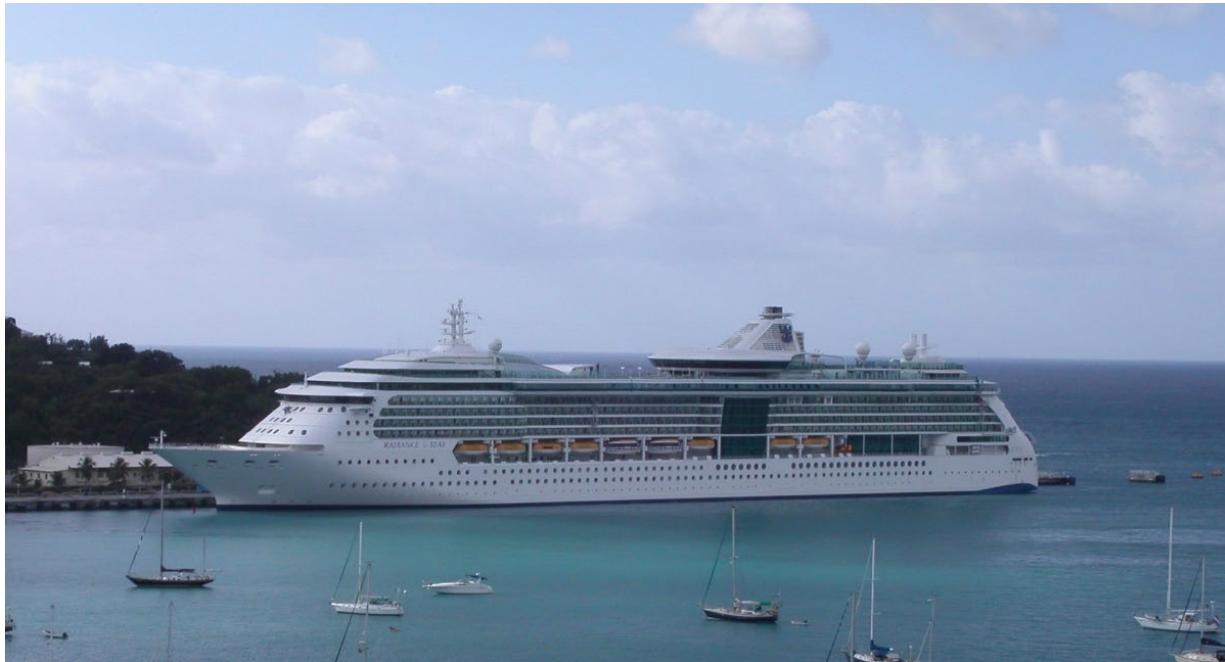
**Figure 1.** *Radiance of the Seas* before the casualty.

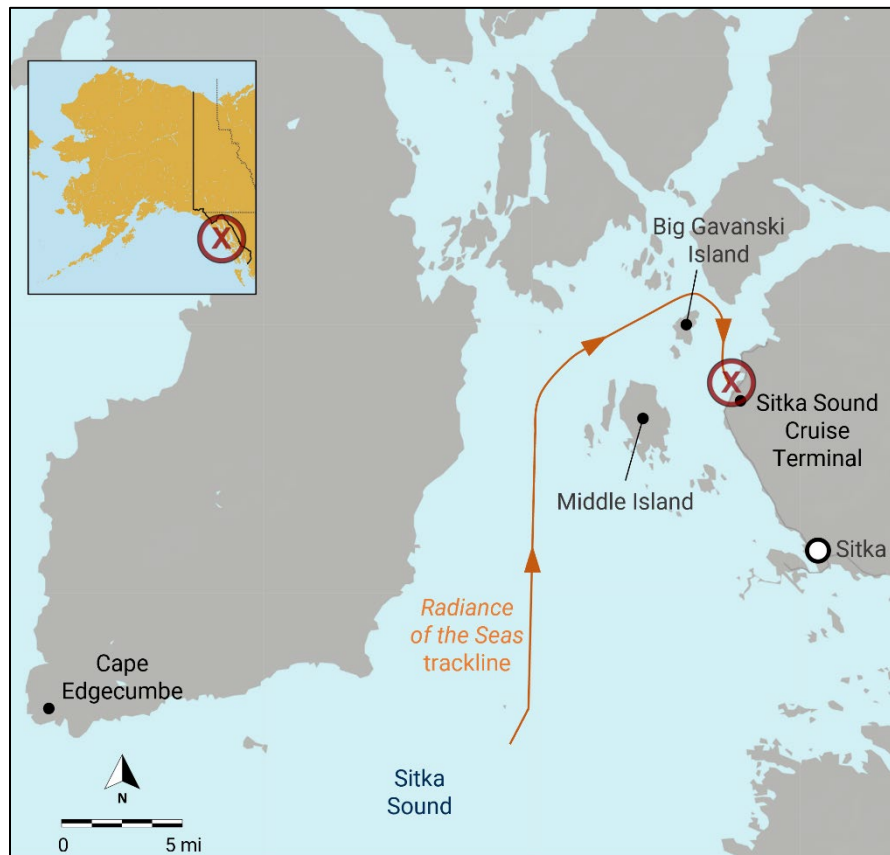
**Figure 2.** Area where *Radiance of the Seas* contacted the Sitka Sound Cruise Terminal mooring dolphin, as indicated by a red X. (Background source: Google Maps)
