End-of-Track Collisions at Terminal Stations
Hoboken, New Jersey, September 29, 2016
and Atlantic Terminal, Brooklyn, New York, January 4, 2017

Special Investigation Report

NTSB/SIR-18/01
PB2018-100561

National
Transportation
Safety Board

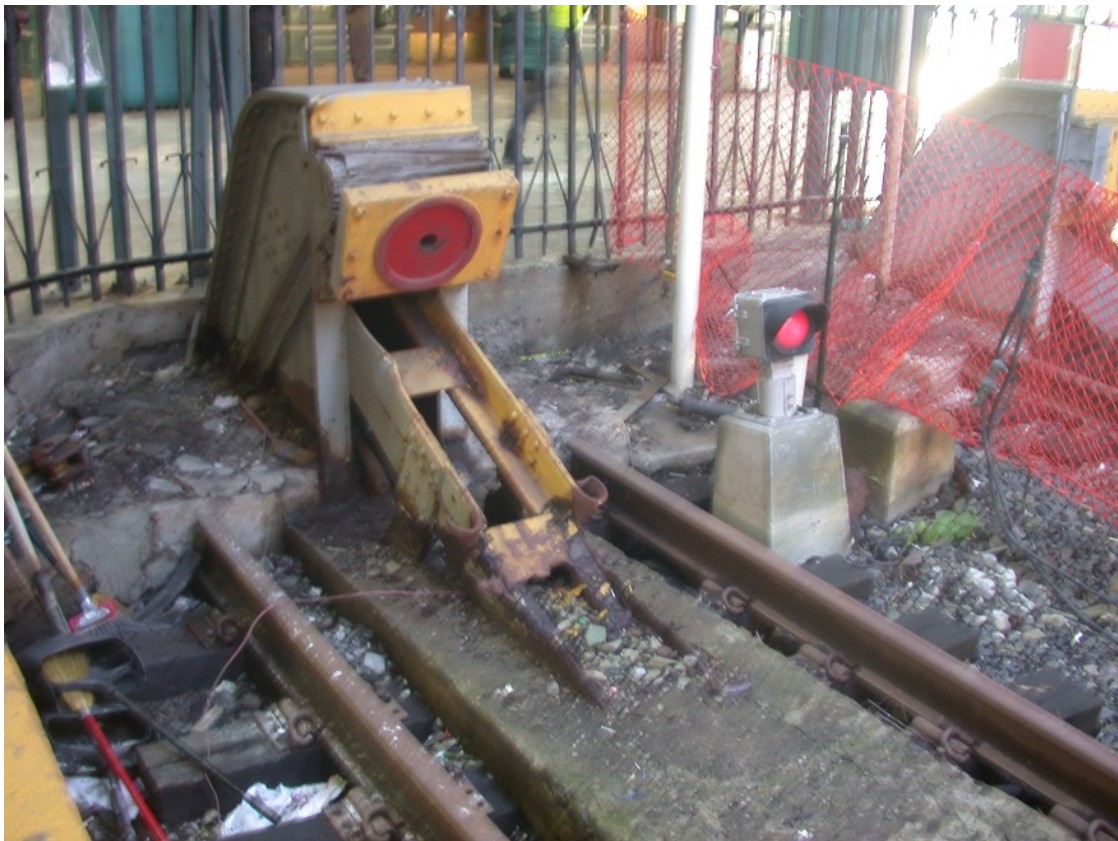
On September 29, 2016, about 8:38 a.m. eastern daylight time, NJT train 1614 failed to stop, overrode a bumping post at the end of track 5, and struck a wall of the Hoboken Terminal. Figure 1 shows an exemplar bumping post at the Hoboken Terminal. This bumping post is a rigid structure that is level with the train's coupler at the end of the track.

Figure 1. Photograph of an exemplar bumping post at the Hoboken Terminal.

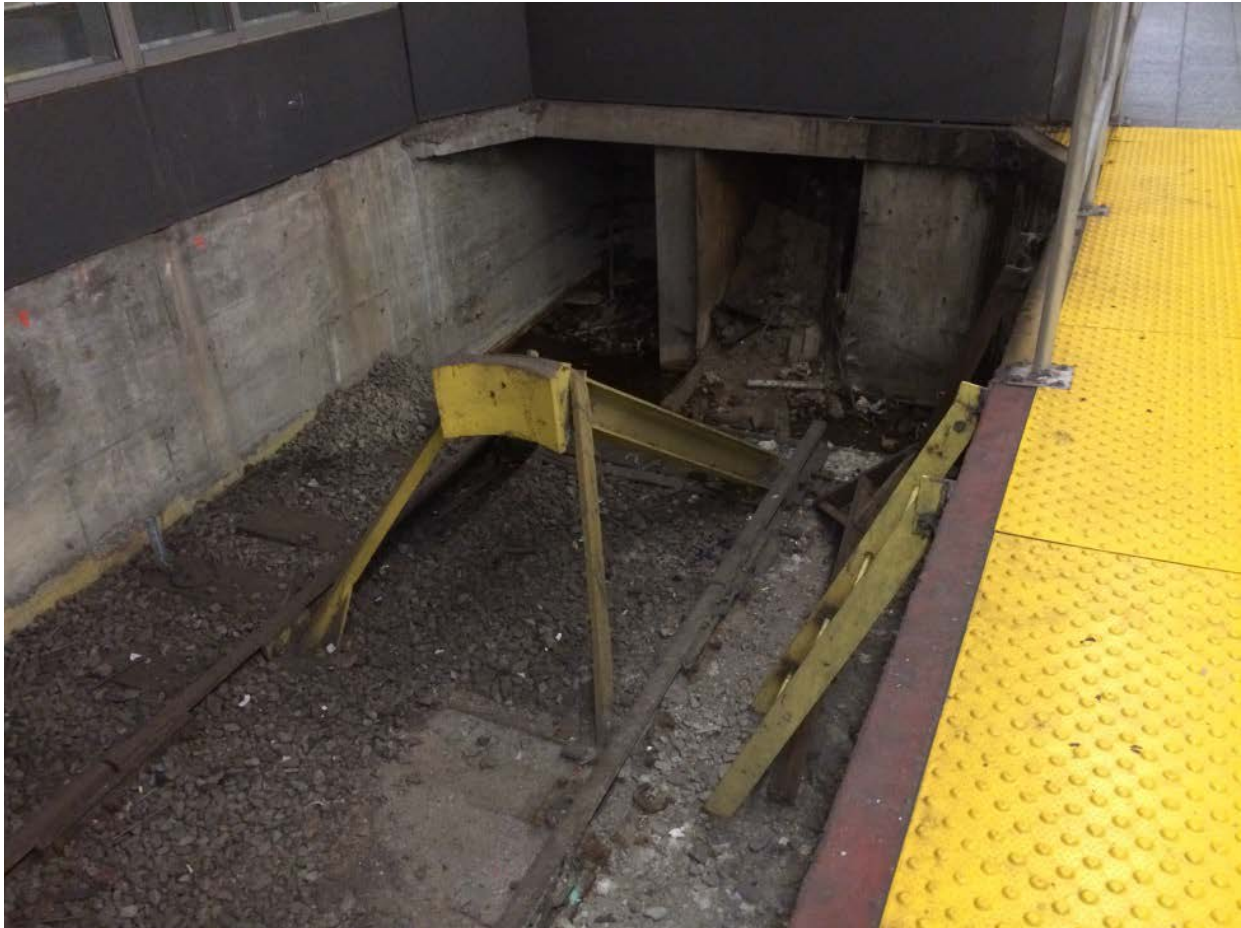
On, January 4, 2017, about 8:18 a.m. eastern standard time, LIRR passenger train 2817, consisting of six cars, collided with the platform at the end of track 6 in the Atlantic Terminal in Brooklyn (a borough of New York City, New York).⁶ Figure 3 shows the triangular bumping post at Atlantic Terminal, with legs supporting a steel block which is level with the train's coupler.

Figure 3. Photograph of the bumping post at Atlantic Terminal prior to the accident. (Photograph courtesy of LIRR.)

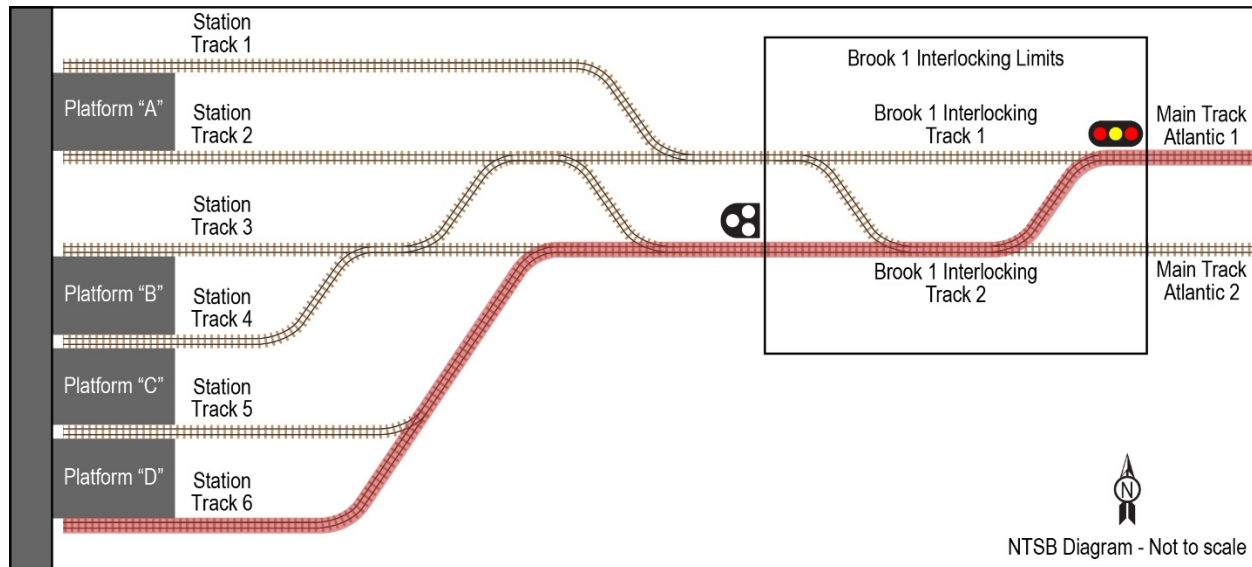
The engineer said he encountered a restricting signal at the Brook 2 Interlocking on main track 1, which required him to slow to restricted speed (not to exceed 15 mph).² (See figure 2.) The train then crossed from main track 1 to main track 2 where it encountered another restricting signal at the Brook 1 Interlocking that also required the train to travel at restricted speed. However, the maximum authorized track speed in the terminal was restricted to 5 mph. In this circumstance, the engineer must still be prepared to stop in one-half his range of vision while not exceeding 5 mph. The train was lined into track 6.

Figure 2. Diagram of tracks at Atlantic Terminal. (Brook 2 is to the right of Brook 1 and is not shown in the figure.)
