APPENDIX E

Explanation of Bias in the Column Force Data, a Method for Correcting the Bias, and Re-Plotted Data From Both Phases I and II that is Corrected for the Bias

18 July 2000
B-H200-17005-ASI

Subject: Dual Elevator PCA Jam Ground Test - Egyptair 767-300ER SU-GAP, Accident Off Nantucket, Massachusetts – 31 October, 1999

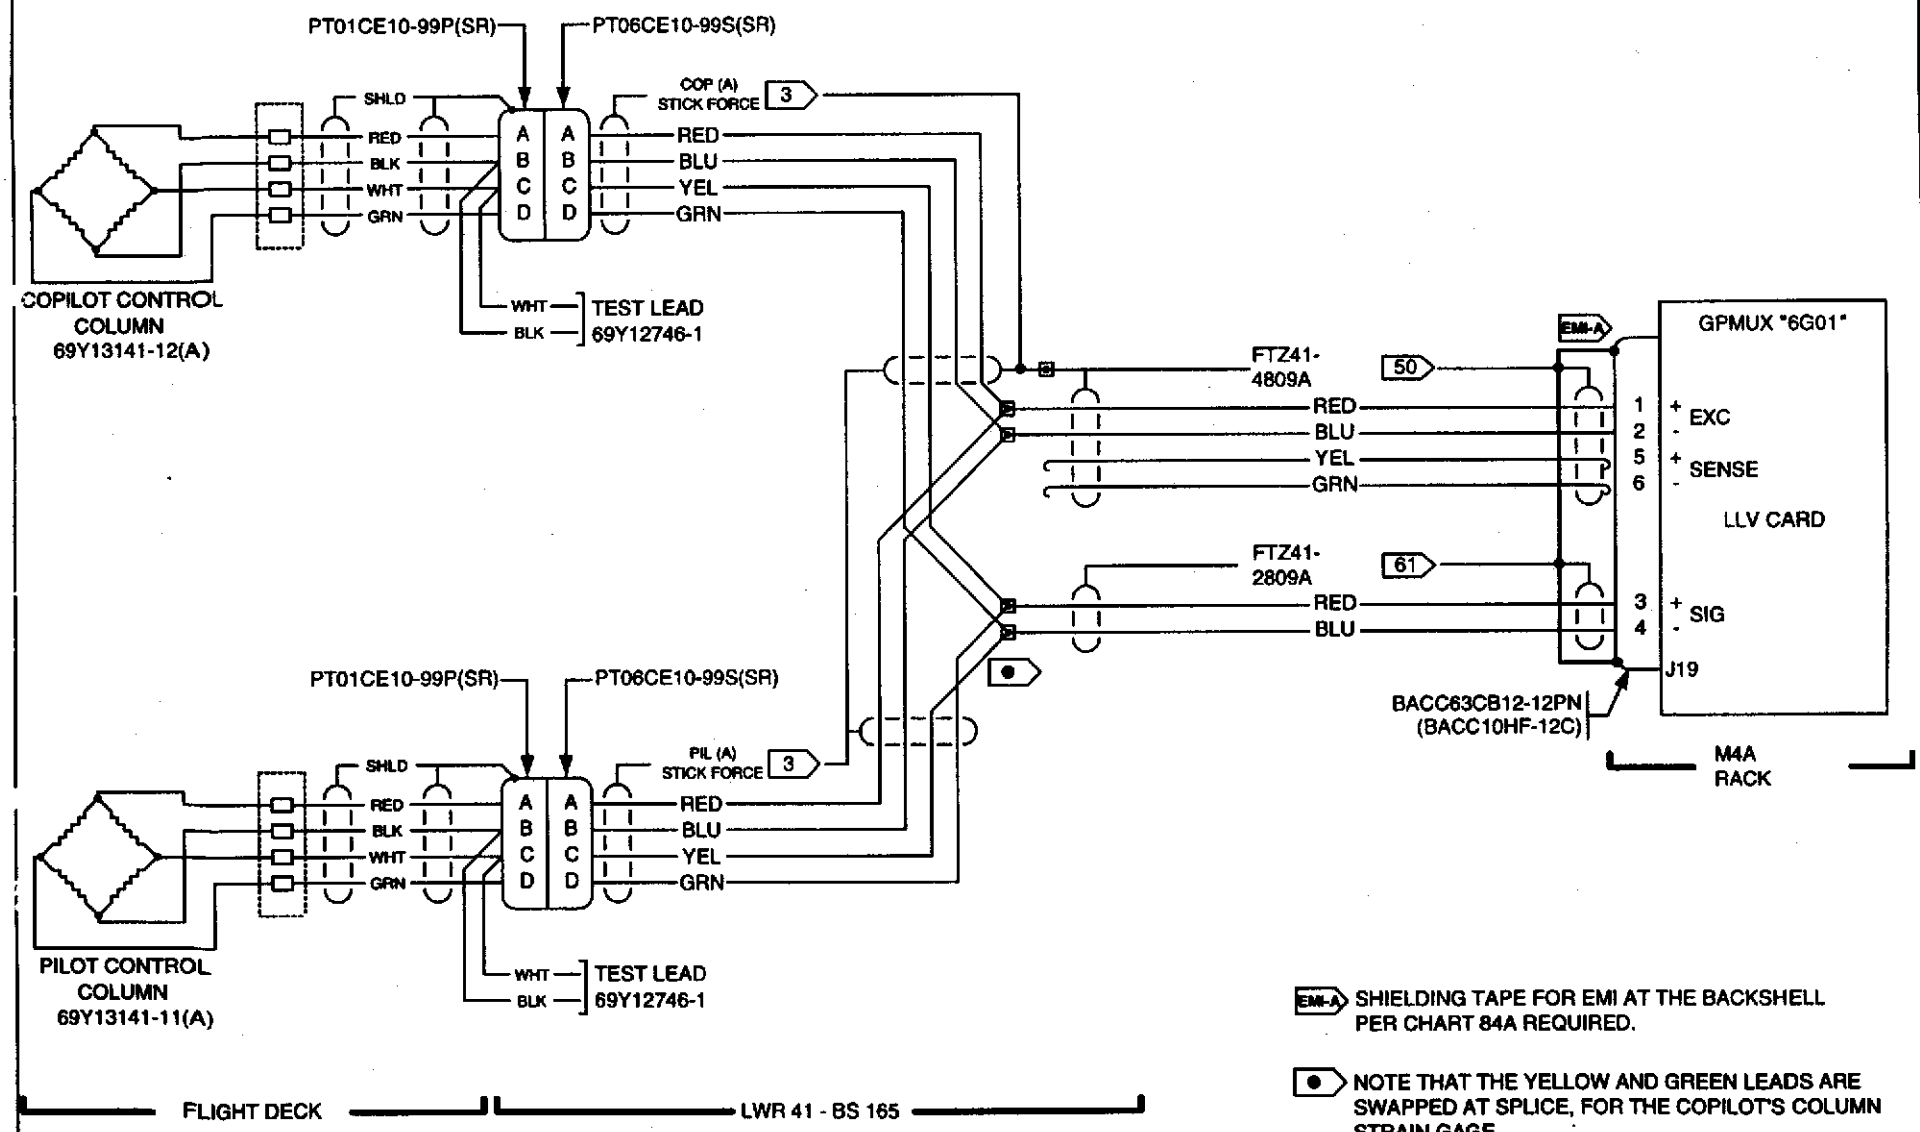
Figure 1

The standard column force instrumentation configuration on VQ001 does not allow the direct measurement of column forces. In the standard configuration, the strain gages that are located at the base of the Pilots and Copilots columns are electrically tied together. The gage on the non-driven column compensates for any forces applied to it by electrically subtracting out the load. When equal forces are applied on both columns simultaneously, the net output is zero. The standard control column force instrumentation is configured as shown in Boeing Flight Test Instrumentation drawings Z6-25-80 and Z6-25-81 which are included as figures 1 and 2, respectively. Each column has two 1000Ω strain gage bridges ('A' and 'B') installed per 69Y13141 Strain Gage Installation – Pilots and Copilots Column Stick Force to measure bending. To measure the pilot's column force (Measurement Number 3060107, Stick Force Pilot's), the 'A' gages on each column are wired together. To measure the first officer's column force (Measurement Number 3064204 Stick Force Copilot's) the 'B' gages on each column are wired together.

To allow for the direct independent measurement of each column force on VQ001, it was necessary to electrically separate the gages on the column. In order to maintain the electrical circuit, strain gage simulator (bridge completion) circuits were constructed to match the resistance provided by the original strain gage circuit. These simulators were installed in place of the gages which are installed on the opposite control column during the standard configuration. For measurement "3060107 Stick Force Pilot's", the simulator replaced the 'A' gage on the Copilots side. For measurement "3064204 Stick Force Copilot's", the simulator replaced the 'B' gage on the pilots side.

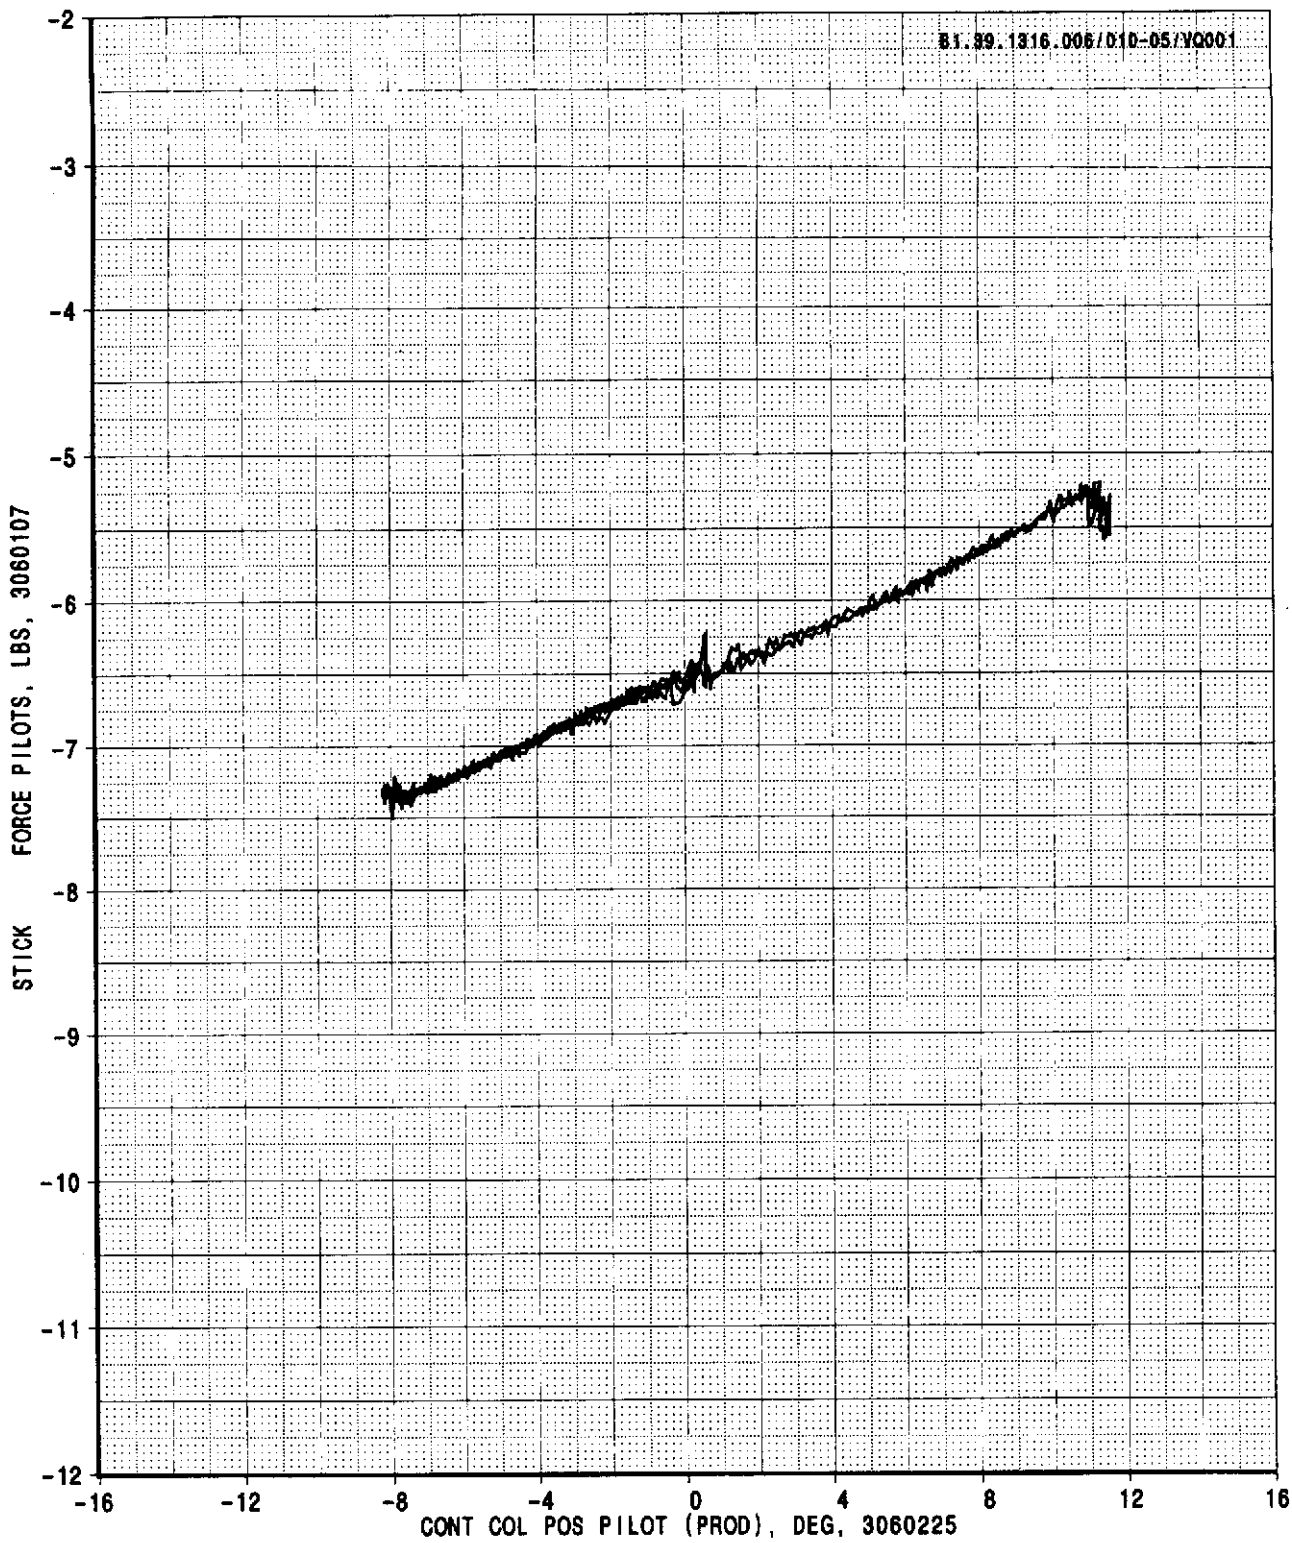
Figure 3 shows a plot of the captain's column force versus the captain's column position for a typical test condition in which the first officer alone made the column inputs. Since no pilot force was being applied to the captain's column during this condition, this plot shows the captain's column force bias directly.

The positive slope characteristic on the column force bias of figure 3 is caused by the effect of gravity on the column mass located above the strain gage. Since our column force instrumentation derives "applied column force" based on a measurement of the total strain at the base of the control column, it is unable to distinguish between the applied pilot forces and the column mass unbalance forces. Since the magnitude of the column mass unbalance forces are roughly only +/- 1 pound of column force relative to those at zero degrees of column, they can be ignored without introducing any significant error. If greater accuracy is desired, the column mass unbalance forces could be accounted for in any computations because they are simply a function of the column angle.

There is very little hysteresis on the column force bias of figure 3. This minimal hysteresis is to be expected for slow column sweeps since there are no friction elements between the strain gage and the top of the control column. The fact that there is no hysteresis shows that the instrumented column force readings are repeatable during a test condition. Some hysteresis could occur on the column force bias trace as a result of either something bumping into the column or due to sudden changes in column velocity. Sudden changes in column velocity produce an inertial force that is sensed by the strain gage at the base of the column. Since most of our testing involved slow column

CALC	B. Cook	17Jul00	REVISED	DATE	Captain's Column Force Bias During Test Condition 006 of Test 10-05	767-400ER VQ001
CHECK						Figure 3
APPD.						
APPD.					BOEING	PAGE 10 of 15

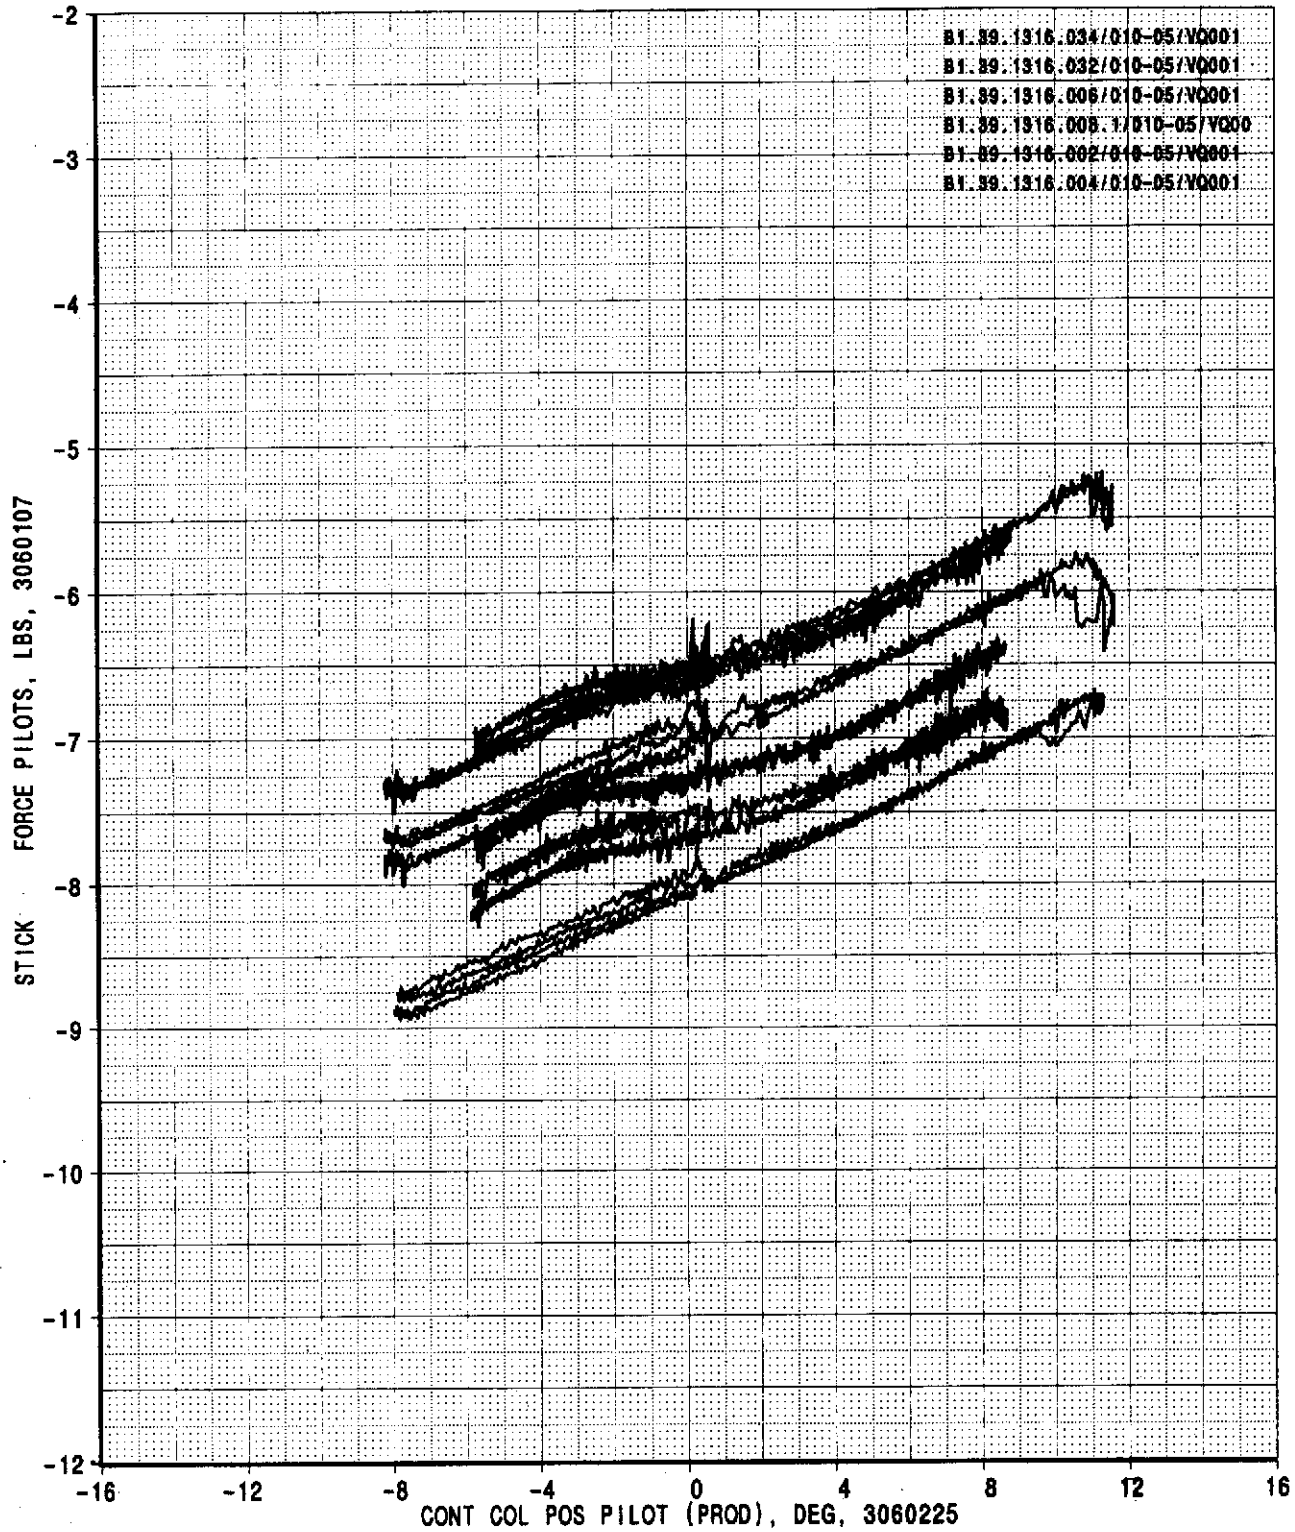
The captain's column force biases during test 010-05 are shown in figure 4. Figure 4 was created by plotting the captain's column force versus the captain's column position for all test conditions in which the first officer alone made the column inputs. Figure 4 is the same as figure 3 except that the column force biases were measured at different times throughout the day. Figure 4 shows a bunch of parallel lines. The fact that the lines in figure 4 don't lay right on top of each other shows that the column force instrumentation bias at zero degrees of column shifted during the course of the day within the range of –6.5 to –8.0 pounds of column force. The fact that these lines are parallel to each other demonstrates that even though the bias shifted throughout the course of the testing as a result of temperature changes, the gain of the instrumented column force was unaffected. Since the same mass unbalance force caused the characteristic slope of these lines, any change to the gain of the instrumented column force would have resulted in non-parallel lines.

Examination of figures 4, 5, 6, and 7 reveals that the column force instrumentation biases all shifted during the course of the day's testing. The cause of this shifting is changes in temperature during the course of the testing. During the design of the strain gage simulator circuits, no attempt was made to produce biases that were constant with respect to temperature. For figures 4, 5, and 6, the shift in the column force instrumentation bias is less

CALC	B. Cook	17Jul00	REVISED	DATE	Captain's Column Force Biases During Test 10-05	767-400ER VQ001
CHECK						Figure 4
APPD.						
APPD.					BOEING	PAGE 10 of 16

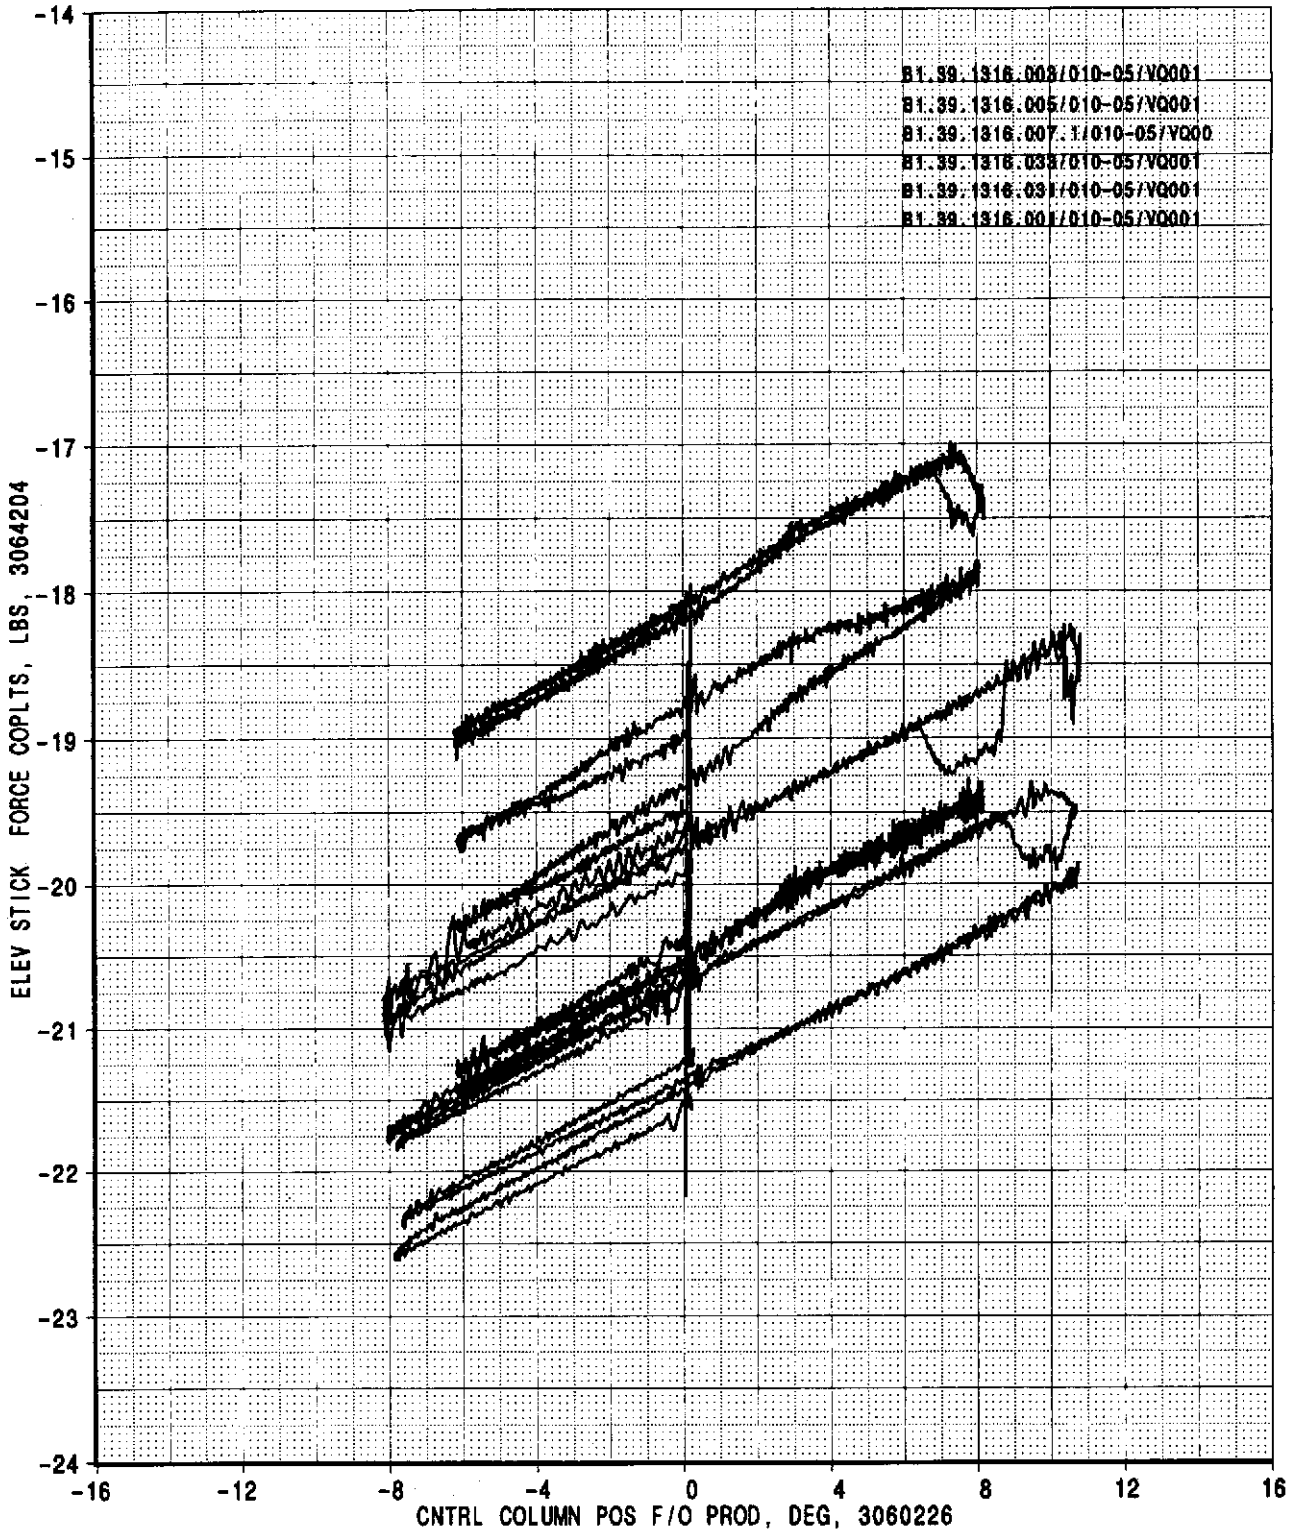
The First Officer's column force biases during test 010-05 are shown in figure 5. Figure 5 was created by plotting the first officer's column force versus first officer's column position for all test conditions where the captain alone made the column inputs.

CALC	B. Cook	17Jul00	REVISED	DATE	First Officer's Column Force Biases During Test 10-05	767-400ER VQ001
CHECK						Figure 5
APPD.						
APPD.					BOEING	PAGE 13 of 16

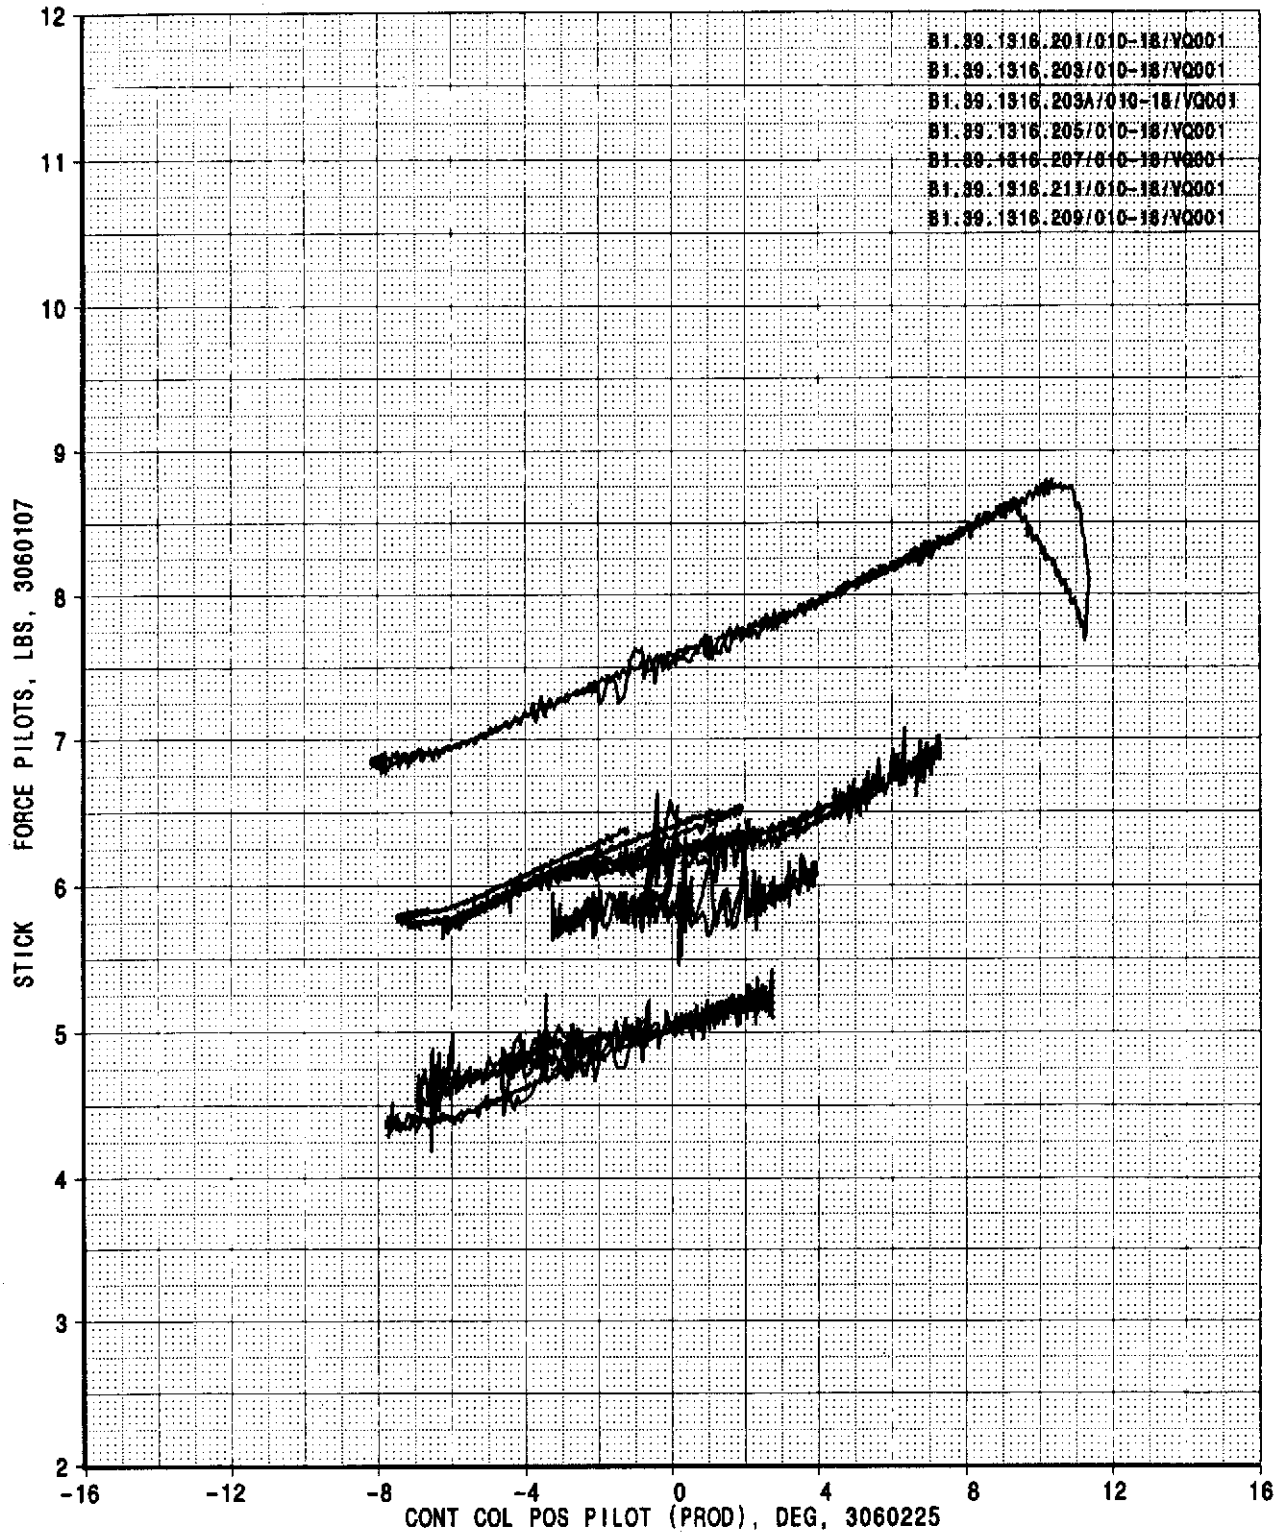
CALC	B. Cook	17Jul00	REVISED	DATE	Captain's Column Force Biases During Test 10-18	767-400ER VQ001
CHECK						Figure 6
APPD.						
APPD.					BOEING	PAGE 13 of 16

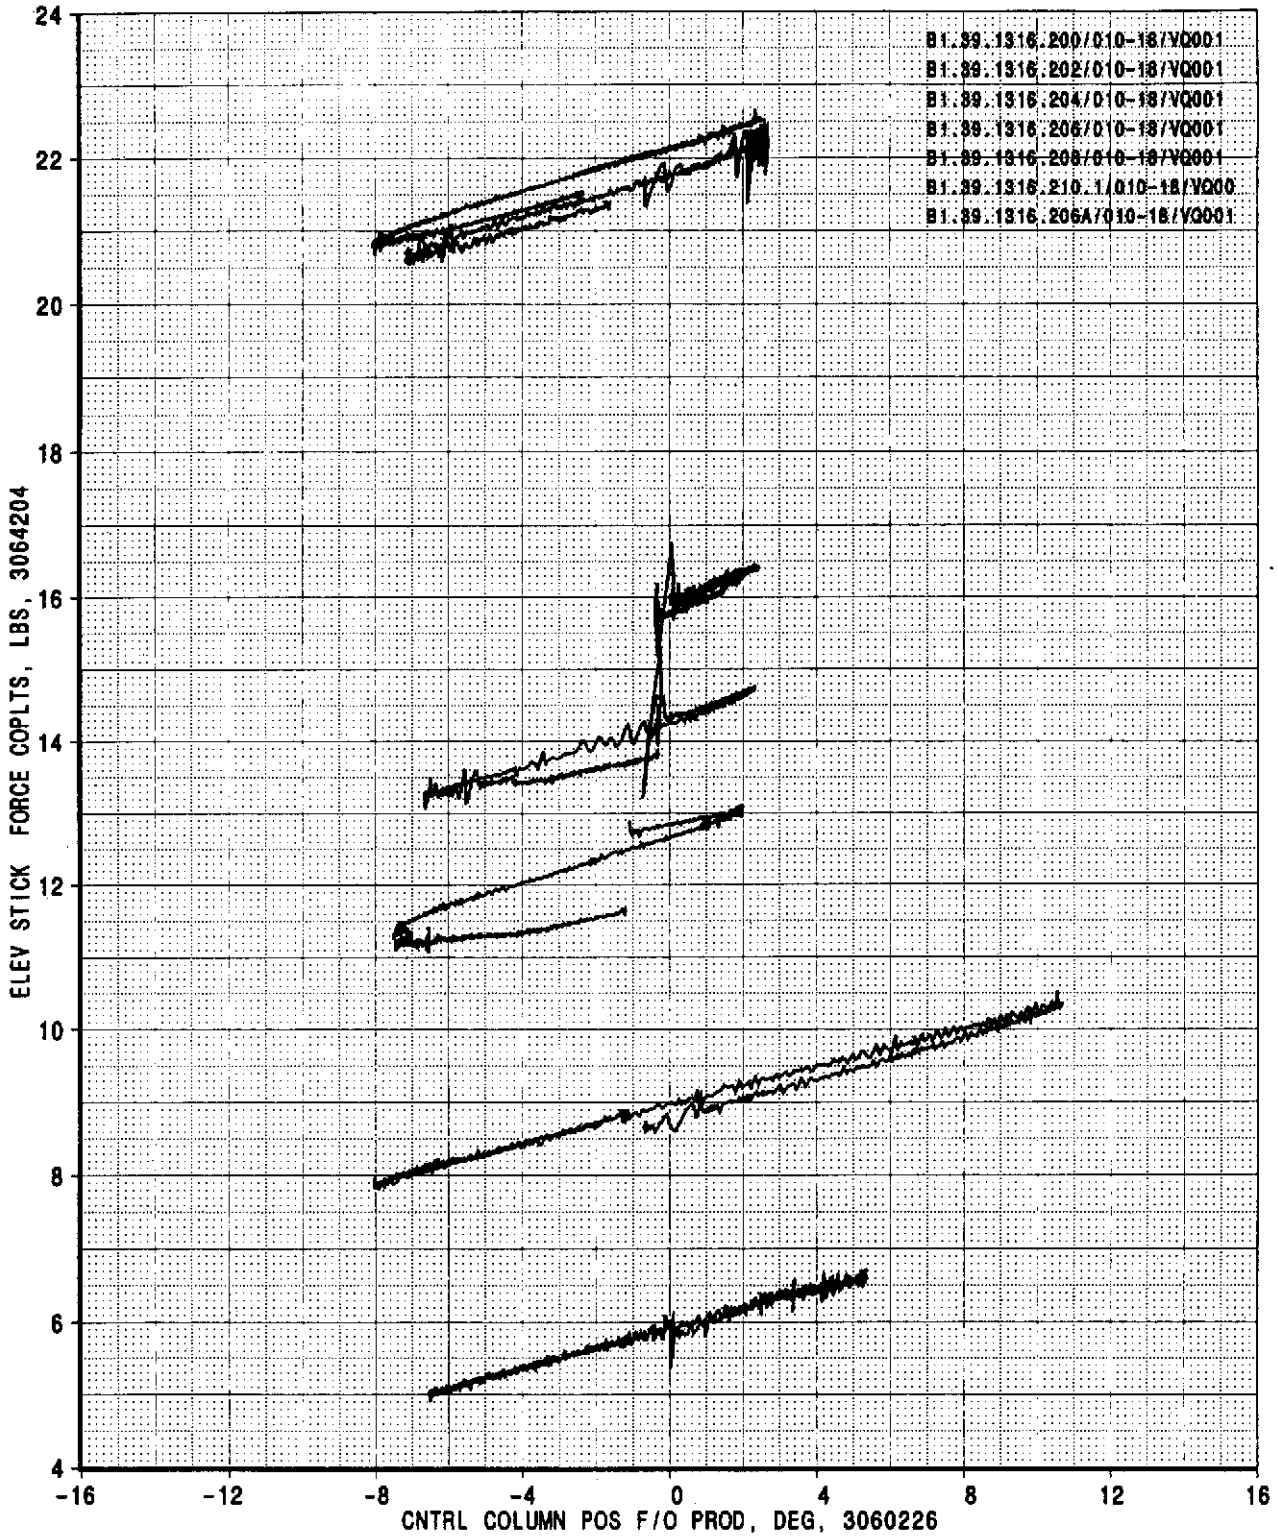
For figure 7, the column force instrumentation bias on the first officer's column during test 010-18 varied from 6 lbs to 22 lbs. This is significantly more shift in the bias than that observed during any other test. Test 010-18 was conducted with 3 main test configurations: (1) single input jams, (2) single input jam plus a single disconnect, and (3) dual input jams. Switching between test configurations during test 010-18 required significant amounts of time because elevator PCAs had to be removed and replaced to produce an input jam. A review of the test conditions completed in each of these three test configurations shows that the column force bias values didn't shift more than a few pounds for the test conditions within a single configuration. The major shifts occurred between main test configurations when large temperature shifts occurred while the airplane configuration was changed.

CALC	B. Cook	17Jul00	REVISED	DATE	First Officer's Column Force Biases During Test 10-18	767-400ER VQ001
CHECK						Figure 7
APPD.						
APPD.					BOEING	PAGE 14 of 16

While the column force instrumentation biases were observed to shift some during the course of a full day of testing, the biases remained constant during each test condition. For this reason, the column force instrumentation biases should be removed by subtracting the force necessary to make the initial hands-off column force equal to zero prior to each test condition.

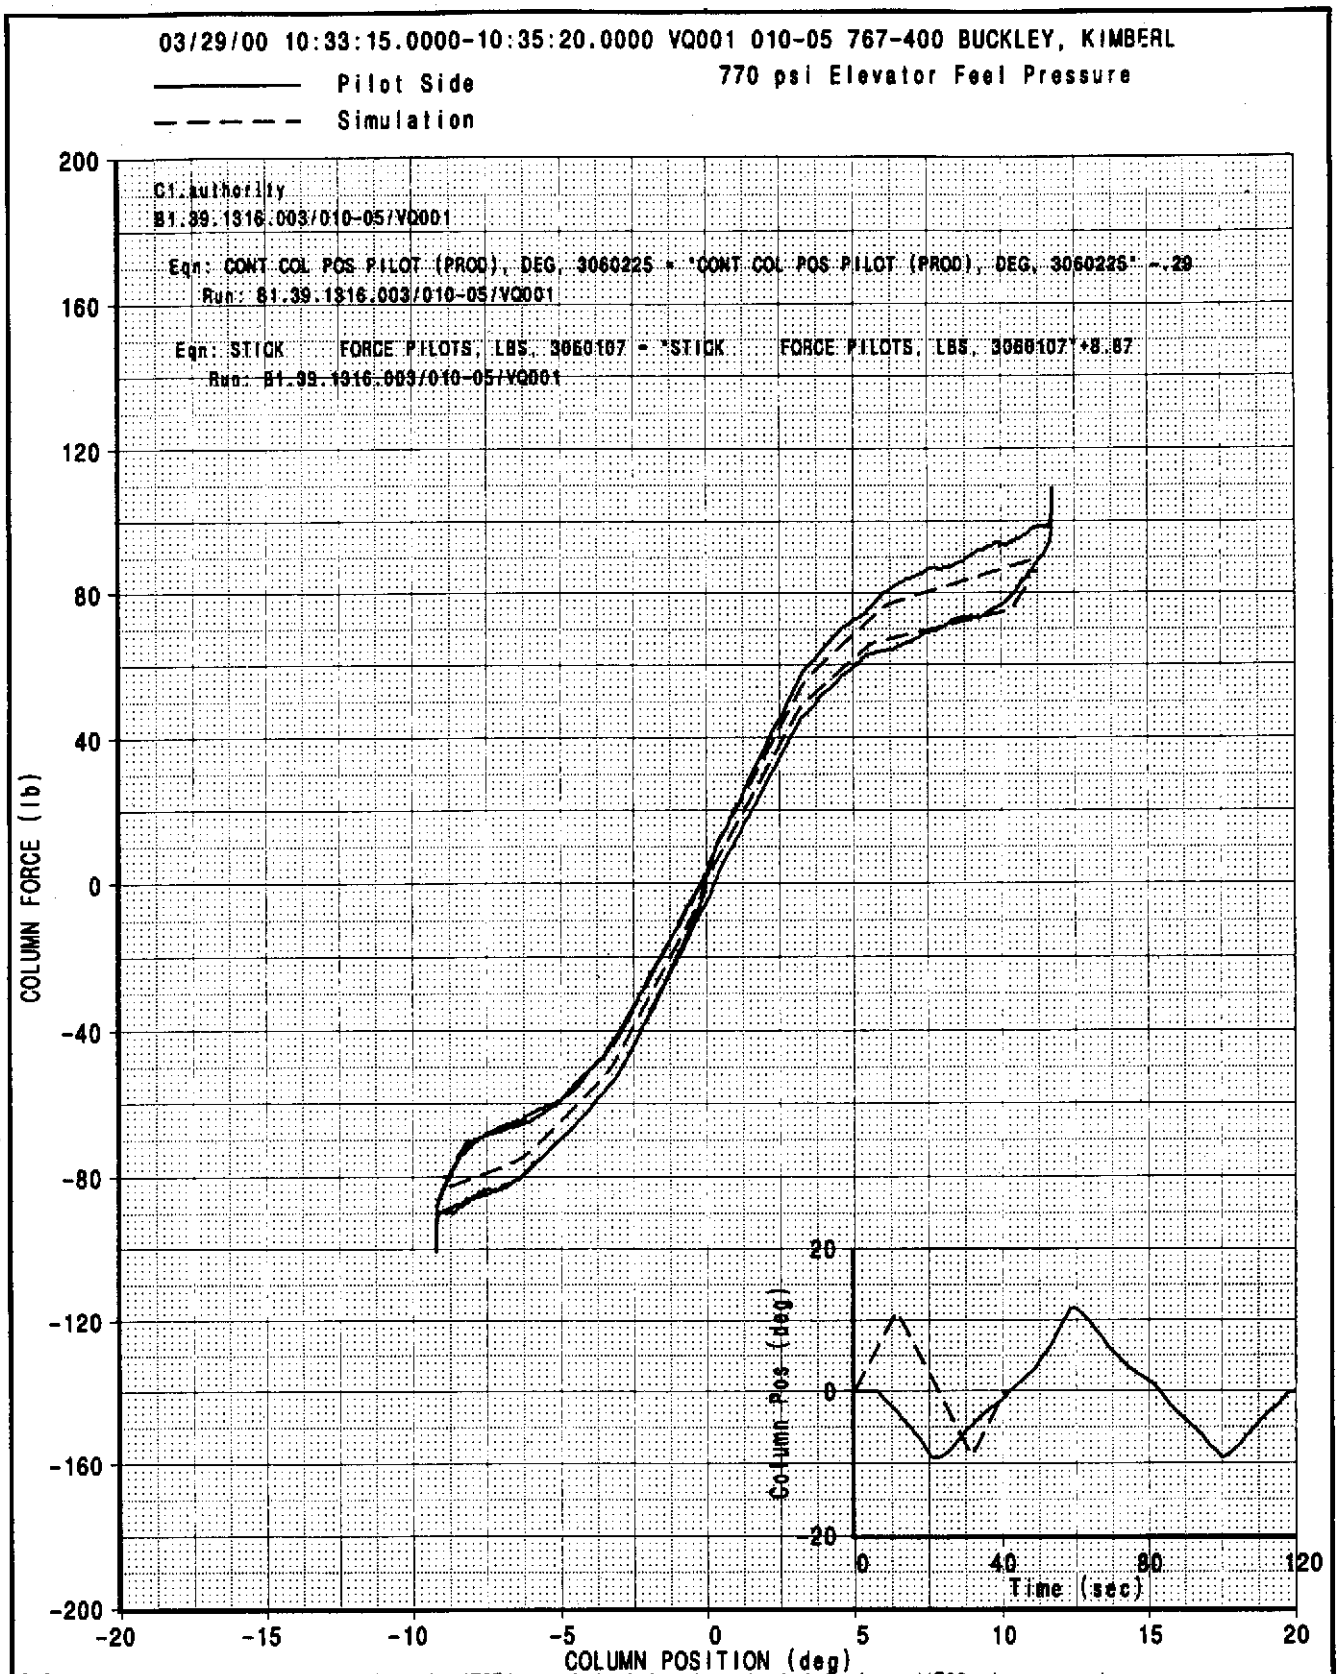
CALC	B.Richardson	17Jul00	REVISED	DATE	Ground Test/Simulation Proof of Match Base Feel Sweep with Biases Removed	767-400ER VQ001
CHECK						Figure 8
APPD.						
APPD.					BOEING	PAGE 15 of 19

Figure 8 shows a plot of column force versus column position during a column sweep on VQ001 at base feel pressure. Figure 9 shows a plot of column force versus column position during a column sweep on VQ001 when the feel pressure was set to 770 psi. In both figures 8 and 9, the VQ001 test data matched well with the predictions once the column force instrumentation biases were removed. This demonstrates that the column force test data gathered from VQ001 can be easily corrected by removing the instrumentation biases and that the forces measured by the instrumentation once this is done is accurate.

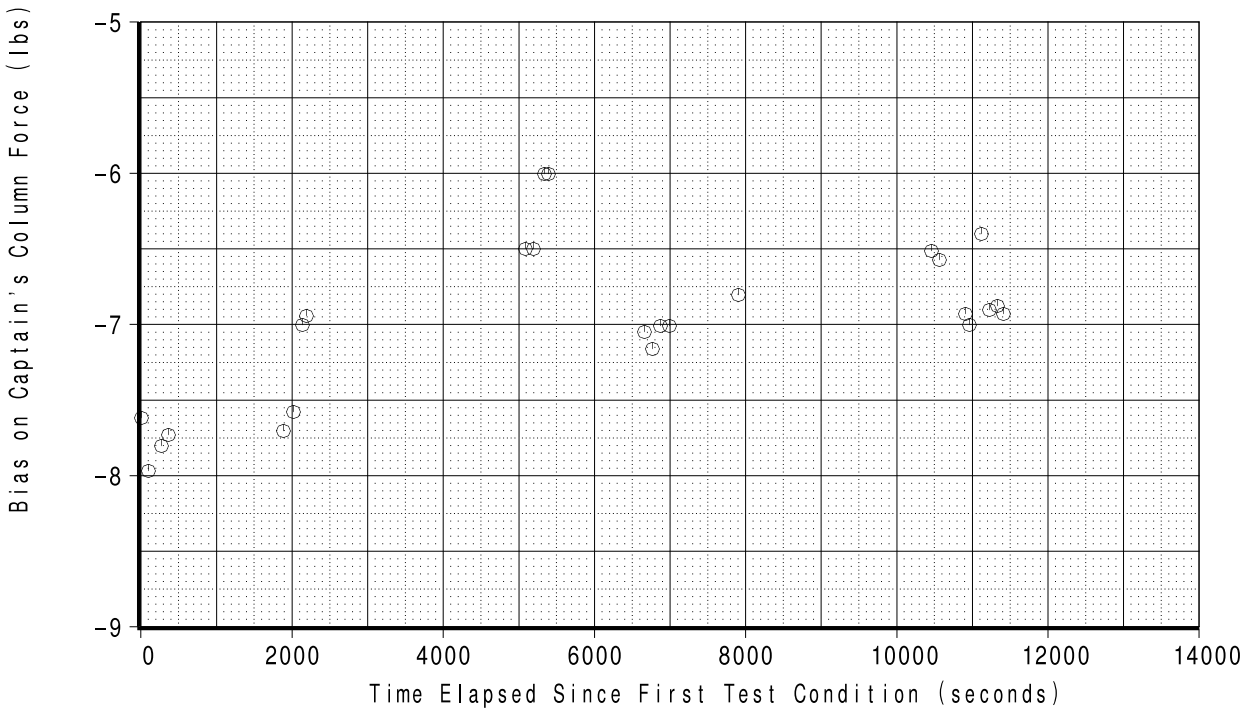
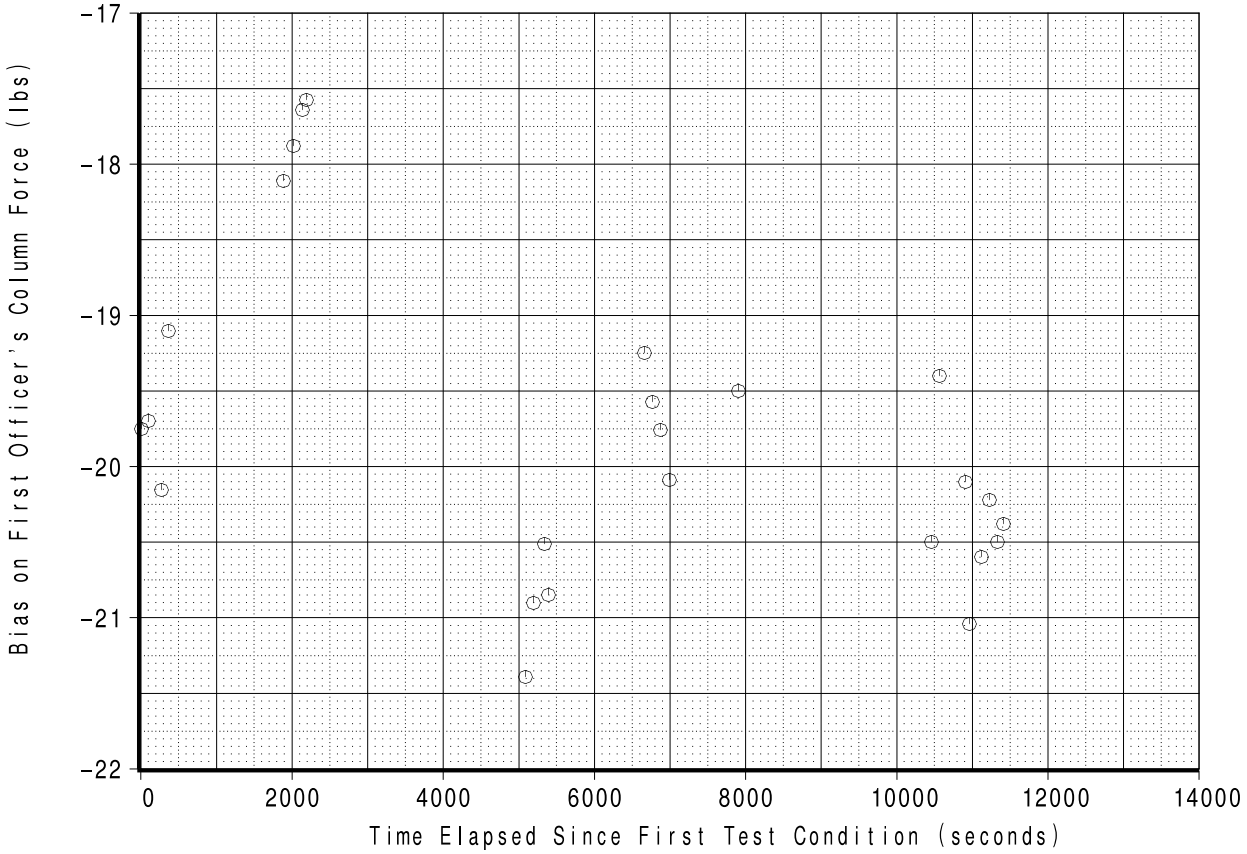
Figure 0 was created to show how the column force instrumentation biases shifted during the test 010-05. Figure 0 plots the column force biases from the table above as a function of the time. From figure 0, it can be seen that the bias on the captain's column force ranged from –6.00 to –7.97 lbs and the bias on the first officer's column force ranged from –21.39 to –17.57 lbs. Within each grouping of test conditions, the biases generally shifted less than 1 lb. The more substantial shifts in biases occurred during the large time intervals between the groups of conditions when larger temperature shifts would be expected to occur.

CALC	Brian Cook	21Jul00	REVISED	DATE	Figure 0: Column Force Biases Versus Time 767 PCA Elevator Disconnect Testing VQ001 Test 010-05 on March 29, 2000	767-400ER VQ001
CHECK						BE326-C00-029 Rev A
APPD.						
APPD.					BOEING	PAGE Figure 0

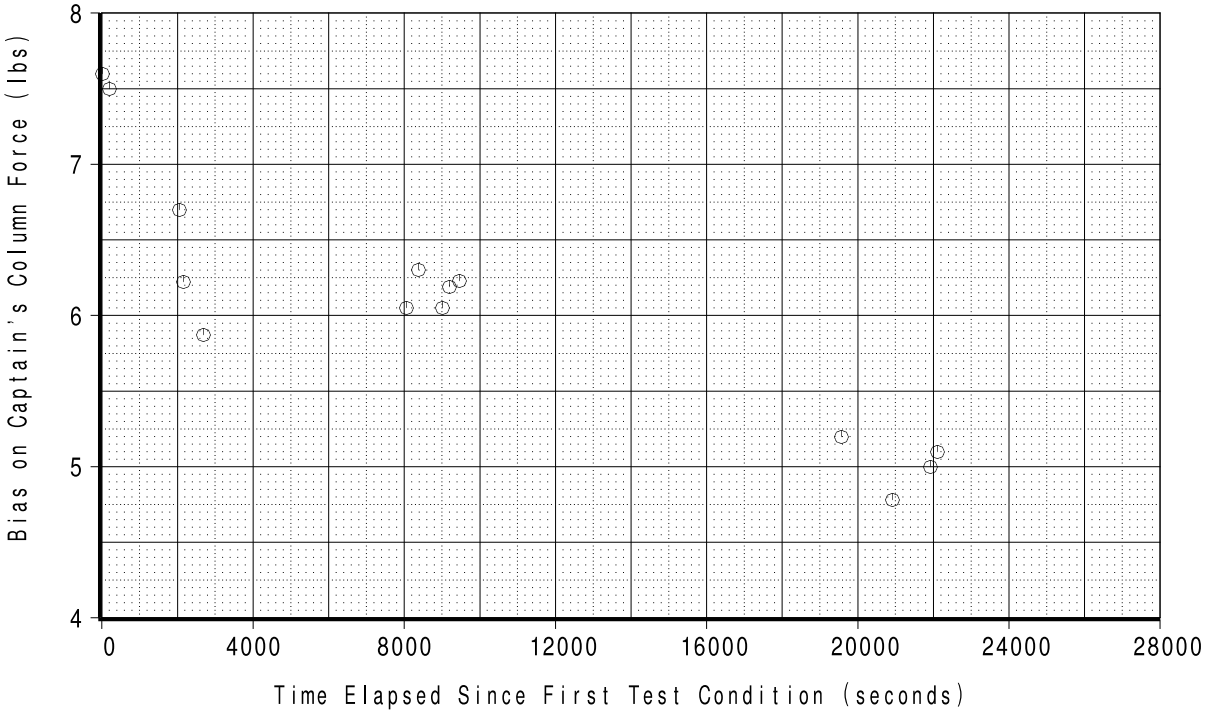
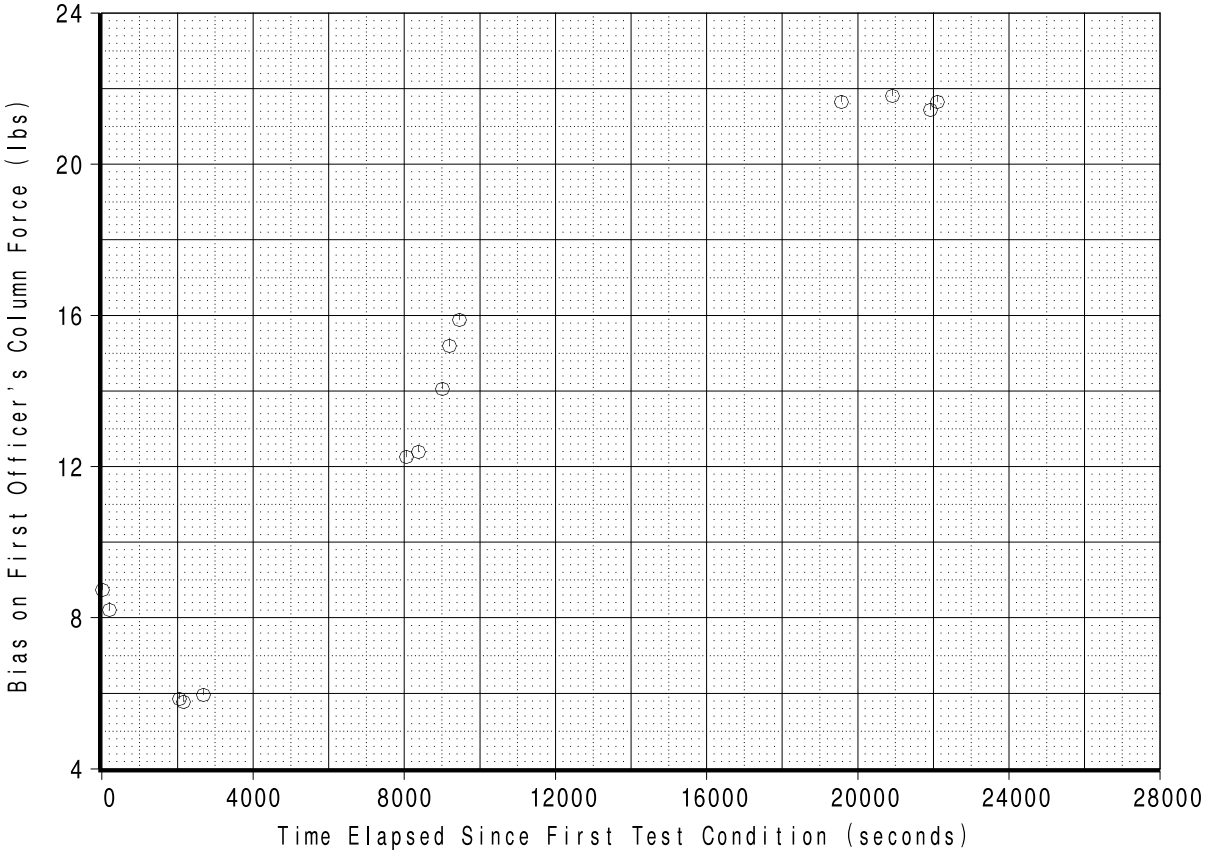
Figure 48.1 was created to show how the column force instrumentation biases shifted during the test 010-18. Figure 48.1 plots the column force biases from the table above as a function of the time. From figure 48.1, it can be seen that the bias on the captain's column force ranged from 4.78 to 7.60 lbs and the bias on the first officer's column force ranged from 5.77 to 21.80 lbs. Within each grouping of test conditions, the biases generally shifted less than a few pounds. The more substantial shifts in biases occurred during the large time intervals between the groups of conditions when larger temperature shifts would be expected to occur.

CALC	Brian Cook	21Jul00	REVISED	DATE	Figure 48.1 Column Force Biases Vs. Time 767 PCA Elevator Jam Testing VQ001 Test 010-18 on April 20, 2000	767-400ER VQ001
CHECK						BE326-C00-029 Rev A
APPD.						
APPD.					BOEING	PAGE Figure 48.1
