**Quick Response No. 331**

***An Analysis of EMS Helicopter  
Incidents***

**Prepared for  
National Transportation Safety Board  
(NTSB)**

# Aviation Safety Reporting System Helicopter Related Incidents Data and Analysis for the National Transportation Safety Board (NTSB)

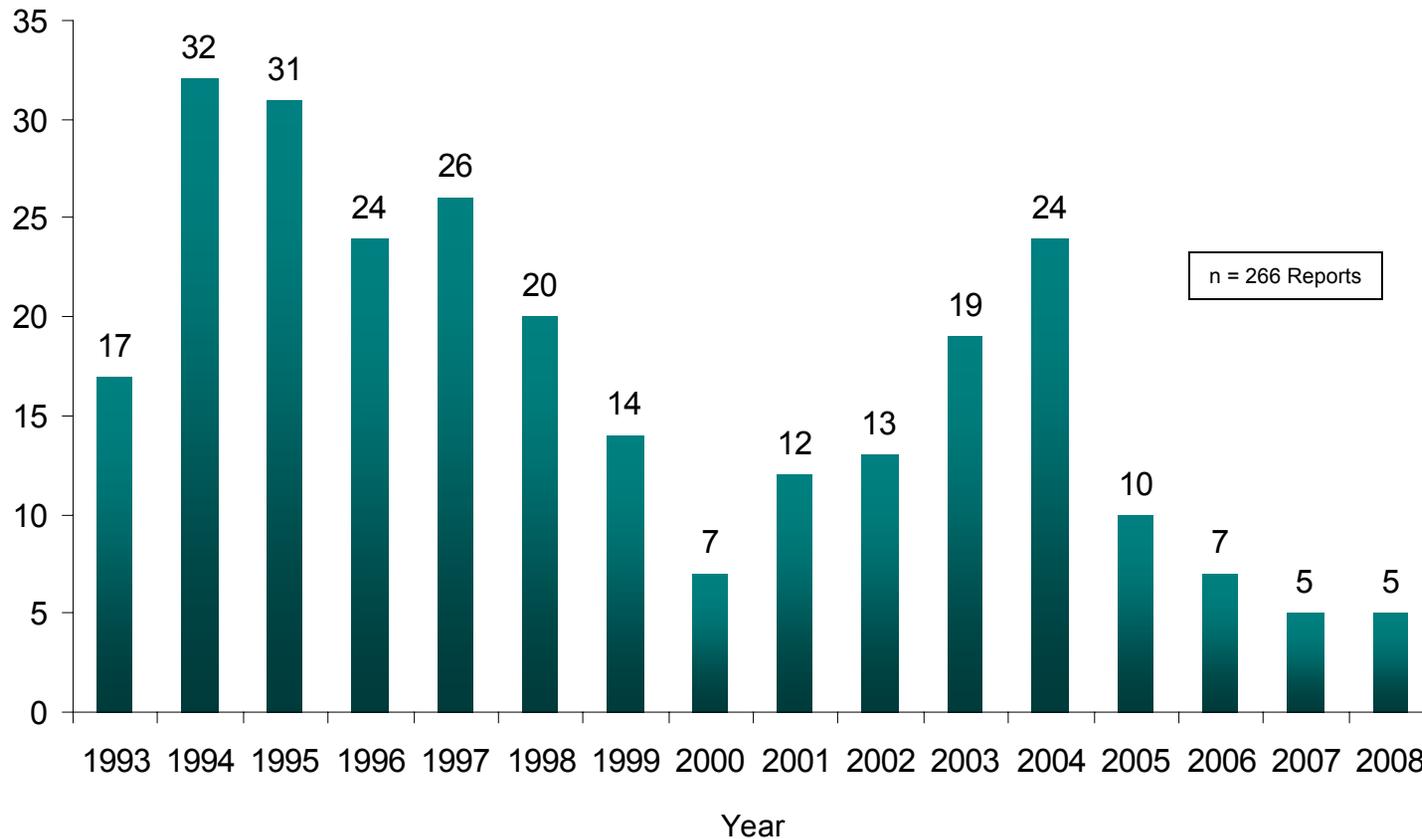
# EMS Helicopter Reports – Year Break

January 1993 to December 2008

Data references ASRS reports that have received full-form analysis and include the reporters' narrative.

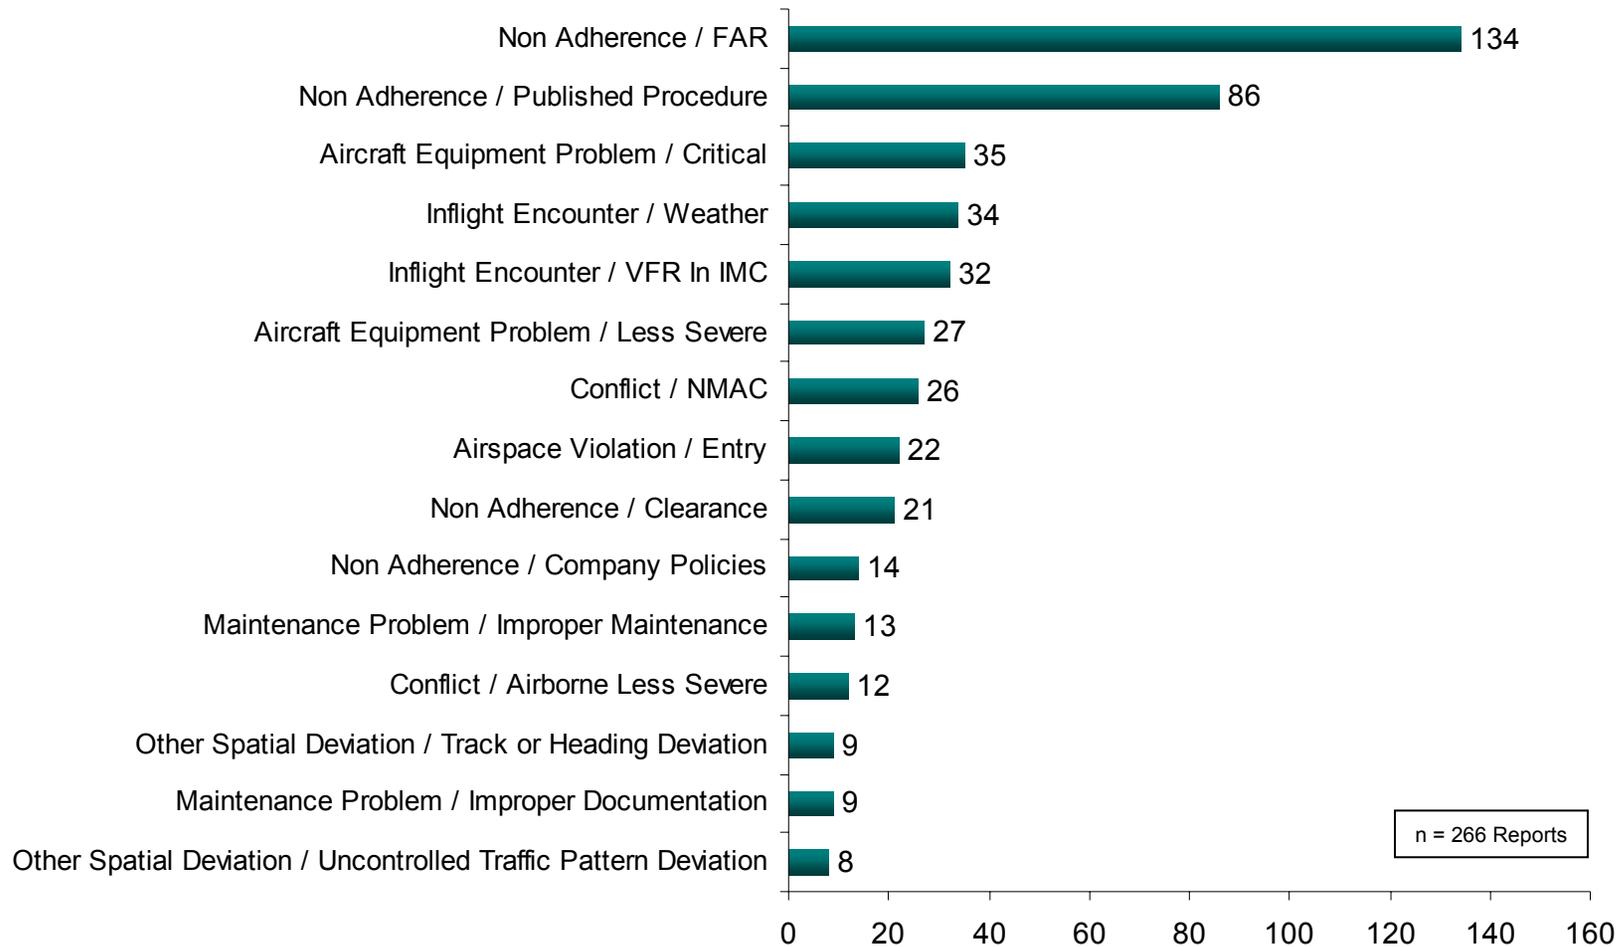
# EMS Helicopter Reports – Top 15 Reported Anomalies

January 1993 to December 2008

Categories are not mutually exclusive. Therefore, a single incident may be coded by ASRS analysts as involving more than one anomaly. Data references ASRS reports that have received full-form analysis and include the reporters' narrative.

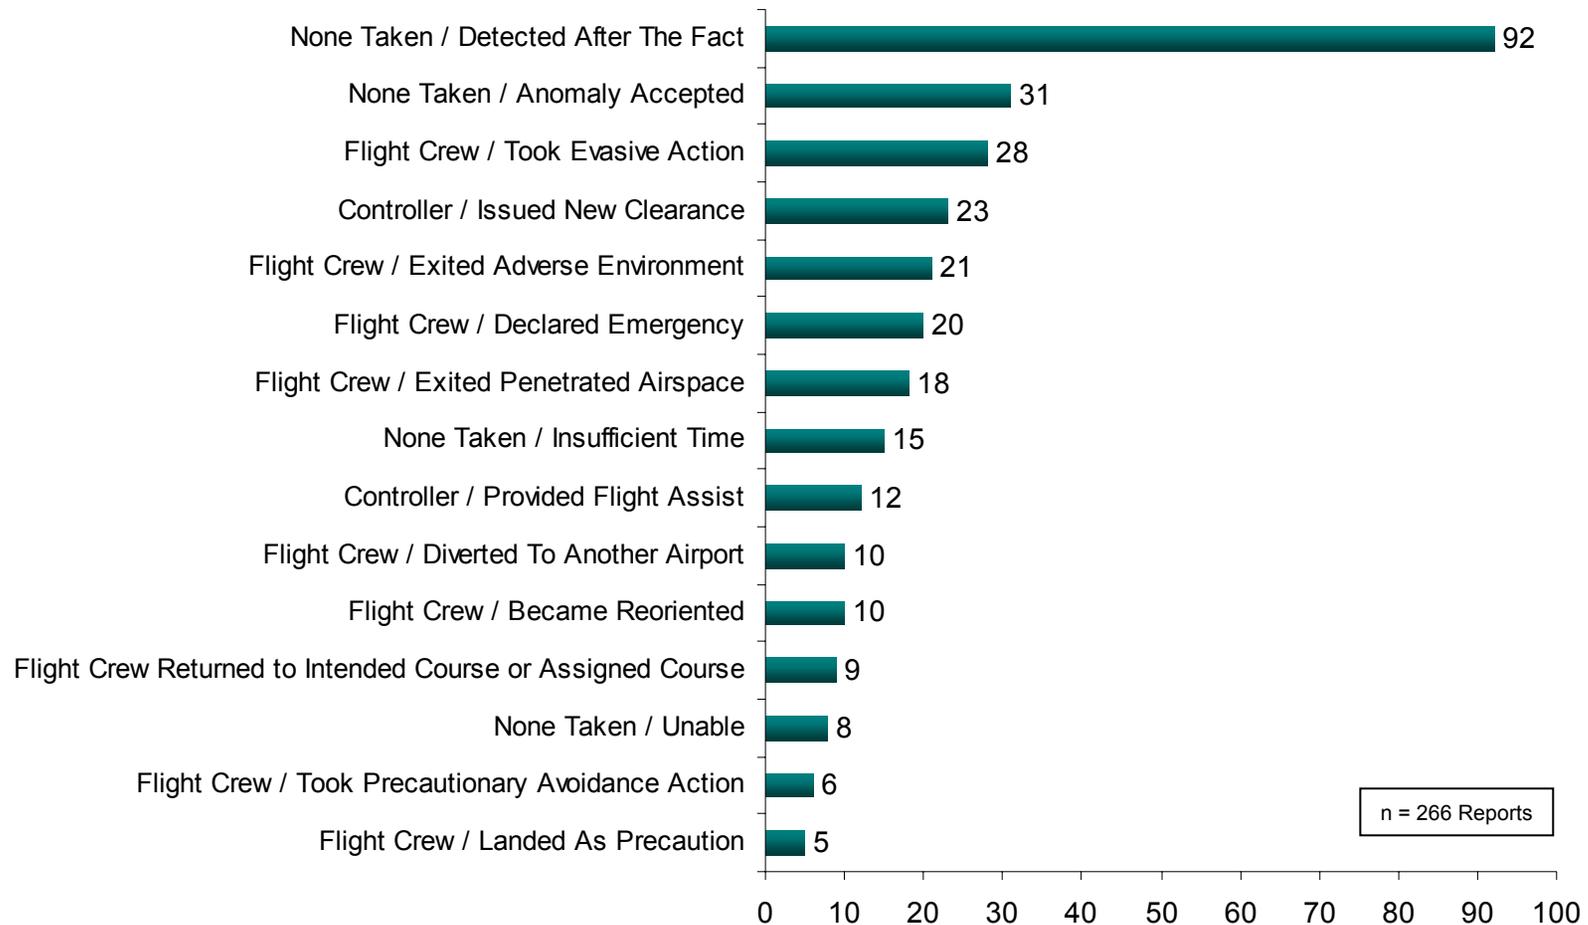
# EMS Helicopter Reports – Top 15 Anomaly Resolutions

January 1993 to December 2008

Categories are not mutually exclusive. Therefore, a single incident may be coded by ASRS analysts as involving more than one resolution. Data references ASRS reports that have received full-form analysis and include the reporters' narrative.

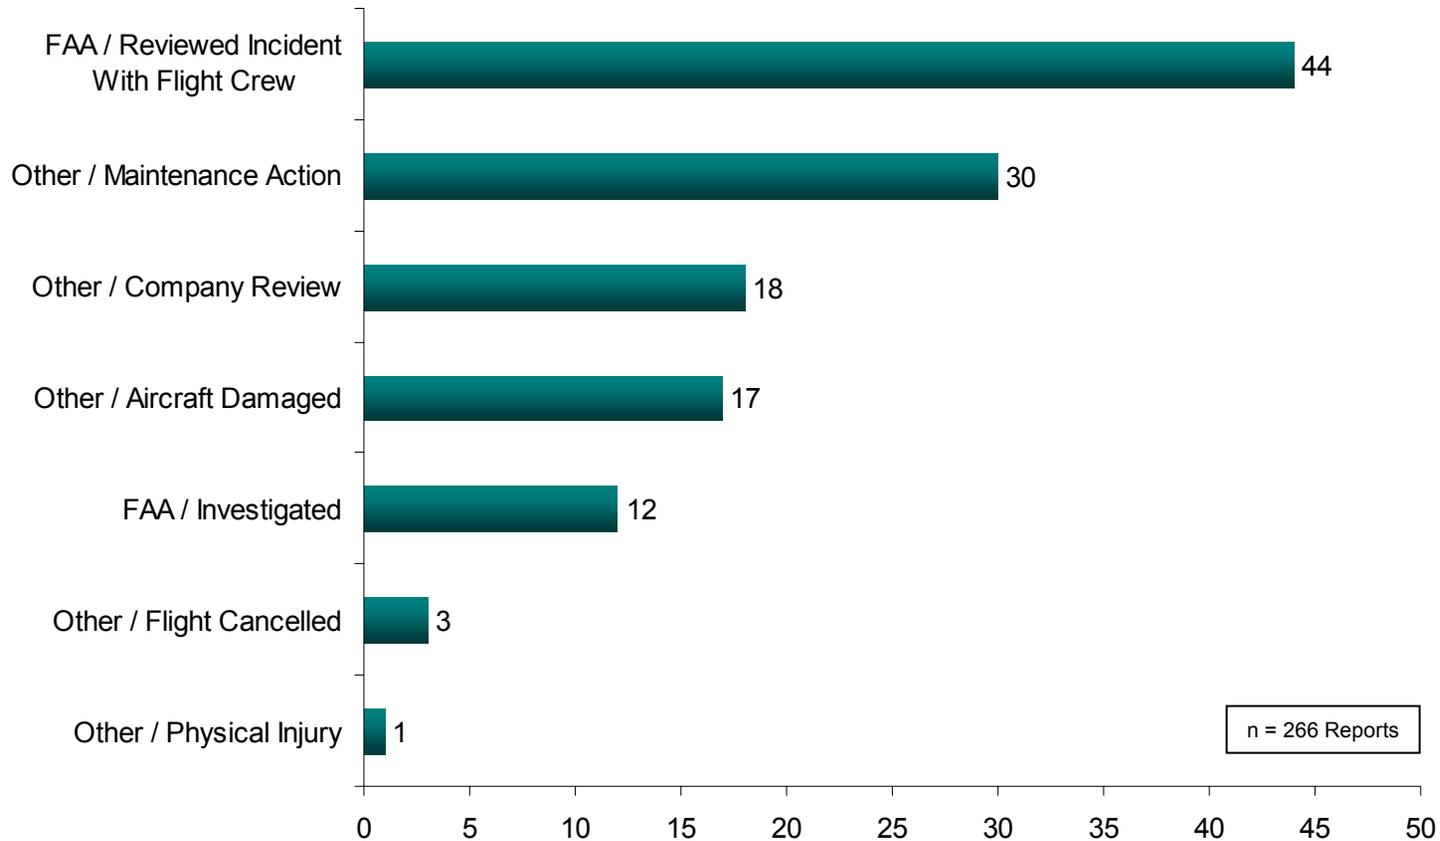
# EMS Helicopter Reports – Anomaly Consequence

January 1993 to December 2008

Categories are not mutually exclusive. Therefore, a single incident may be coded by ASRS analysts as involving more than one consequence. Data references ASRS reports that have received full-form analysis and include the reporters' narrative.

- An aircraft equipment problem was analyzed to have occurred in 52 (19.5%) total incidents.
- Aircraft damage occurred during 17 (6.3%) incidents and 30 (11.2%) incidents resulted in maintenance action.

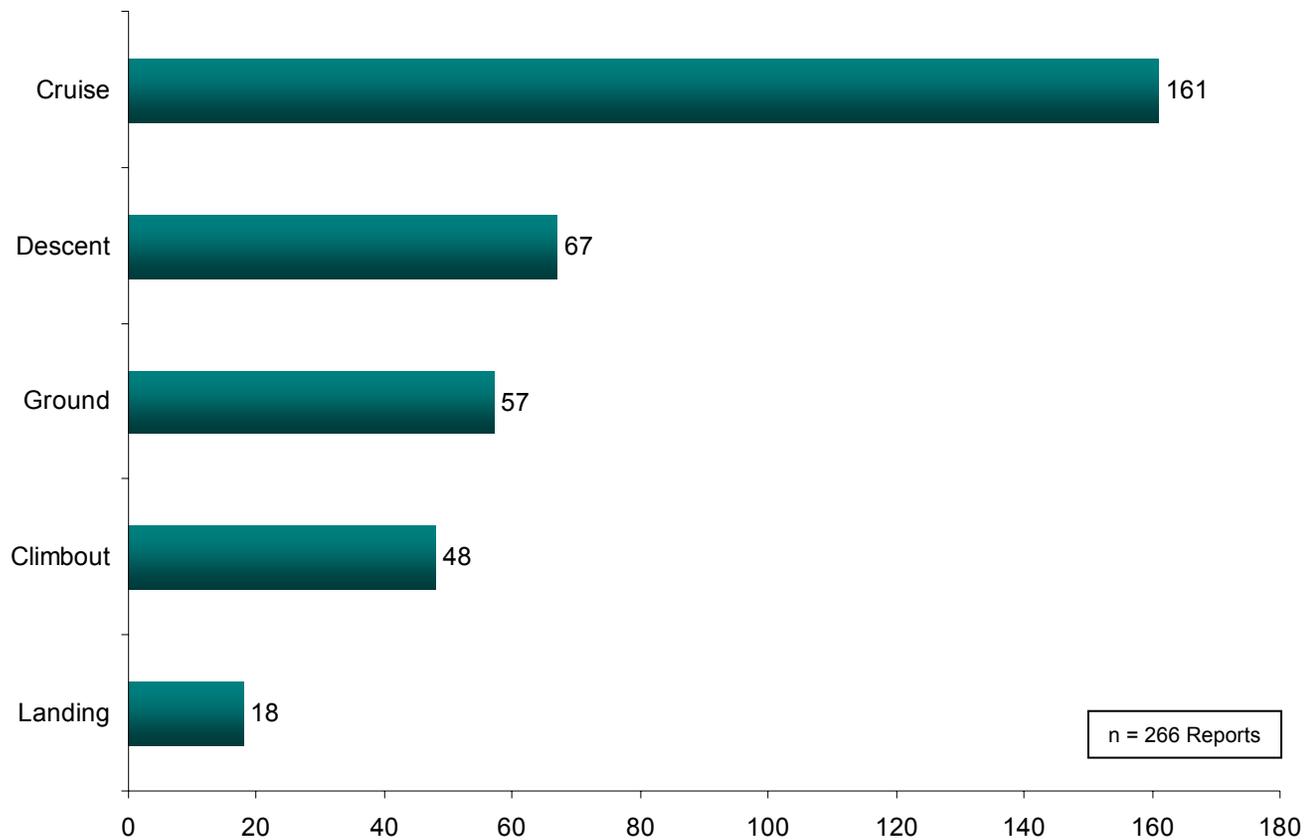
# EMS Helicopter Reports – Flight Phase

January 1993 to December 2008

Categories are not mutually exclusive. Therefore, a single incident may be coded by ASRS analysts as involving more than one flight of phase. Data references ASRS reports that have received full-form analysis and include the reporters' narrative.

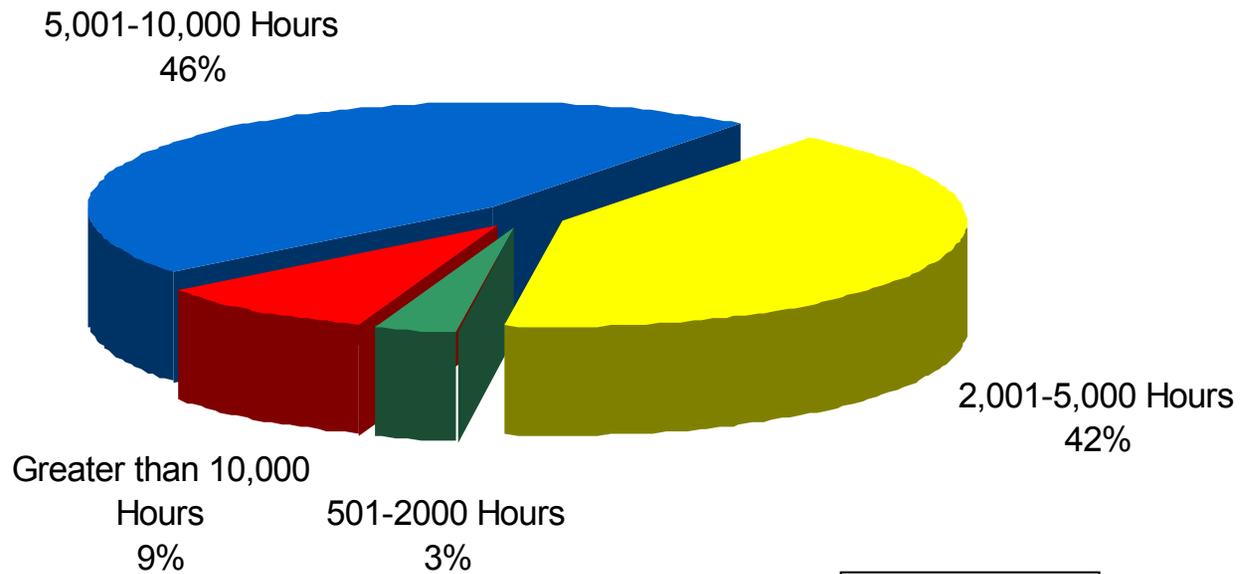
# EMS Helicopter Reports – Total Flight Time

January 1993 to December 2008

n = 244 of 266 Reports

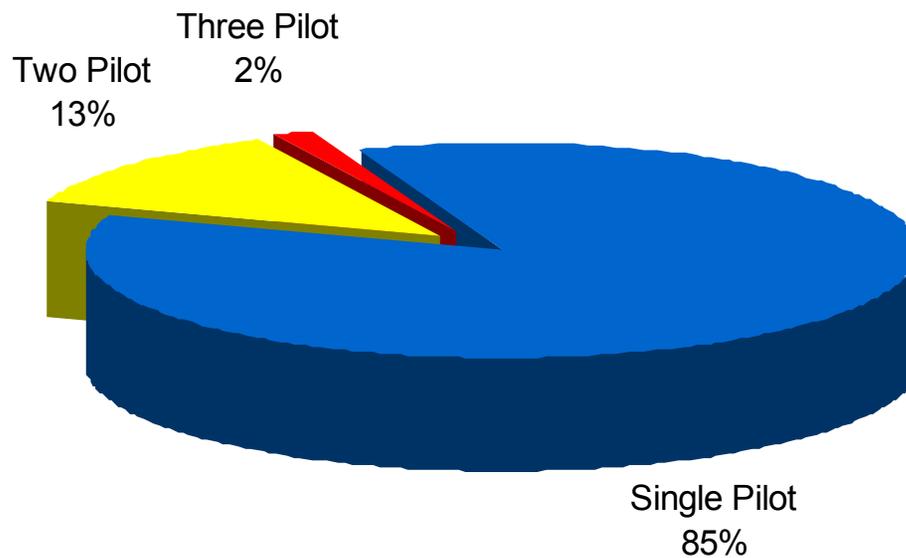
# EMS Helicopter Reports – Crew Size

January 1993 to December 2008

n = 253 of 266 Reports

- The majority of incidents occurred in visual meteorological conditions (182) (84.9%) and daylight conditions (144) (59%).
- Single pilot operations were involved in 217 (85.7%) incidents.

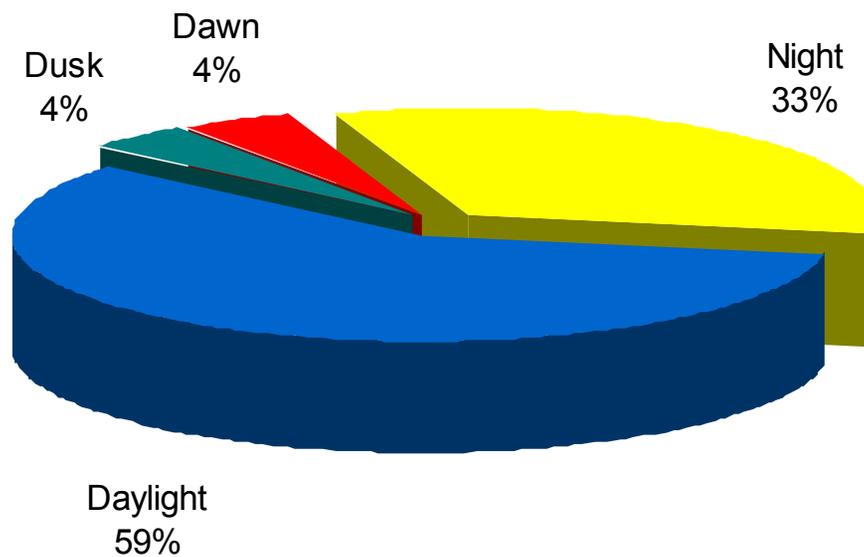
# EMS Helicopter Reports – Lighting Conditions

January 1993 to December 2008

n = 247 of 266 Reports

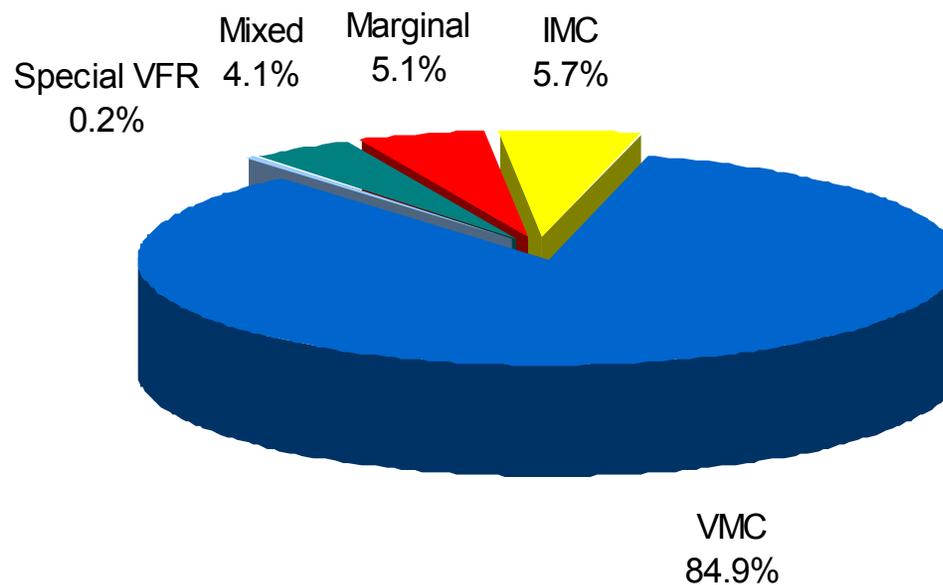
# EMS Helicopter Reports – Flight Conditions

January 1993 to December 2008

n = 240 of 266 Reports

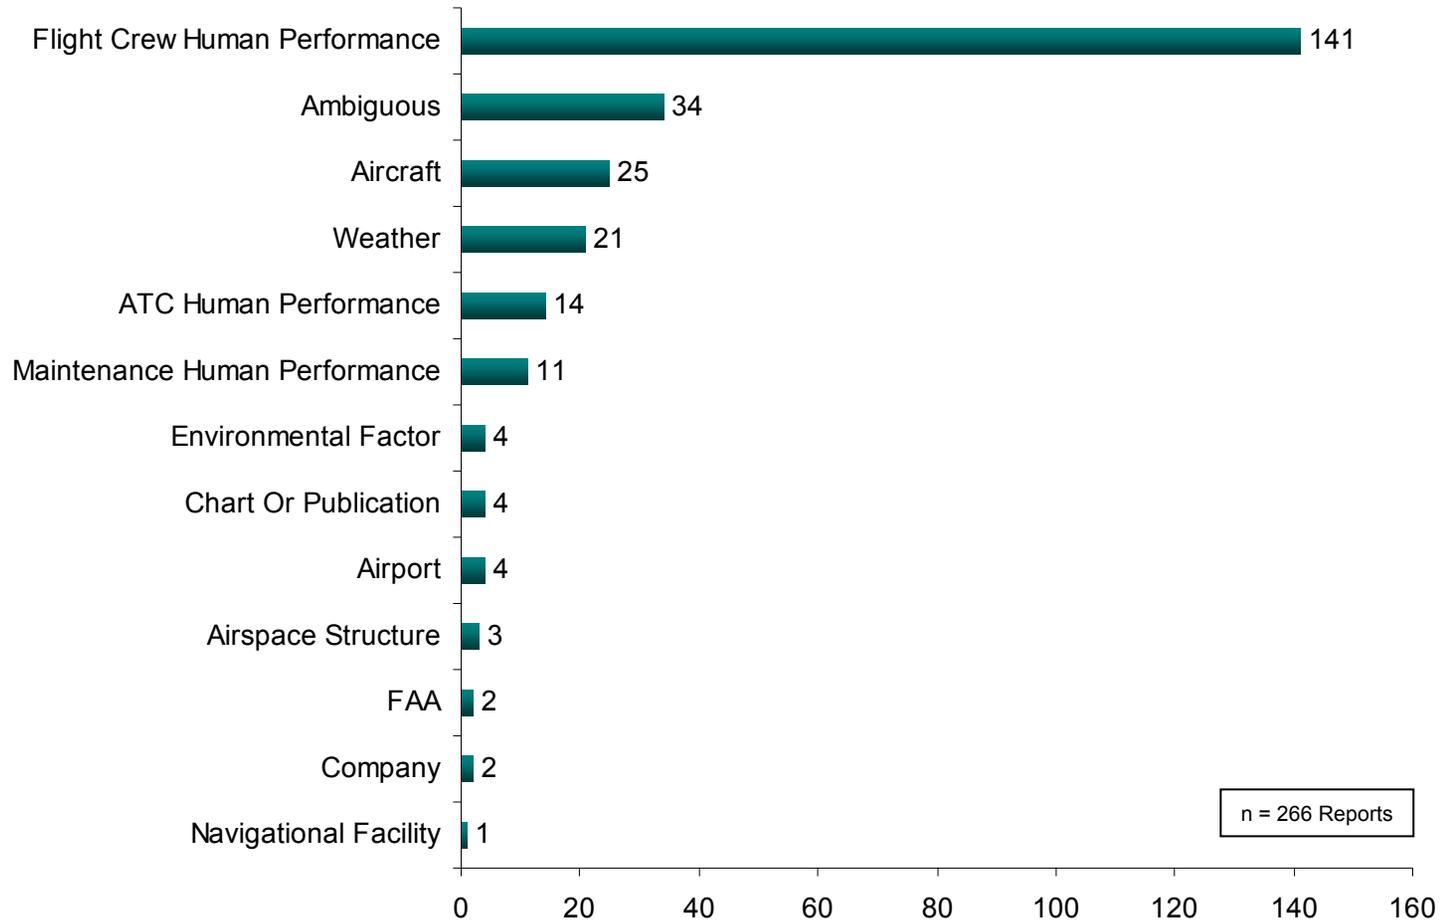
# EMS Helicopter Reports – Primary Problem

January 1993 to December 2008

Data references ASRS reports that have received full-form analysis and include the reporters' narrative.
