NATIONAL TRANSPORTATION SAFETY BOARD
Office of Aviation Safety
Washington, DC 20594

SURVIVAL FACTORS SPECIALIST'S FACTUAL REPORT

Operator : Maryland State Police
Aircraft : Aerospatiale (Eurocopter) AS365N1 [N92MD]
Location : District Heights, MD
Date : September 27, 2008
Time : 2358 EDT¹
NTSB # : MIA08MA203

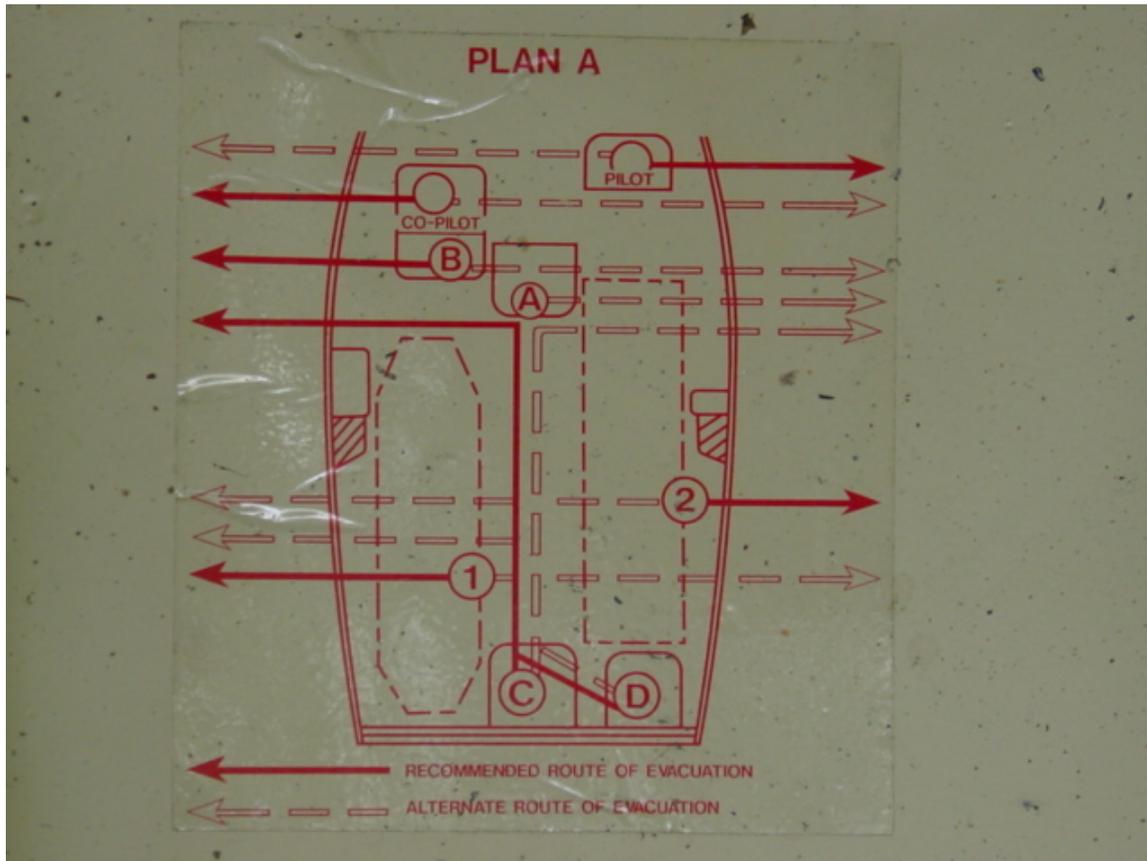
Figure 1. An interior placard showing the seating configuration of N92MD as well as evacuation routes for the occupants.

The helicopter was equipped with two forward-facing pilot seats adjacent to two automotive-type, forward-hinged doors. There was an aft-facing medic seat (A) positioned just aft and between the two the pilot seats. The medic seat had an integral four-point inertia reel restraint. There was a small aft-facing jumpseat (B) directly behind the copilot's seat next to an emergency exit door on the left side of the helicopter. There were two litter positions (1 & 2) - one each on the left and right side of the helicopter. According to Corporal Jon Longest, Maryland State Police flight paramedic, the primary litter position was on the left side of the helicopter. The primary patient was loaded through a sliding door on a litter, which slid and locked into a floor-mounted fixture. The locking mechanism was a circular handle which, when turned 180 degrees, grasps the tubular frame of the litter. According to Cpl. Longest, standard operating procedures were for the primary patient to be loaded headfirst so that the patient's head is near the medic seat.
