**ATTACHMENT 32 – COPY OF MINUTES OF MEETINGS, EMAILS AND
HANDWRITTEN NOTES FROM JULY 24, 2006 THROUGH MAY 2007 AS IT
RELATES TO PROPOSAL FOR STEEL PLATING OF ALL 52 FRACTURE
CRITICAL TRUSS MEMBERS**

2. Invitation for Proposal for a Steel Crack Monitoring System

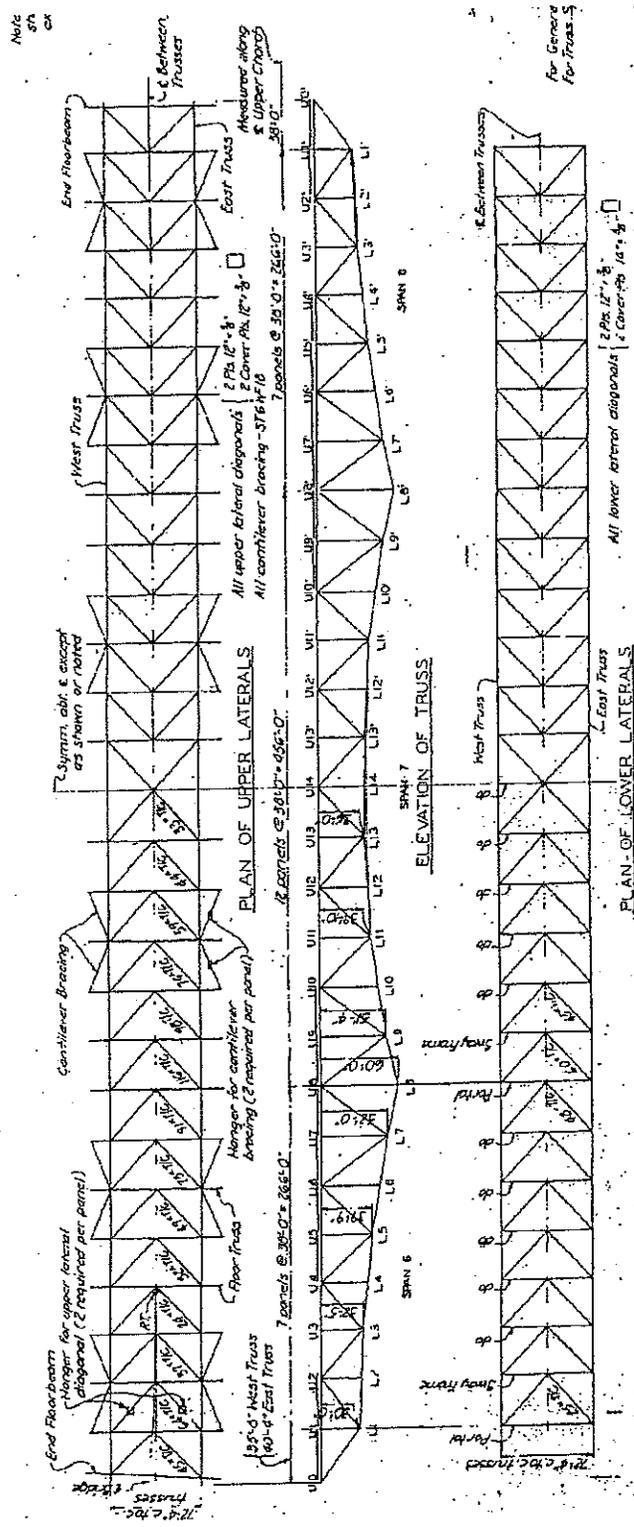
Figure 1: Deck Truss Framing Plan and Elevation from Original Contract Plans
(Highlighted Members are Identified Fracture Critical Members)

The following table lists the identified 13 fracture critical truss members on one half of each truss. Due to the double symmetry of the deck truss, there are a total of 52 fracture critical main truss members on the bridge structure. Figure 1 shows all the fracture critical members on one truss, or 26 members. These include the corresponding chord members on the opposing side of the zero-force vertical from the fracture critical members identified by the redundancy analysis.

The fracture critical members can be divided into two general groups: (1) relatively more fatigue sensitive members (L1-L2, L2-L3, U0-U1, U1-U2, U4-U5, and U5-U6), these members are subject to higher fatigue load stress ranges, not satisfying the Fatigue Guide Specifications' infinite fatigue life check for Category E, but are subjected to lower total stresses and have thinner web plates that are more forgiving for brittle fracture; and (2) relatively more fracture sensitive members (L11-L12, L12-L13, L13-L14, U6-U7, U7-U8, U8-U9, and U9-U10), these members have larger cross sections and are subject to very low fatigue load stress ranges, satisfying all AASHTO infinite fatigue life checks for Category E, but are subjected to higher total stresses and have thicker web plates that do not tolerate the existence of through-thickness cracks before the occurrence of brittle fracture.

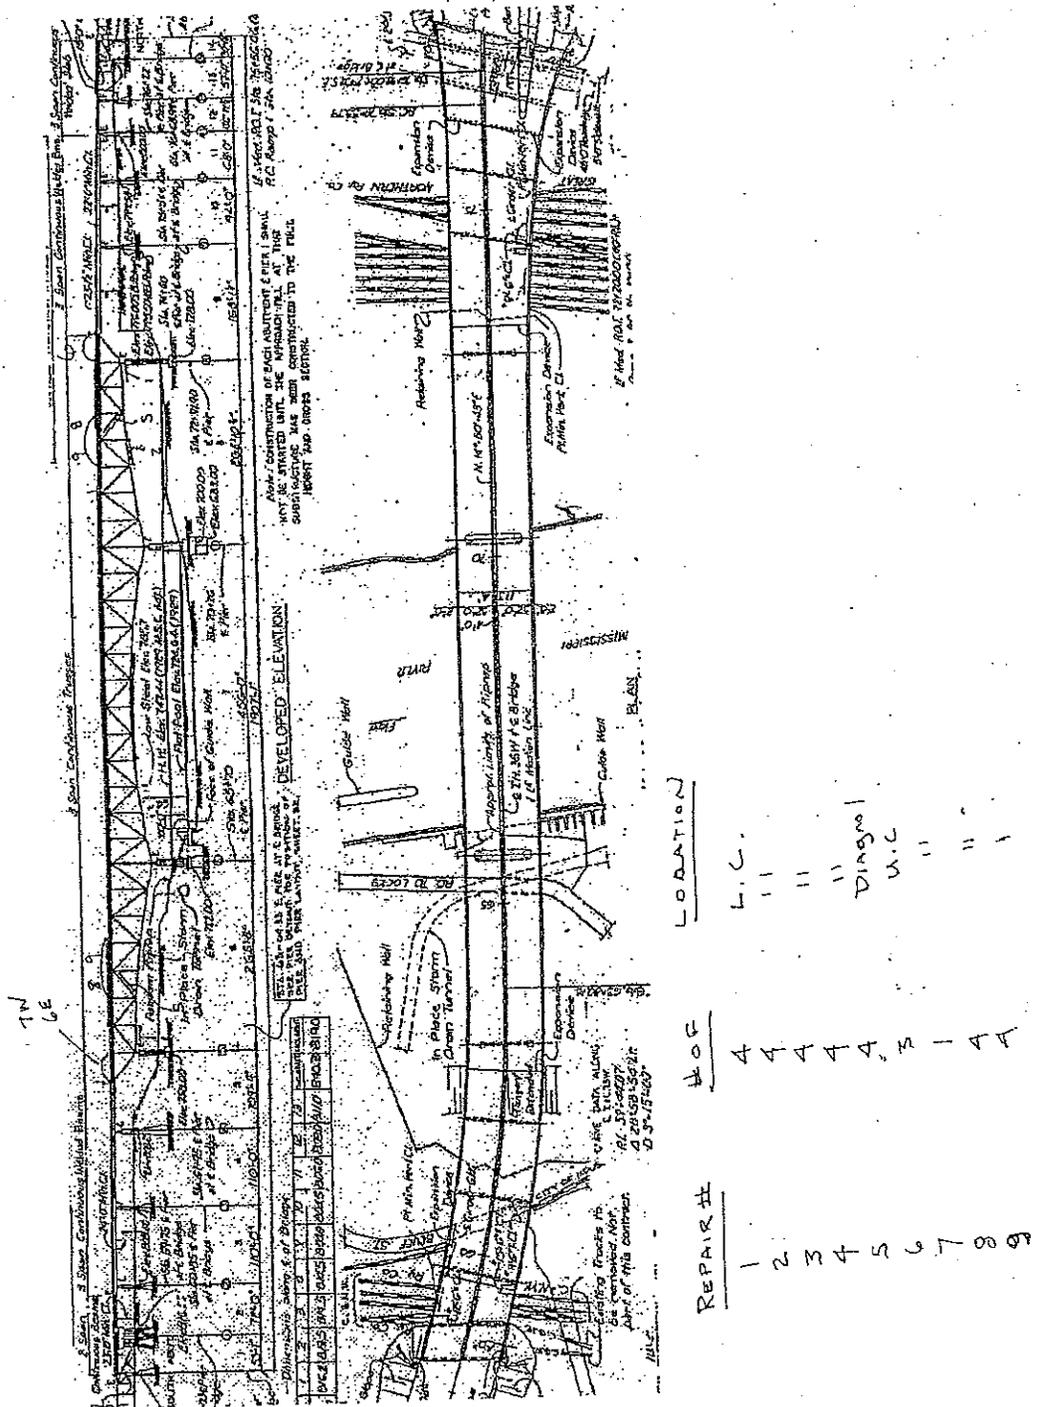
Figure 1-1. Bridge 9340 General Plan and Elevation from Original Contract Plan

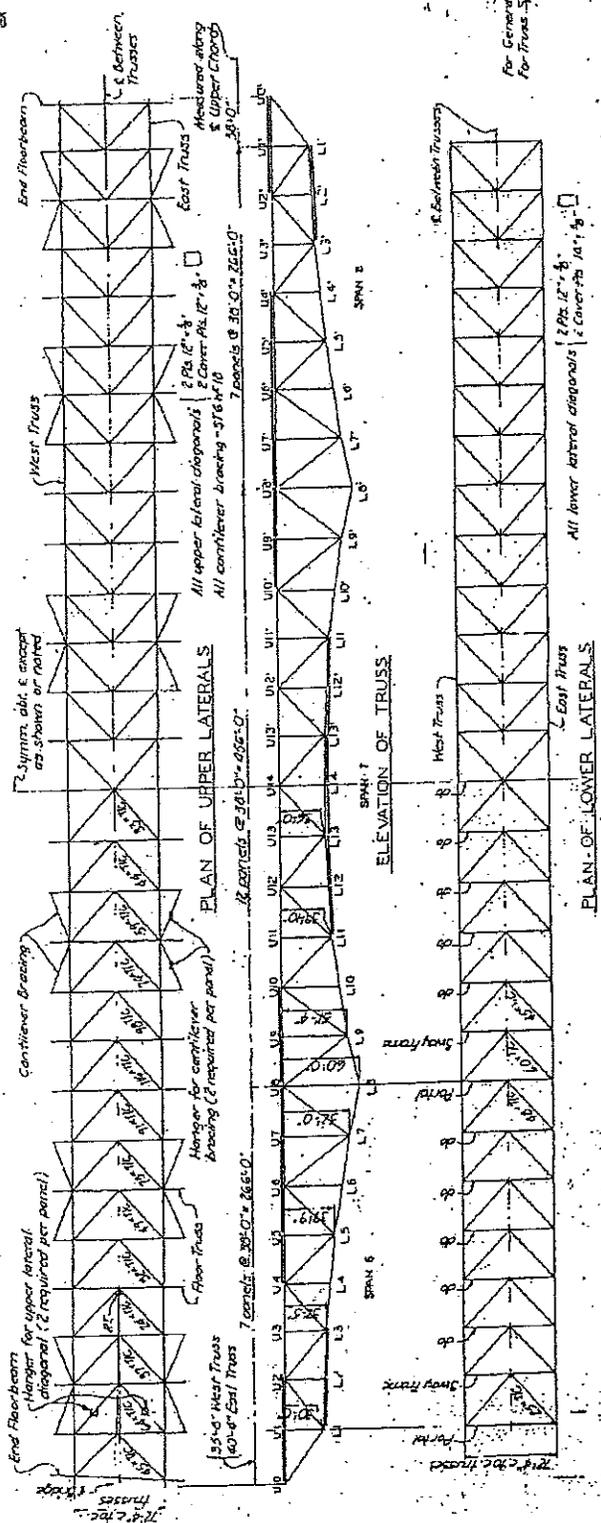
Figure 1: Deck Truss Framing Plan and Elevation from Original Contract Plans
(Highlighted Members are Identified Fracture Critical Members)

The following table lists the identified 13 fracture critical truss members on one half of each truss. Due to the double symmetry of the deck truss, there are a total of 52 fracture critical main truss members on the bridge structure. Figure 1 shows all the fracture critical members on one truss, or 26 members. These include the corresponding chord members on the opposing side of the zero-force vertical from the fracture critical members identified by the redundancy analysis.

The fracture critical members can be divided into two general groups: (1) relatively more fatigue sensitive members (L1-L2, L2-L3, U0-U1, U1-U2, U4-U5, and U5-U6), these members are subject to higher fatigue load stress ranges, not satisfying the Fatigue Guide Specifications' infinite fatigue life check for Category E, but are subjected to lower total stresses and have thinner web plates that are more forgiving for brittle fracture; and (2) relatively more fracture sensitive members (L11-L12, L12-L13, L13-L14, U6-U7, U7-U8, U8-U9, and U9-U10), these members have larger cross sections and are subject to very low fatigue load stress ranges, satisfying all AASHTO infinite fatigue life checks for Category E, but are subjected to higher total stresses and have thicker web plates that do not tolerate the existence of through-thickness cracks before the occurrence of brittle fracture.
