1 **National Transportation Safety Board**

15 **Investigator-in-Charge's Factual Report**

16 Grounding of Container Vessel *New Delhi Express*
17 April 15, 2006

18
19 DCA-06-MF-013
20
21

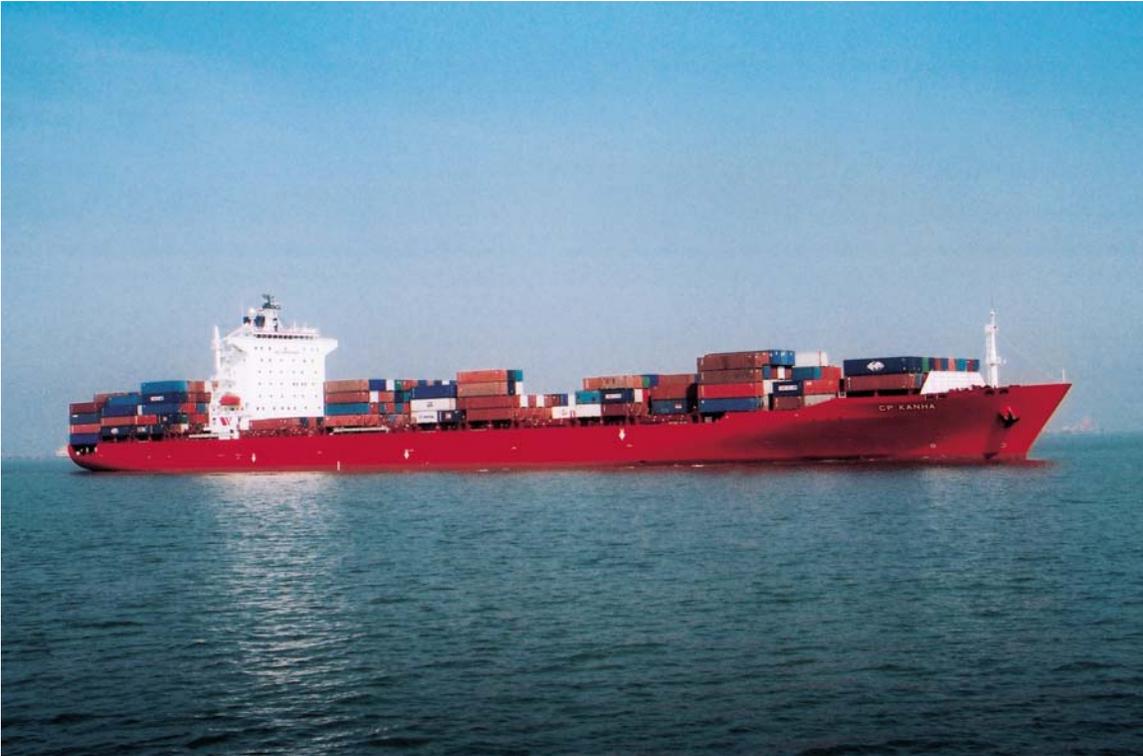
Figure. The *New Delhi Express*.

23 On the morning of April 15, 2006, after a transatlantic voyage which began on
24 April 8 at the port of Gibraltar, the Hong Kong-flag container-ship *New Delhi Express*
25 (see the figure) approached the waters off New York Harbor. The vessel was bound for
26 Port Newark, New Jersey, to discharge and load containers at pier 59.
