National Transportation Safety Board
M/V Massachusetts Fire Factual Report

Vessel: SPV *Massachusetts*
Date: June 12, 2006
Location: Near Long Island Bridge, Boston Harbor, Boston, Massachusetts
NTSB No.: DCA06MF016

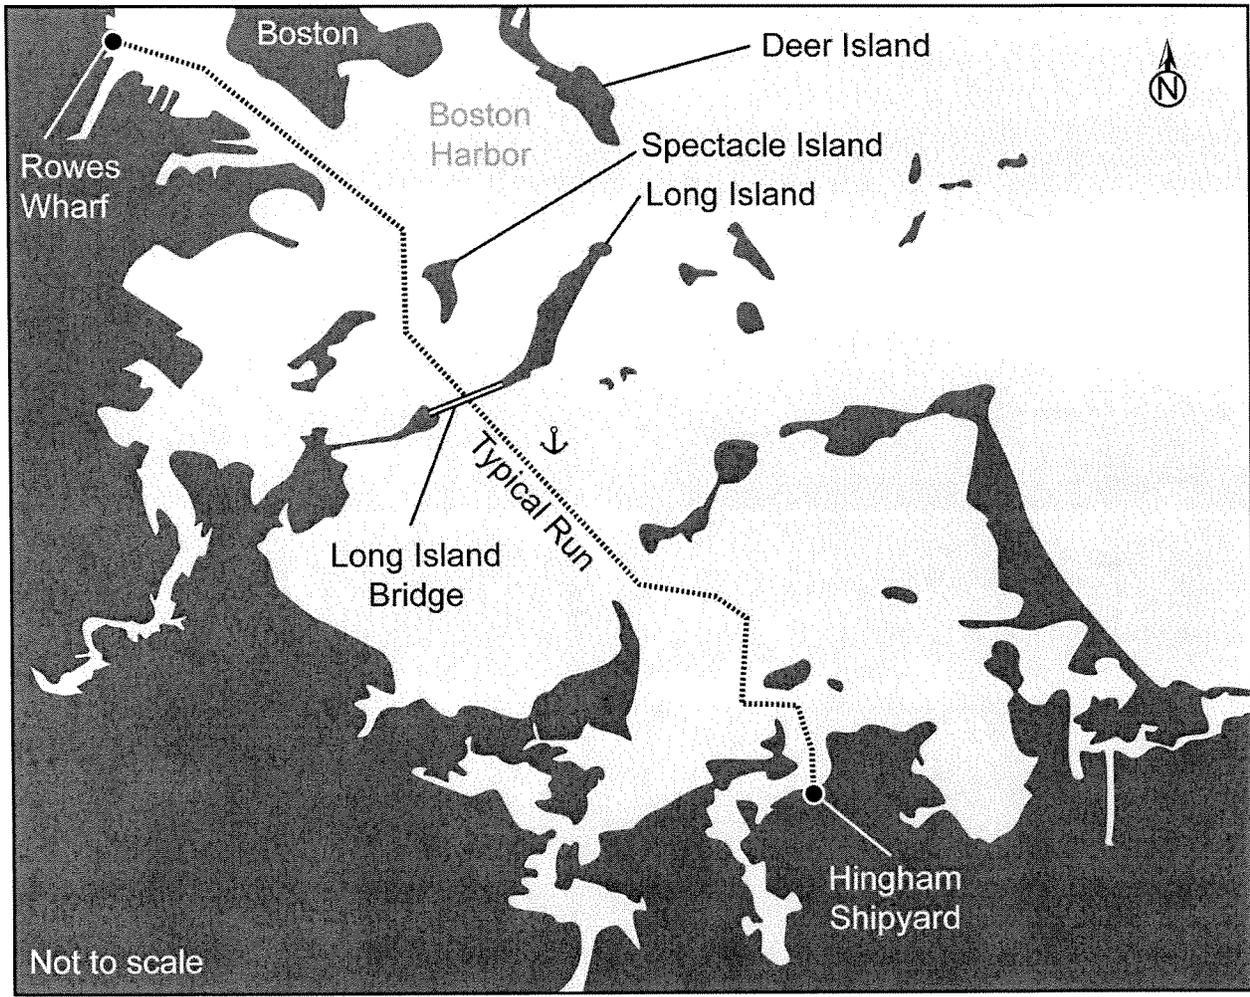
1
2 Figure 2- Typical commuter trip route for *Massachusetts*

2 The vessel boarded 65 passengers, a typical passenger count for the 1600 trip from
3 Boston's Rowes Wharf to the Hingham Shipyard. The Massachusetts departed the dock on
4 schedule with the mate at the helm. See figure 2 below for a diagram of the Massachusetts
5 typical daily commuter route from Rowes Wharf to Hingham Shipyard. Prior to departing, the
6 master of the *Massachusetts* provided a safety briefing to passengers. This briefing was
7 delivered over the PA system to the inner accommodation areas, as well as the outer decks.
8 Passengers were informed about the location and type of lifesaving equipment on board and told
9 to follow the instructions of crewmembers in case of an emergency.
10 Soon after leaving Rowes Wharf, the captain went to the engine room to bleed air out of the air
11 conditioning system. He did not detect anything out of the ordinary at that time. The captain then
12 returned to the pilothouse. Approximately 10 minutes into the trip, about 1610, the upper deck

1 Having made contact with the *Laura*, the captain navigated the *Massachusetts* to the east
2 just outside of the channel, approximately one half mile south of the Long Island Bridge, and
3 ordered the mate to drop the anchor. The *Massachusetts* anchor location is designated by the
4 anchor symbol in figure 2. Having safely anchored the vessel, the captain sent the mate to the
5 main deck to secure the emergency fuel oil shutoff valves, located behind the bar service area, on
6 the starboard side. The 2 deckhands returned to the upper deck to attend to the passengers. At
7 this time the captain shut down the starboard inboard engine. The generator shut down due to
8 fuel starvation about 30 seconds after the after the emergency shutoff valves were secured.

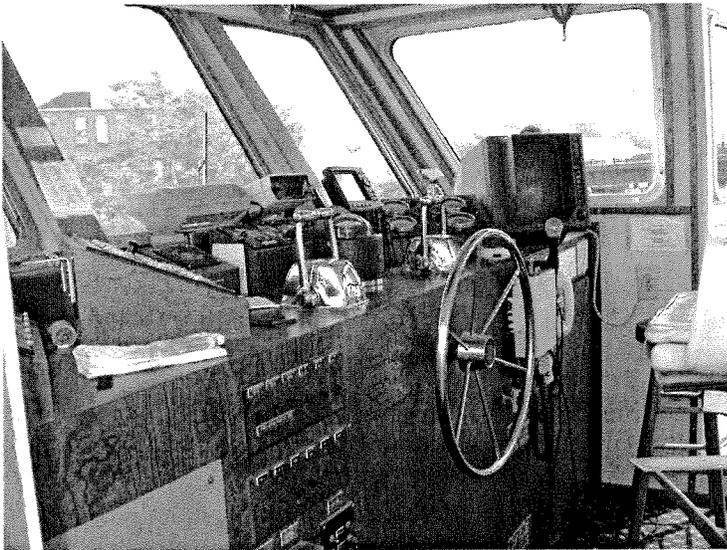
8
9 Figure 3- *Massachusetts* pilothouse

10 The pilothouse (figure 3) was accessed from a short forward ladder on the upper deck. The
11 equipment available to the captain consisted of:
