APPENDIX II

Standard 12" (325 mm) IDOD/MFL Tool Specification

Standard 12" (305 mm) Deformation Tool Specification

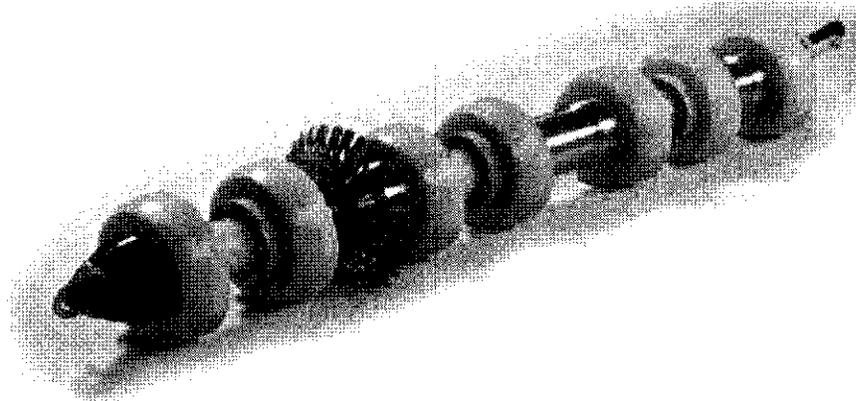
DEF Tool Specifications

Deformation sensor type	Low mass, direct measuring arms
Sample frequency	Up to 500 samples per second
Data discarded by filtering	None
Data storage	Solid state flash memory
Tool transmitter	Pulsed low frequency
Inertial navigation sensors	Solid state INS
Operating pressure range ¹	300 to 2000 psi (21 to 137.8 bar)
In-line temperature range	14 to 131 °F (-10 to 55 °C)
Maximum tool speed ²	15 ft/s (4.6 m/s)
Minimum bend radius	1.5D
Minimum bore in 1.5D bend	10.75 in (273 mm)
Minimum bore for straight pipe	9.56 in (243 mm)
Defect location aids	GPS equipped AGMs, on board INS and pipeline features
Odometer resolution	0.118 in (2.99 mm)
Number of odometers	2

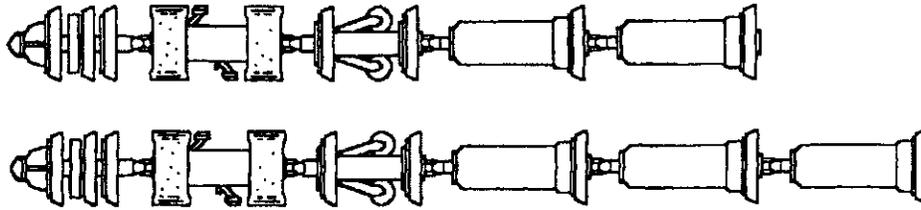
12 INCH (300 mm) TYPE 3A LINALOG TOOL

INSPECTION CAPABILITY			DIMENSIONAL DATA		
Min. wall thickness:	.188 in	4.78 mm	inch	mm	
Max. wall thickness:	.625 in	15.88 mm	Section 1	21	533
			Section 2	23	584
			Section 3	19	483
			Section 4	27	686
			Section 5	30	762
			Section 6	29	737
OPERATING PARAMETERS*					
Speed Range	.5 to 5.0 mph	.8 to 8.0 km/h			
Temp. Range	40° to 140°F	4° to 60°C

RUN TIME	TOOL LENGTH		TOOL MASS		TRAY MASS	
	hrs	inch	mm	lbs	kg	lbs	kg
Single Batt. Pkg.	22	119	3,023	740	336	66	30
Dual Batt. Pkg.	44	149	3,785	810	368	88	40

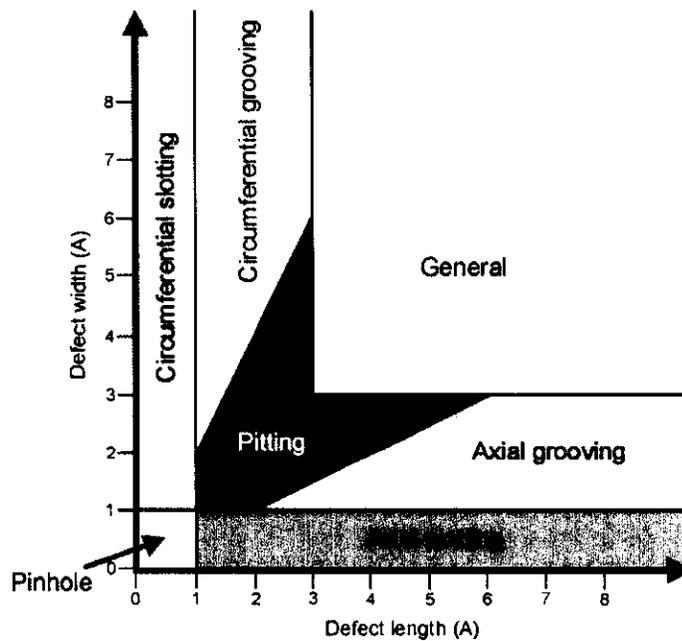
Magnetic Flux Leakage (MFL) is an indirect method. It uses and is being affected by more than one physical property. The influence of the defect shape on the sizing accuracy is parameterized by dimension classes, which depend on the outer length and width of the feature

All reported metal loss features are being classified according to these dimensions as per the following POF specification graph.

Note A = wall thickness or 10 mm, whichever value is greater
