AIRCRAFT ACCIDENT REPORT

TEXAS INTERNATIONAL AIRLINES, INC.

DOUGLAS DC-9, N1308T

HARLINGEN, TEXAS

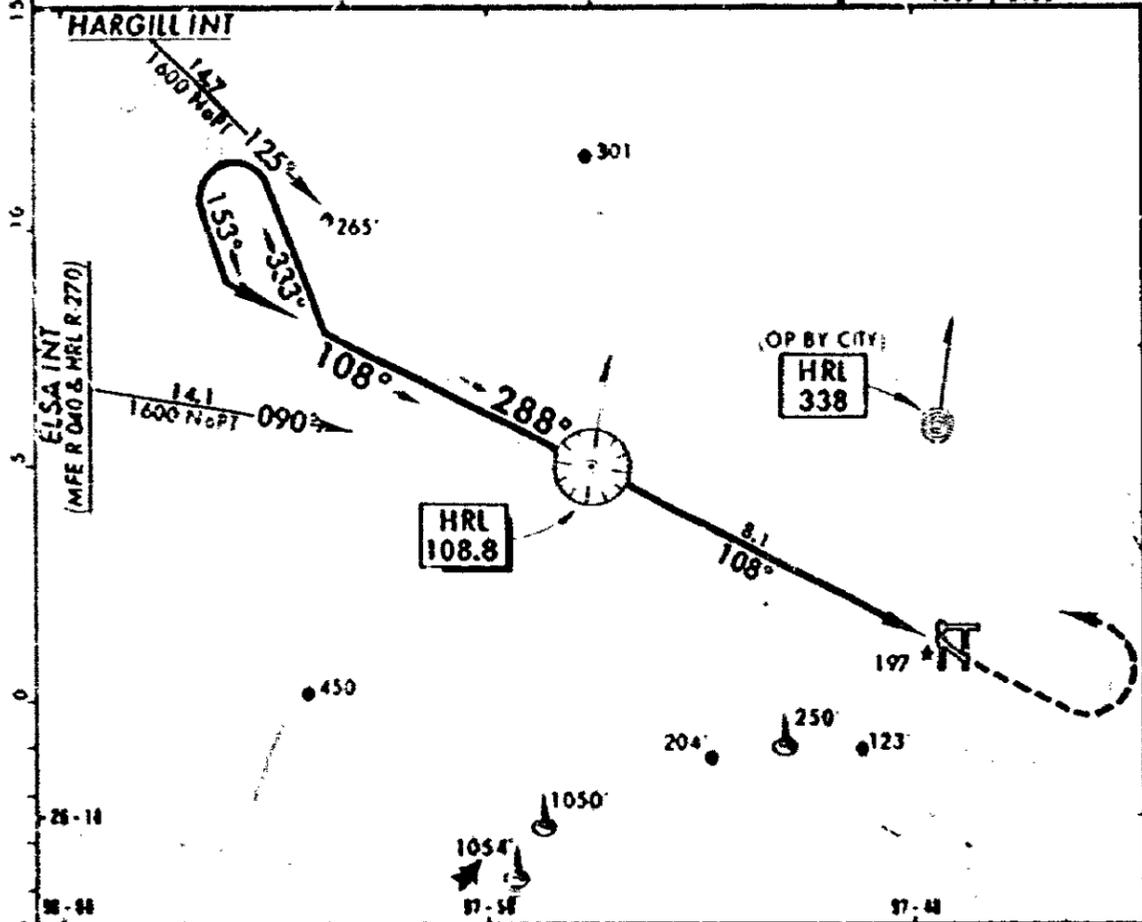
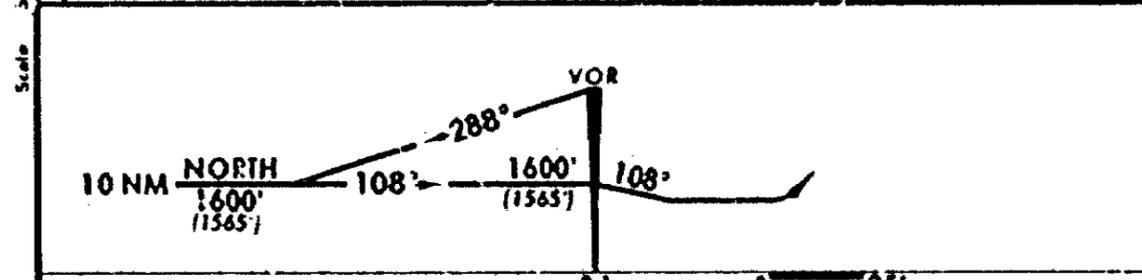
ENR 24 VOR-1
VOR 109.8 HRL

BROWNSVILLE Approach 119.5	Departure	Ground	MSA 270° - 090° - 270° 1500 2100
-------------------------------	-----------	--------	--

PULL UP to 1600 feet, turn LEFT to HRL VOR.

CIRCLE-TO-LAND	
	With Harlingen Altimeter Setting MSL	With Brownsville Altimeter Setting MSL
A	600'(565')-1	680'(645')-1
B	600'(565')-1 1/2	680'(645')-1 1/2
C	600'(565')-2	680'(645')-2
D & S Eng Jet	Non-Std 700'(665')-2	Non-Std 700'(665')-2
