AIRCRAFT ACCIDENT REPORT

PILGRIM AVIATION AND AIRLINES, INC.,

De Havilland Turbo Prop DHC-6,

N124PM, In Long Island Sound

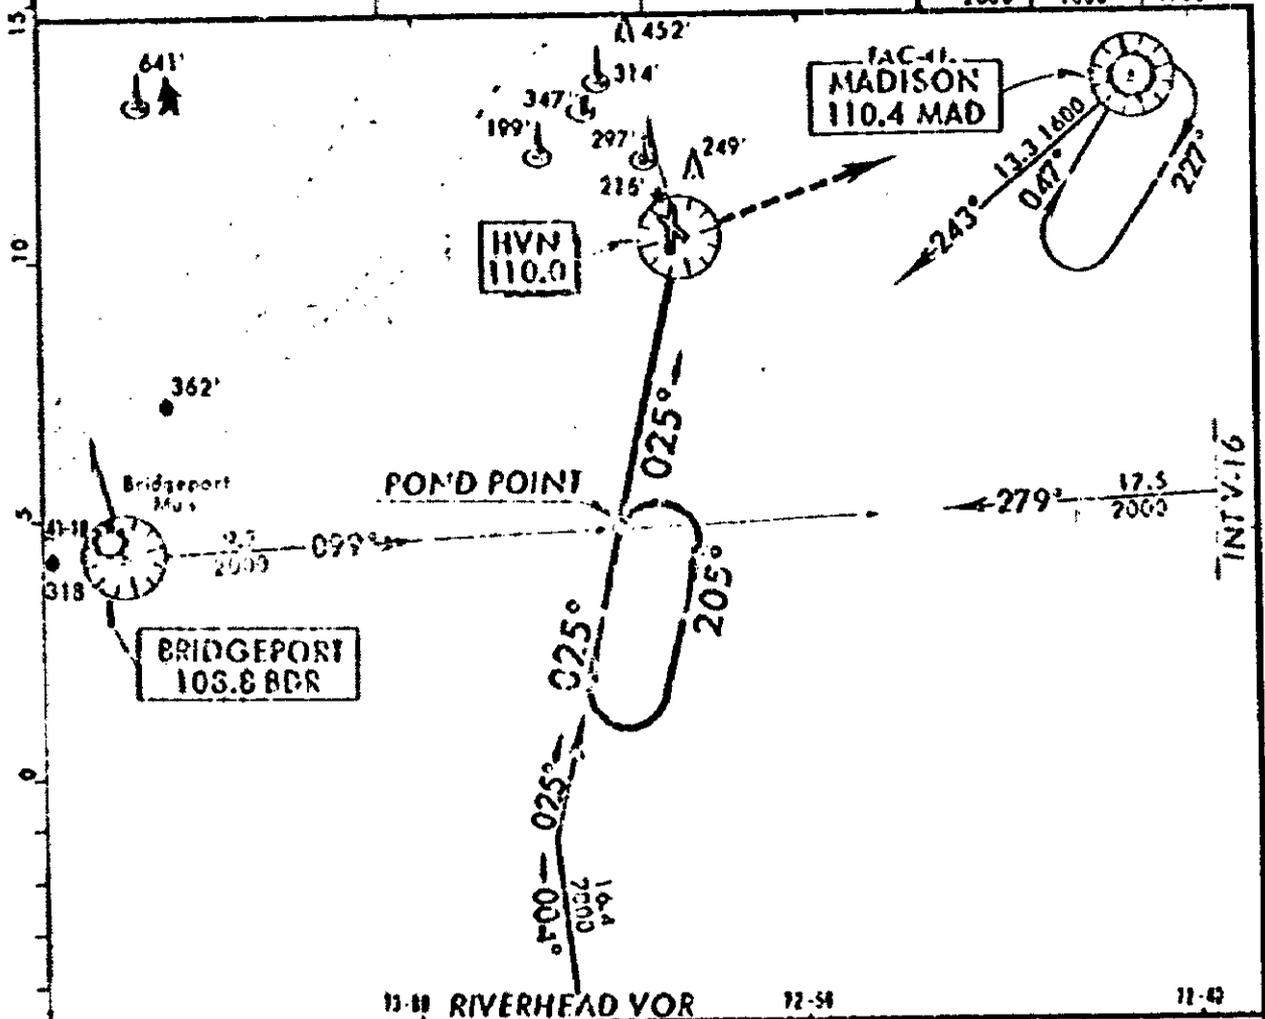
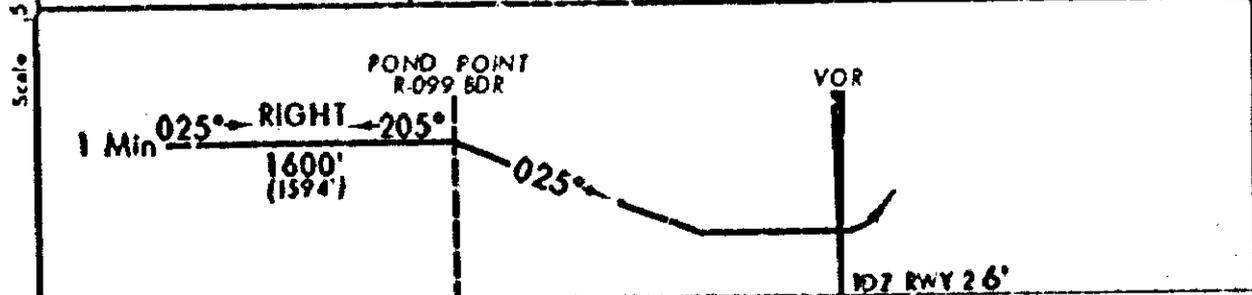
MSA
270° - 090° 180° 270°
2600 | 1600 | 1700

PULL UP: turn RIGHT to 2000 feet to MAD VOR and hold SOUTHWEST.

STRAIGHT-IN LANDING RWY 2		CIRCLE-TO-LAND		
MOA 380' (374) Control Zone Effective		MOA 420' (414) Control Zone not Effective		
		Control Zone Effective	Control Zone not Effective	
		MOA	MOA	
A			A 600' (586') - 1	640' (626') - 1
B			B 600' (586') - 1 1/2	640' (626') - 1 1/2
C			C 600' (586') - 2	640' (626') - 2
D			D 600' (586') - 2	640' (626') - 2
MOA	MOA 380' (374)	MOA 420' (414)	Non-Std 680' (668') - 2	Non-Std 680' (668') - 2
