1. Report No. NTSB-AAR-74-12	2. Government Accession No.	3. Recipient's Catalog No. PB 238637	
4. Title and Subtitle Aircraft Accident Report - Eastern Air Lines, McDonnell Douglas DC-9-31, N8967E, Akron-Canton Regional Airport, North Canton, Ohio, November 27, 1973		5. Report Date November 5, 1974

AIRCRAFT ACCIDENT REPORT

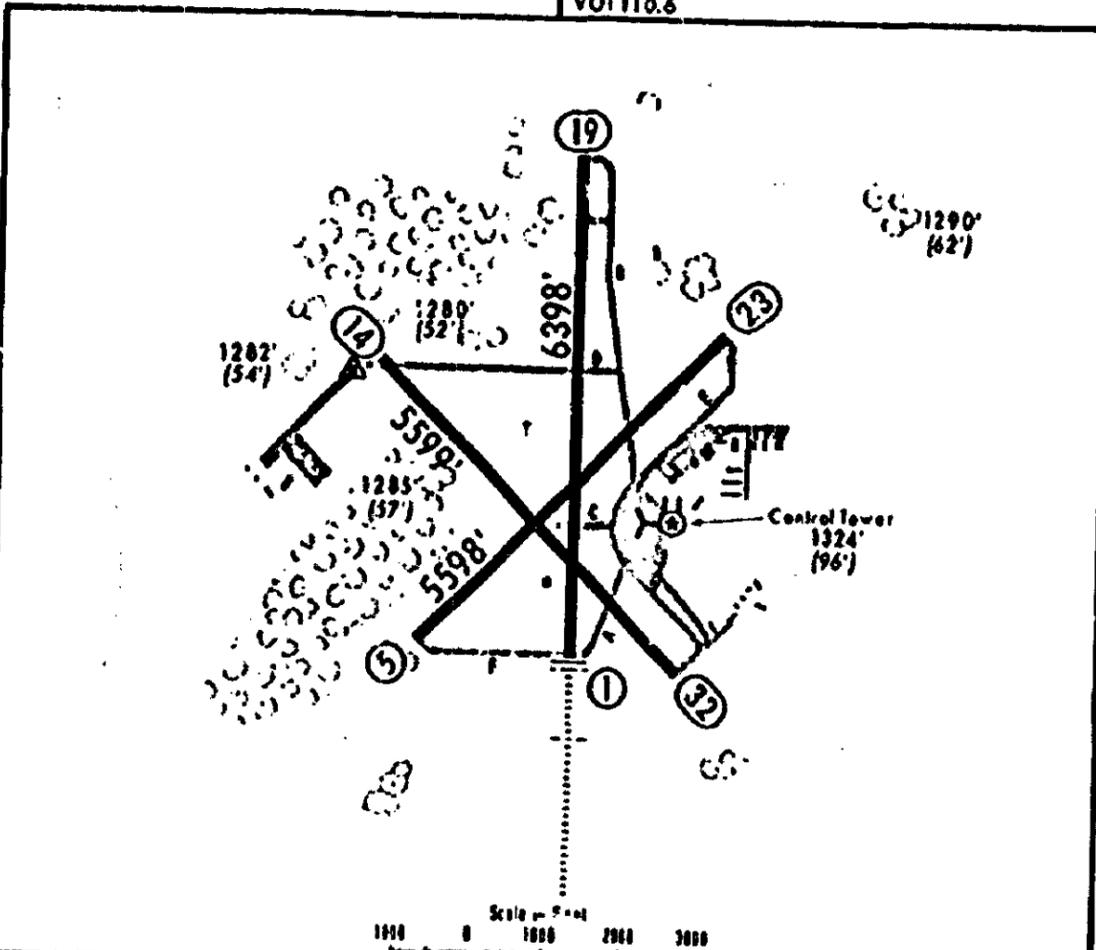
ADDITIONAL RUNWAY INFORMATION

RWY	LIGHTING	USEABLE LENGTHS			WIDTH
		LANDING BEYOND Threshold	Glide Slope	TAKE OFF	
1	MIRL HIALS SFL				150'
19	MIRL VASI-I		5453'		
5	MIRL				150'
23	MIRL REN VASI-I				
14	MIRL				150'
32	MIRL
