Aircraft Accident Report - Knob Hill Inc
Cessna-421, N999MB, Nogales, Arizona
January 22, 1977

AIRCRAFT ACCIDENT REPORT

**KNOB HILL INC.,
CESSNA-421, N999MB**

REPORT NUMBER: NTSB-ARR-77-11

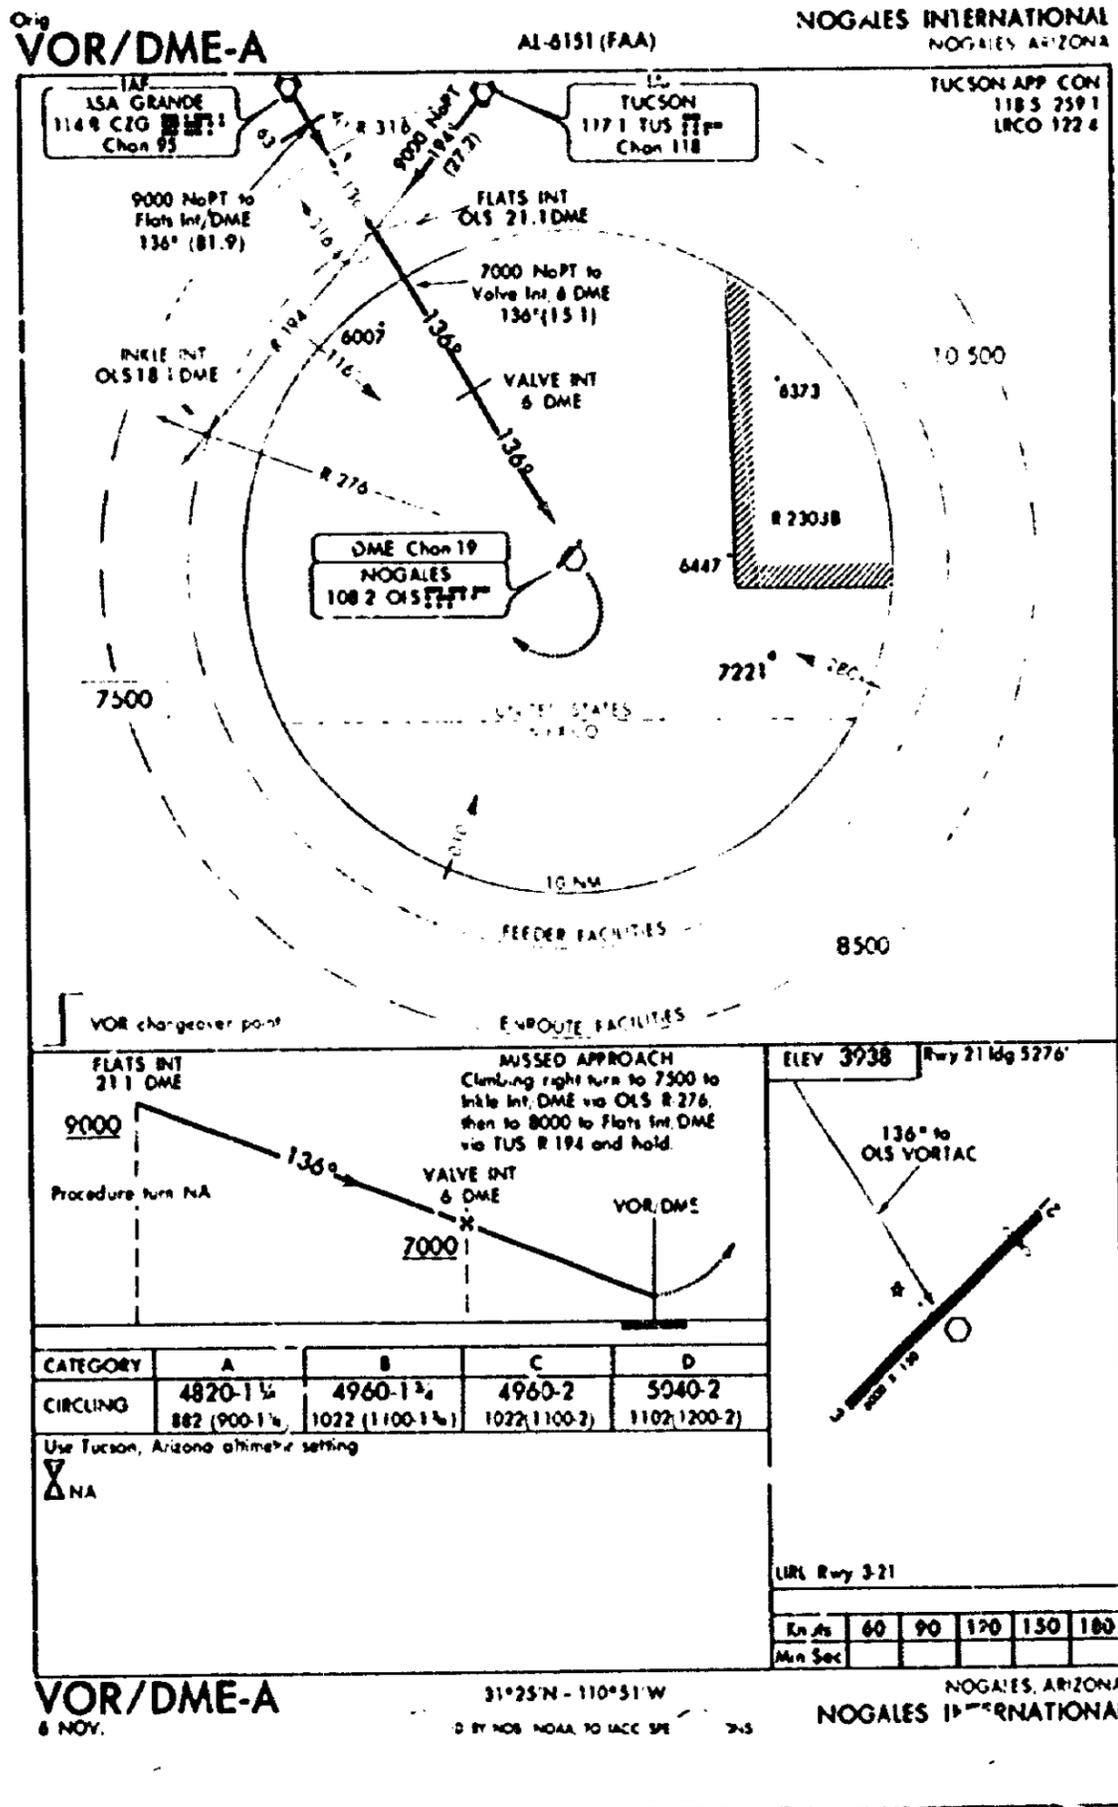
APPENDIX E

PUBLISHED BY THE FEDERAL AVIATION ADMINISTRATION

"ILLUSTRATION ONLY - NOT TO BE USED FOR NAVIGATIONAL PURPOSES"
