**Aircraft Accident Report - Atlantic City Airlines, Inc.
DeHavilland DHC-6, Twin Otter, N101AC Cape May County
Airport New Jersey, December 12, 1976**

AIRCRAFT ACCIDENT REPORT

ATLANTIC CITY AIRLINES, INC.,
DeHAVILLAND DHC-6, TWIN OTTER, N101AC

REPORT NUMBER: NTSB-AAR-77-12

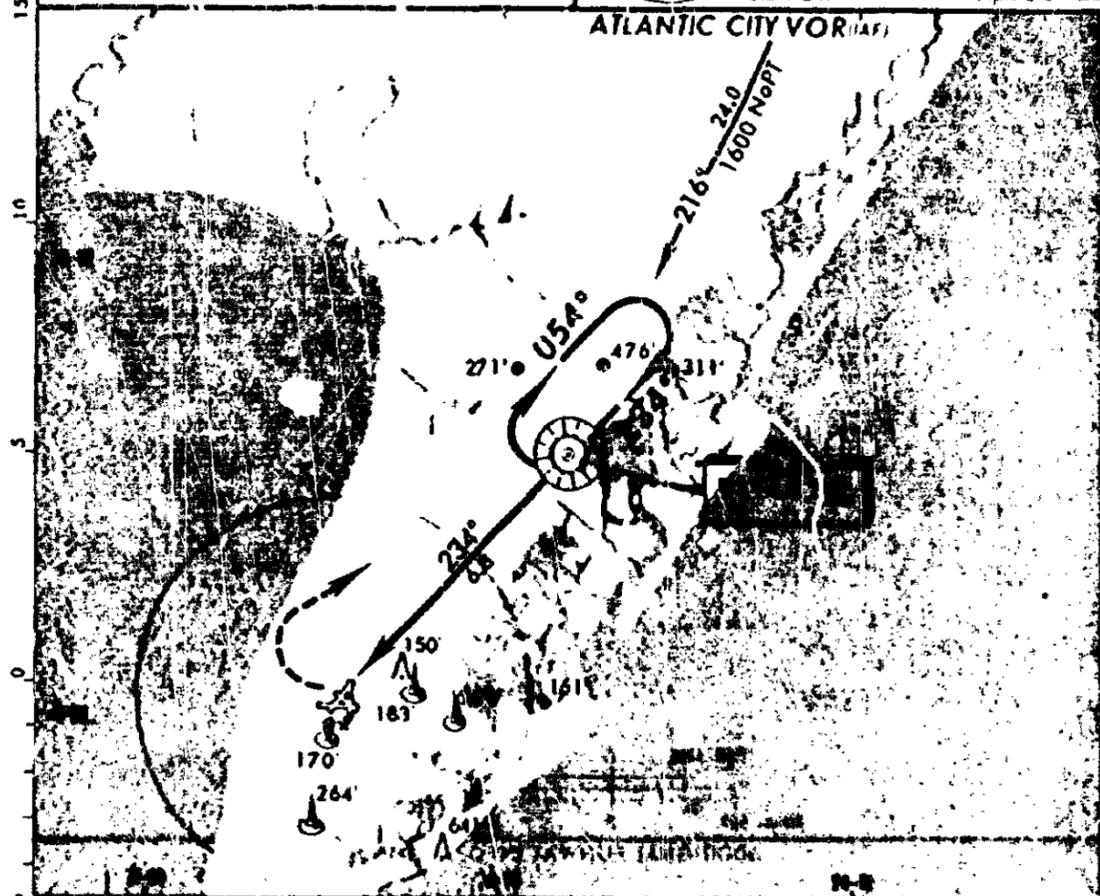
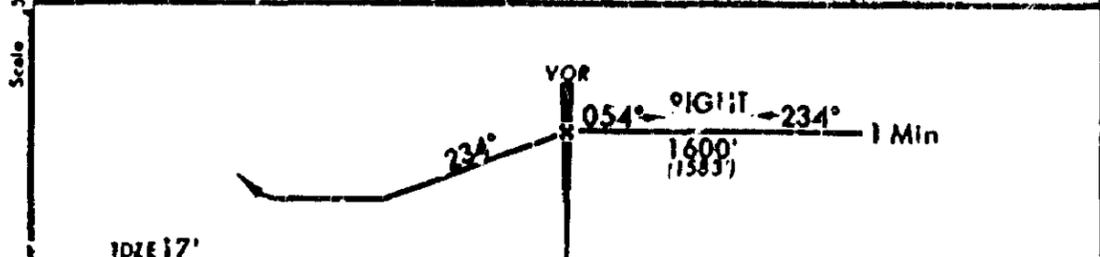
ATLANTIC CITY Approach (R)-See apt. chart for freq.
Without approved weather service, use Millville altimeter setting.

PULL UP: Climbing RIGHT turn to 1600 feet direct SIE VOR and hold NORTHEAST.

STRAIGHT-IN LANDING RWY 28		CIRCLE-TO-LAND	
NOA 440'(423) With Approved Weather Service	NOA 540'(523) With Millville Altimeter Setting	With Approved Weather Service	With Millville Altimeter Setting
A	1	A	480'(458)-1
B		B	560'(538)-1
C		C	500'(478)-1 1/2
D		D	580'(558)-2
		E	580'(558)-2

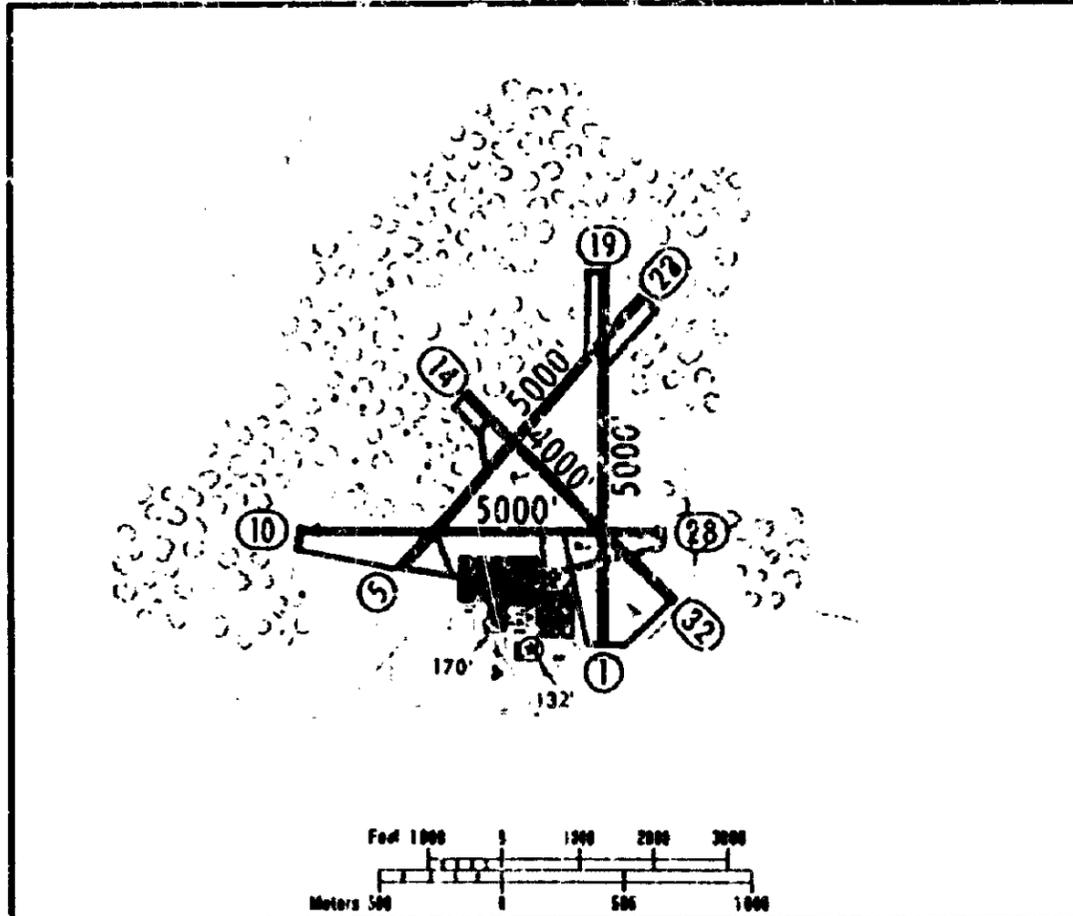
ADDITIONAL RUNWAY INFORMATION

RWY		USABLE LENGTHS			WIDTH
		LANDING BEYOND Threshold	Glide Slope	TAKE-OFF	
1 19	MIRL VASI (non-std)				150'
5 23					150'
10 28	MIRL				150'
14 32					150'
