AIRCRAFT ACCIDENT REPORT

**TEXASGULF AVIATION, INC.
LOCKHEED JETSTAR N520S
NEAR WESTCHESTER COUNTY AIRPORT
WHITE PLAINS, NEW YORK
FEBRUARY 11, 1981**

NT35-AAR-81-13

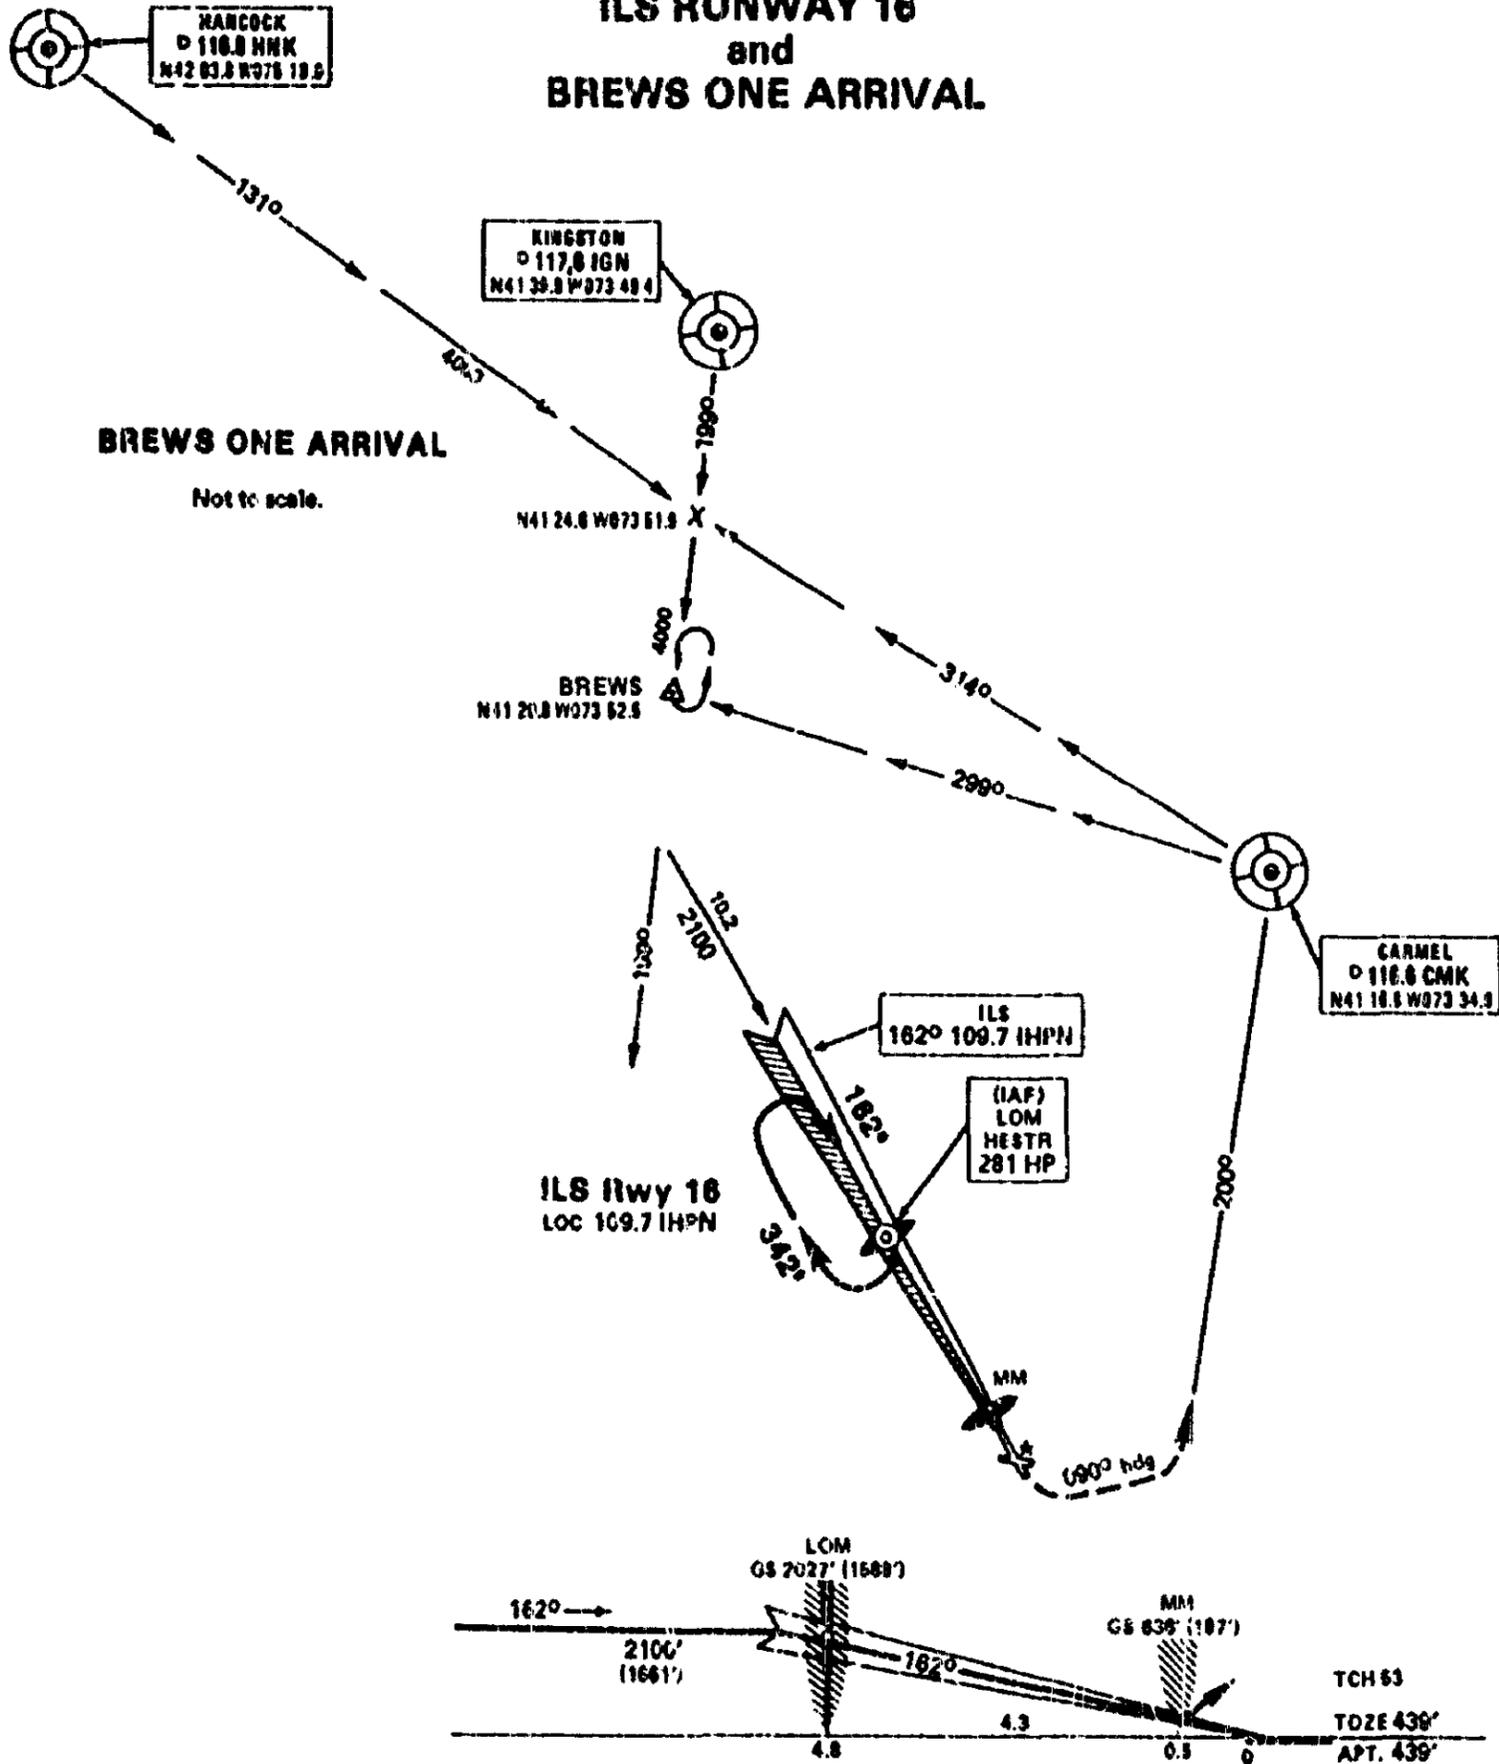
APPENDIX D

WESTCHESTER COUNTY AIRPORT
WHITE PLAINS, NEW YORK
ILS RUNWAY 16
and
BREWS ONE ARRIVAL

MISSED APPROACH: Climb to 1000' then climbing LEFT turn to 2100' via heading 090° and inbound CMK VOR R-200 to CMK VOR and hold.
