# **NATIONAL TRANSPORTATION SAFETY BOARD**

## **AIRCRAFT ACCIDENT REPORT**

**MCDONNELL DOUGLAS CORPORATION,  
DC-9-80, N1002G,  
YUMA, ARIZONA,  
JUNE 19, 1980.**

**NTSB-AAR-81-16**

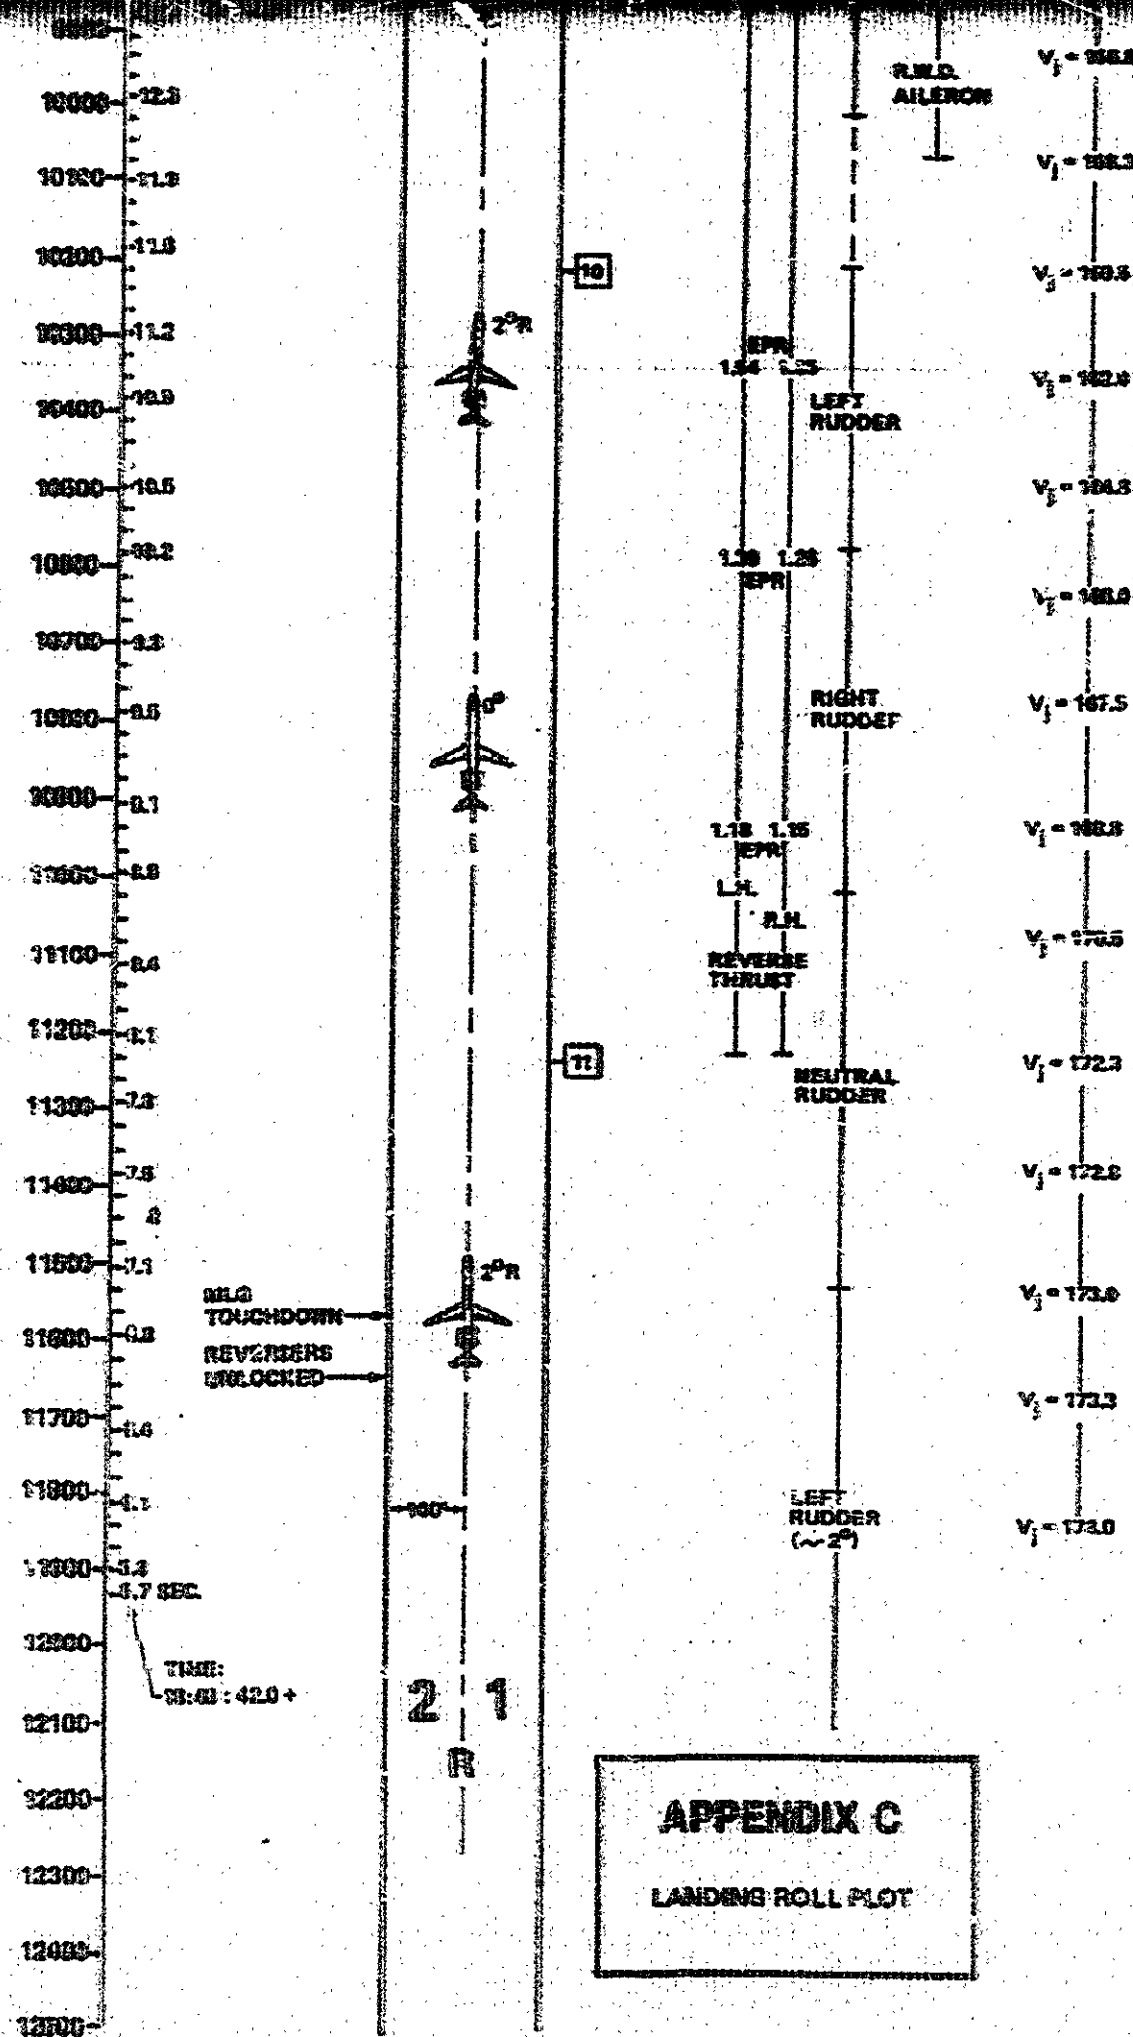
DISTANCE REMAINING (FT)

3.1 Findings . . . . .	22
3.2 Probable Cause . . . . .	23
<b>4. RECOMMENDATIONS . . . . .</b>	<b>23</b>
<b>5. APPENDICES . . . . .</b>	<b>29</b>
Appendix A--Investigation and Hearing . . . . .	29
Appendix B--Personnel Information . . . . .	30
Appendix C--Landing Roll Ground Plot . . . . .	31
