AIRCRAFT ACCIDENT REPORT

**UNIVERSAL AIRWAYS, INC.
BEECH 65-A80/EXCALIBUR CONVERSION, N100UV
NEAR MADISONVILLE, TEXAS**

JULY 2, 1981

NTSB-AAR-81-17

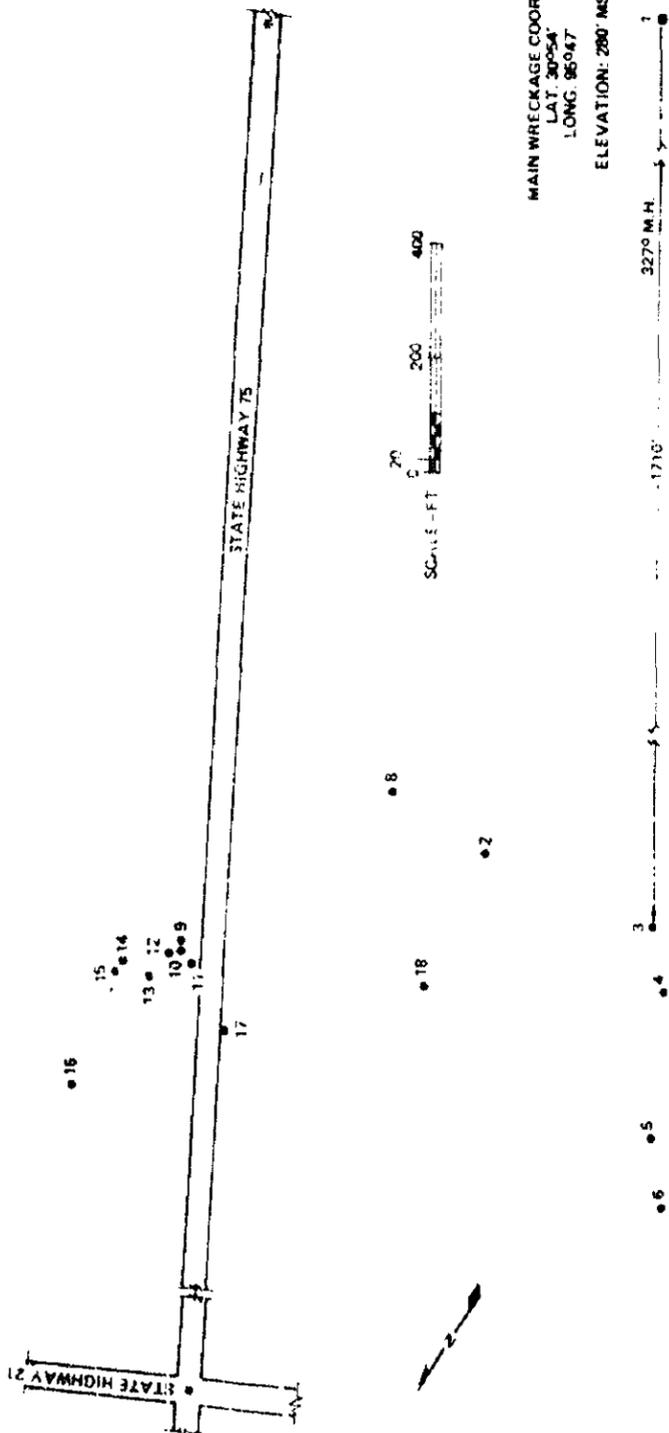
1. Distance between asterisks (*) indicates 7 nautical miles.
2. Main Wreckage located 7 nautical miles east southeast of Muldoonville, Texas, approximately 680 feet from the right edge of State Highway 75.
3. All distances between numbers are to scale except between numbers 1 and 2.

- Legend:**
1. Main Wreckage
 2. Left Wing
 3. Right Wing
 4. Piece of left Elevator
 5. Piece of vertical Stabilizer
 6. Portion of Elevator
 7. Portion of Elevator
 8. Left horizontal Stabilizer
 9. Right horizontal Stabilizer
 10. Rudder Top Tip
 11. Piece of Empennage Interior Structure
 12. Portion of outer Right Wing Leading Edge
 13. Rudder Top Tip
 14. Piece of Empennage Skin
 15. Portion of Empennage Structure/Skin
 16. Piece of Elevator Leading Edge
 17. Main Entrance Door
 18. Emergency Exit Hatch
 19. Approximately 2 1/2' Right Wing Tip
 20. Interior Carpet and Passenger
 21. Portion of Tail Cone Fiberglass

2.4 Powerplant Teardown	14
3. CONCLUSIONS	15
3.1 Findings	15
3.2 Probable Cause	16
4. SAFETY RECOMMENDATIONS	16
5. APPENDIXES	19
Appendix A—Investigation and Hearing.	19
Appendix B—Personnel Information	20
Appendix C—Aircraft Information.	21
Appendix D--Wreckage Distribution Chart	22
