NATIONAL TRANSPORTATION SAFETY BOARD

AIRCRAFT ACCIDENT REPORT

A. E. STALEY MANUFACTURING COMPANY, INC.
CANADAIR CHALLENGER CL-600, N805C
HAILEY, IDAHO
JANUARY 3, 1983

NTSB/AAR-83/05

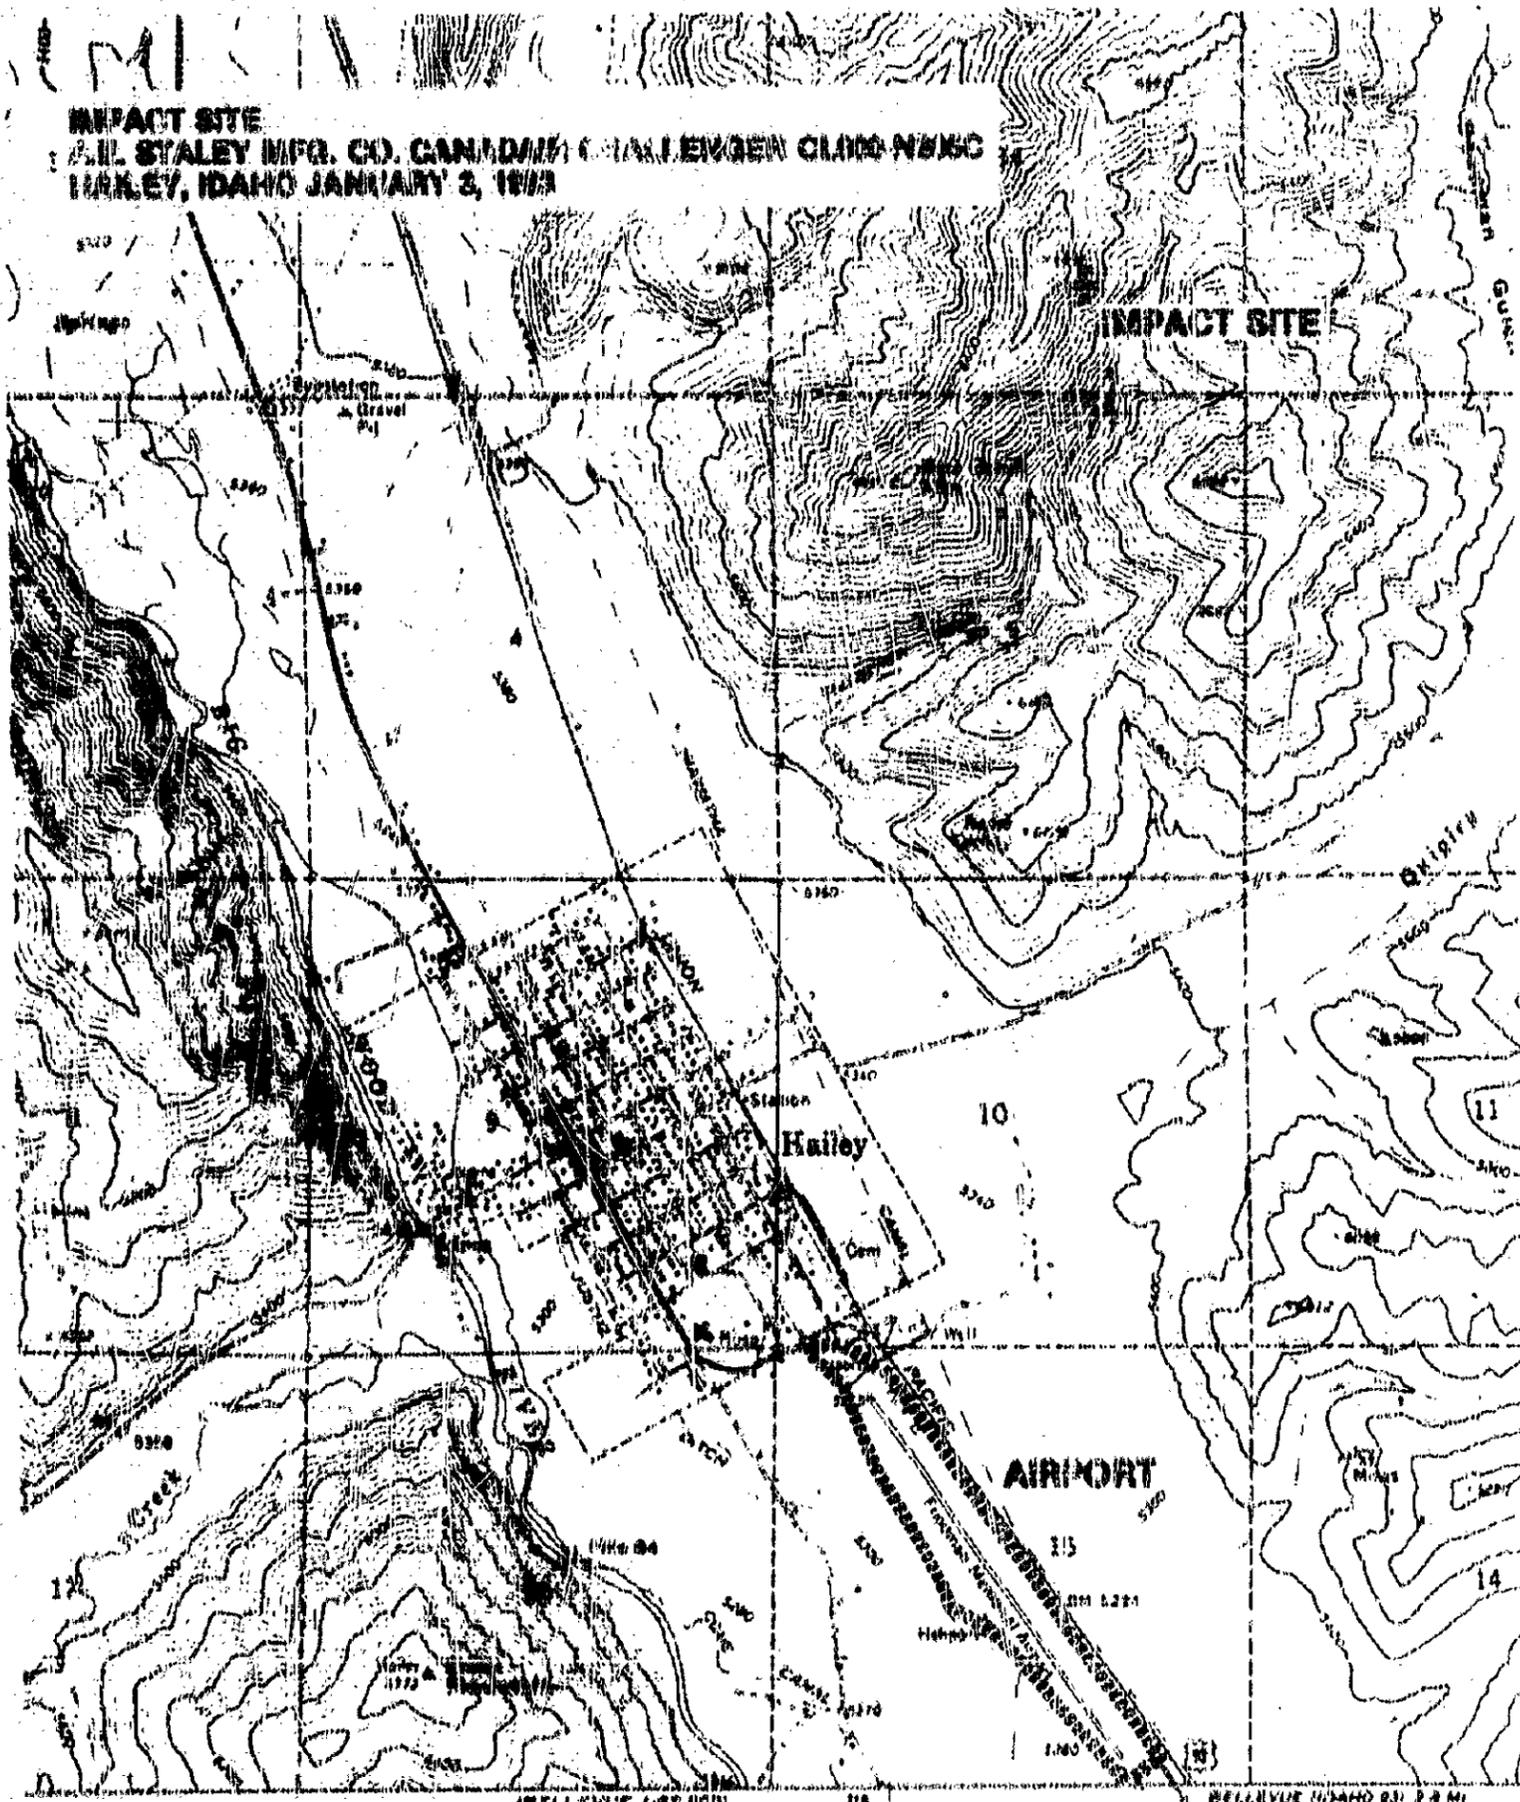
IMPACT SITE
A. H. STALEY INFO. CO. CANADIAN CHALLENGER CLIMATIC
HAILEY, IDAHO JANUARY 3, 1973

SCALE 1:24,000

About 1030, the chief pilot of the A. E. Staley Manufacturing Company, who was to board N805C at Sun Valley, arrived at the airport. Since the airplane was overdue, he instituted inquiries to several nearby airports to determine where the airplane had landed. At 1300, he asked ATC ^{12/} to make a full communications search. At 1400, after being told that the airplane had not been found, he requested an air search. While waiting for search and rescue teams to arrive, the chief pilot rented an airplane, and about 1700, found the accident site. The impact site, elevation about 8,520 feet, was about 2.2 nmi north of Sun Valley Airport at coordinates 43°32'50" N latitude, 114°17'35" W longitude.
