National Transportation Safety Board

Marine Accident Brief

Sinking of Motor Vessel *Exito*

Accident no.	DCA17FM004
Vessel name	<i>Exito</i>
Accident type	Sinking
Location	Bering Sea, 4 miles north of Cape Kalekta, Unalaska Island, Alaska ¹ 54° 05' N, 166° 20' W
Date	December 6, 2016
Time	2140 Alaska standard time (coordinated universal time – 9 hours)
Injuries	Two fatal
Property damage	Loss of vessel \$310,000 est., loss of cargo \$500,000 est.
Environmental damage	Approximately 2,000 gallons of diesel fuel, twelve 55-gallon drums of ethylene glycol (anti-freeze), and one industrial X-ray machine (hazardous material) released into the sea
Weather	Visibility 10 miles, winds north-northwest at 20 knots with gusts to 30 knots, air temperature 38°F, water temperature 41°F, seas 8–10 feet, no reported icing conditions
Waterway information	The Akutan Pass is open water between the islands of Unalaska and Akutan in the Bering Sea. The Bering Sea is north of the Aleutian Islands, which form an island chain in the North Pacific Ocean.

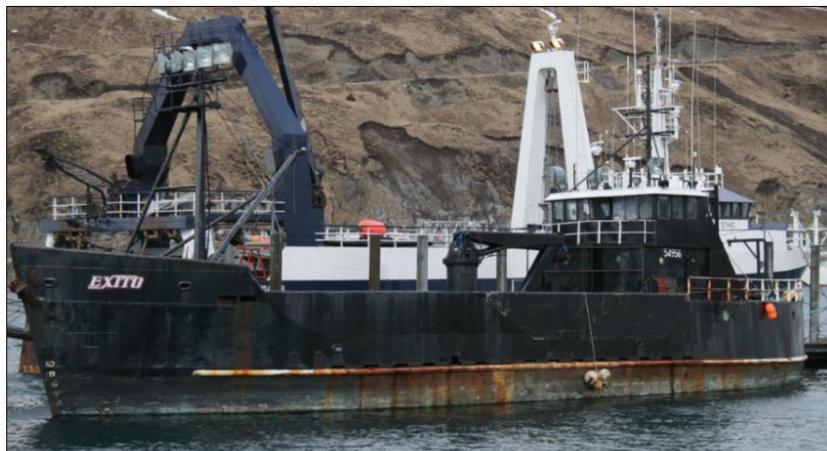
Exito in Dutch Harbor, March 2006. (Photo by Coast Guard)

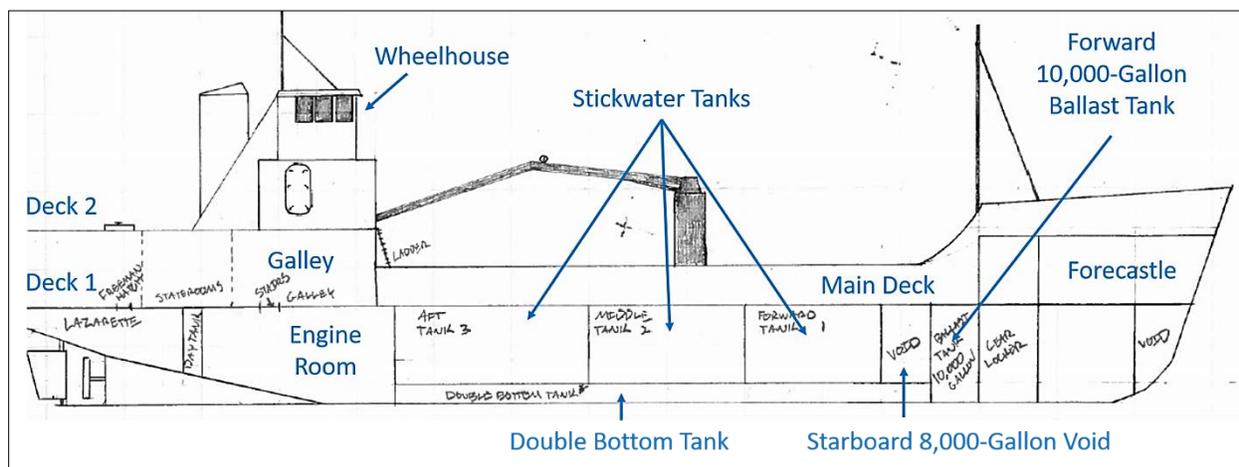
Profile of the *Exito* drawn by the captain.

The *Exito* had an open main deck that was used for placement of cargo and crab waste, three centerline tanks below the main deck for stowing stickwater, and a deckhouse aft. A wooden plank surface was installed on top of the steel main deck. The forecabin forward contained a small generator, which the crew called the “hotel generator,” that provided power for the vessel’s accommodation. Back aft, enclosed walkways on both the port and starboard side of the deckhouse were accessed through steel watertight doors from the main deck. Inside each walkway, another watertight door accessed the galley in the deckhouse. In addition to kitchen equipment, the galley

had a common area with a table and TV for the crew. A berthing area was aft of the galley. At the far aft end of the deckhouse on this deck (deck 1), a ladder led up to a weatherdeck on deck 2 via a watertight hatch.

In the center of the deckhouse was a stairwell that led down to the engine room or up to deck 2, which had accommodation spaces for the captain and the vessel's only other crewmember, a deckhand. Deck 2 had watertight doors on both the port and starboard sides that opened to the aft weatherdeck. The vessel's only liferaft was stowed on the aft port side of the deck 2 weatherdeck. The center stairwell in the deckhouse continued up from deck 2 to the wheelhouse.

In the engine room, two main propulsion diesel engines drove twin propellers, while two Caterpillar 3306 diesel generators supplied electrical power to the vessel. Since these generators consumed more fuel than the smaller hotel generator up forward, they were used only when there was a demand for power to the vessel's pumps and hydraulic systems. Three 5-inch electrically driven centrifugal pumps in the engine room were connected to a common manifold for the three centerline stickwater tanks. The engine room also had two electrically driven bilge pumps. In addition to these pumps, a portable submersible pump was used to empty the forward ballast tank. The vessel was fitted with a bilge alarm system that would give an indication in the wheelhouse of a high-water level in the engine room, lazarette, or forepeak.
