NATIONAL TRANSPORTATION SAFETY BOARD

RAILROAD ACCIDENT REPORT

**COLLISION OF AMTRAK TRAIN 66, THE NIGHT OWL
WITH ON-TRACK MAINTENANCE-OF-WAY EQUIPMENT
CHESTER, PENNSYLVANIA
JANUARY 29, 1988**

NTSB/RAR-89/01

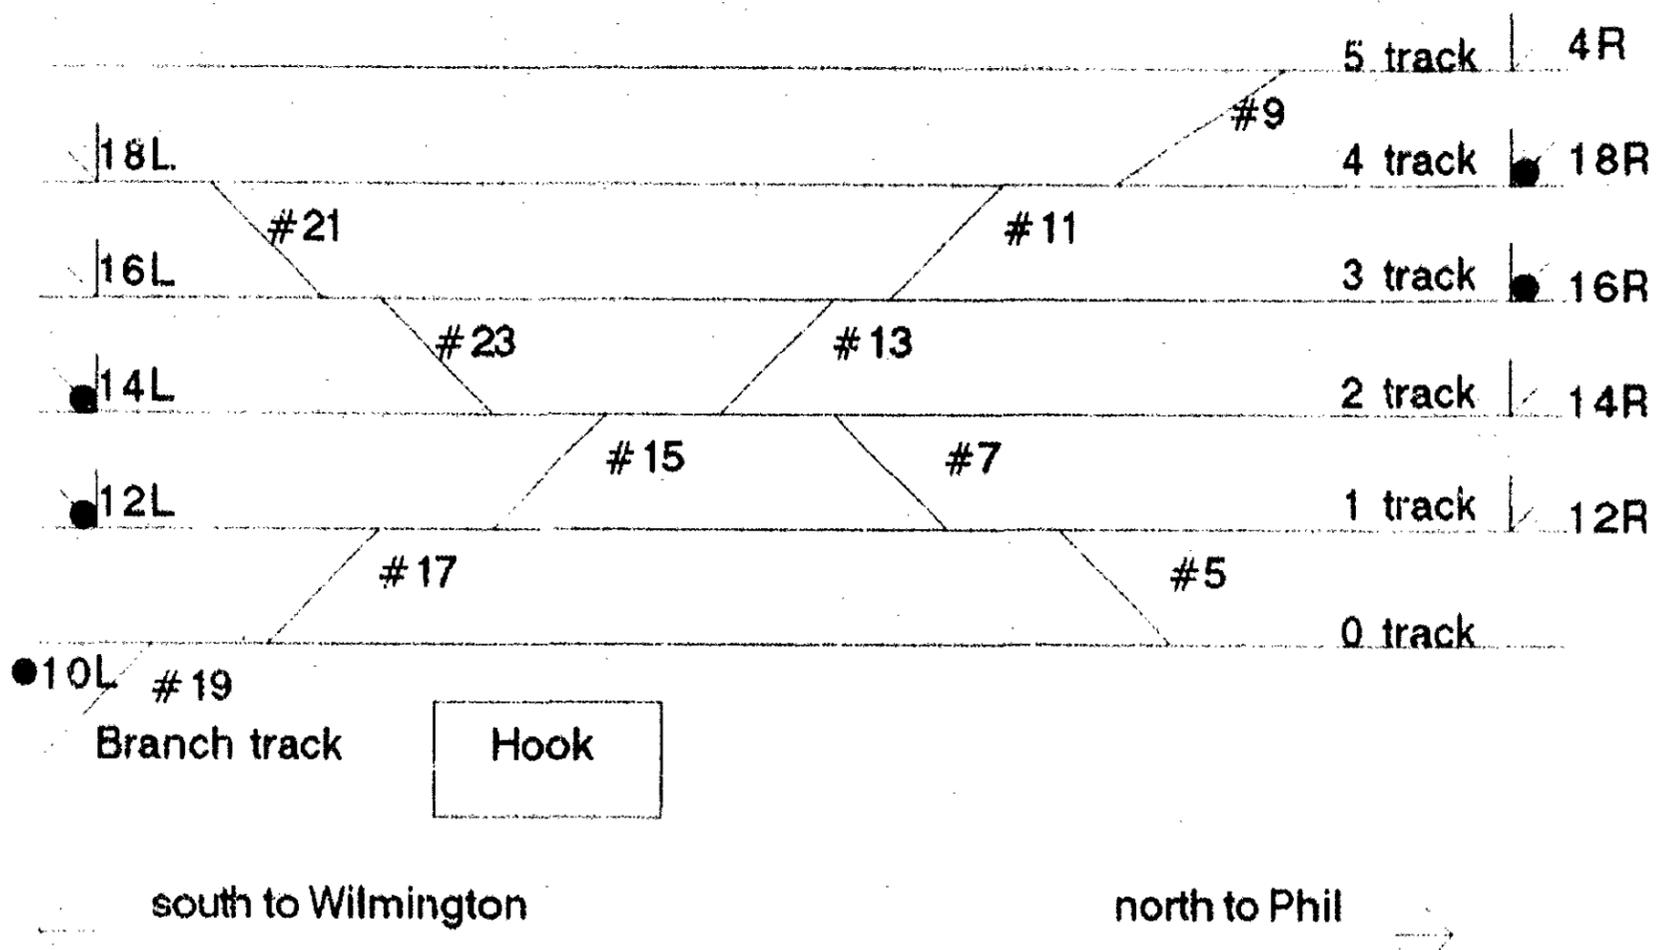
- Signal for current of traffic
- | Signal against the current of traffic

not to scale

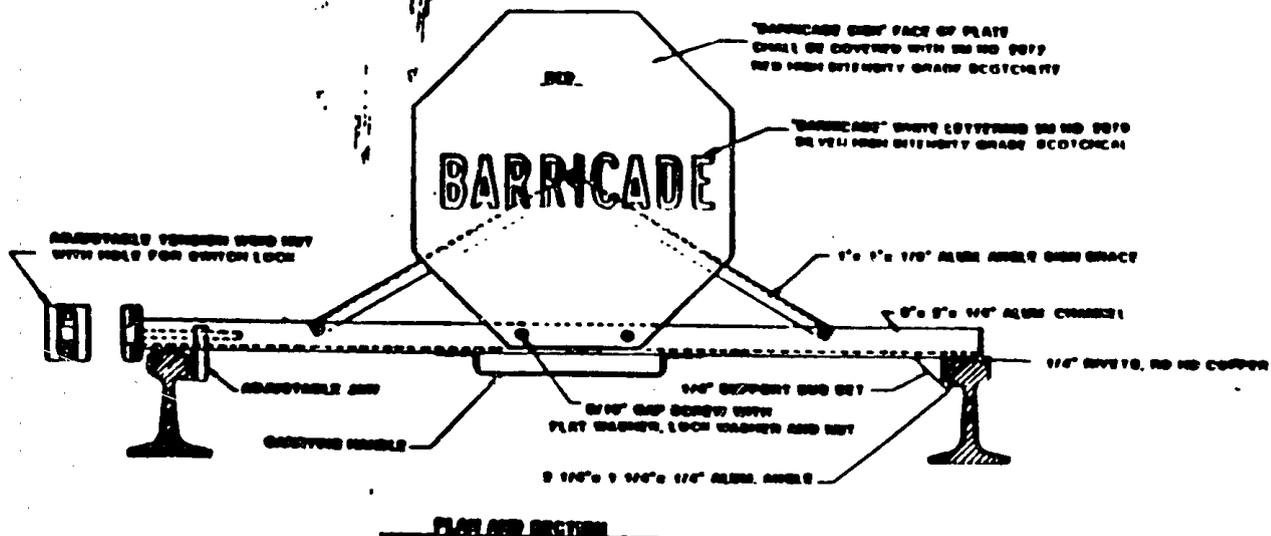
ENGINEERING PRACTICE	ORIGINAL ISSUE DATE 4/18/85 REVISED DATE -----	NUMBER 2005
	FILE NUMBER	PAGE <u>2</u>
TITLE TRACK BARRICADES	RECOMMENDED DATE	OF <u>2</u>
	APPROVED DATE

TYPICAL INSTALLATION
