# National Transportation Safety Board

## Safety Recommendation

**In reply refer to:** A-10-98 and -100 (Urgent)  
and A-10-99 and -101

The National Transportation Safety Board (NTSB) has identified a critical safety issue with General Electric Company (GE) CF6-45/-50 series turbofan engine low pressure turbine (LPT) stage 3 (S3) disks that requires immediate action.<sup>1</sup> The investigations of several recent uncontained<sup>2</sup> LPT S3 disk failures have determined that the CF6-45/-50 engine LPT S3 disk, a critical, life-limited rotating engine part, can fail unexpectedly when excited by high pressure (HP) rotor unbalance vibration resulting from localized high pressure turbine (HPT) blade material loss. (See figure.) A turbine disk failure can release high-energy engine debris capable of damaging an airplane and endangering its passengers. This failure mode was identified in the 1970s, but an uncontained failure did not occur until 2008. GE established inspection procedures to mitigate this failure mode on August 28, 2009, via GE Service Bulletin (SB) 1307. However, an uncontained LPT S3 disk failure occurred following an inspection using the new procedures, which has

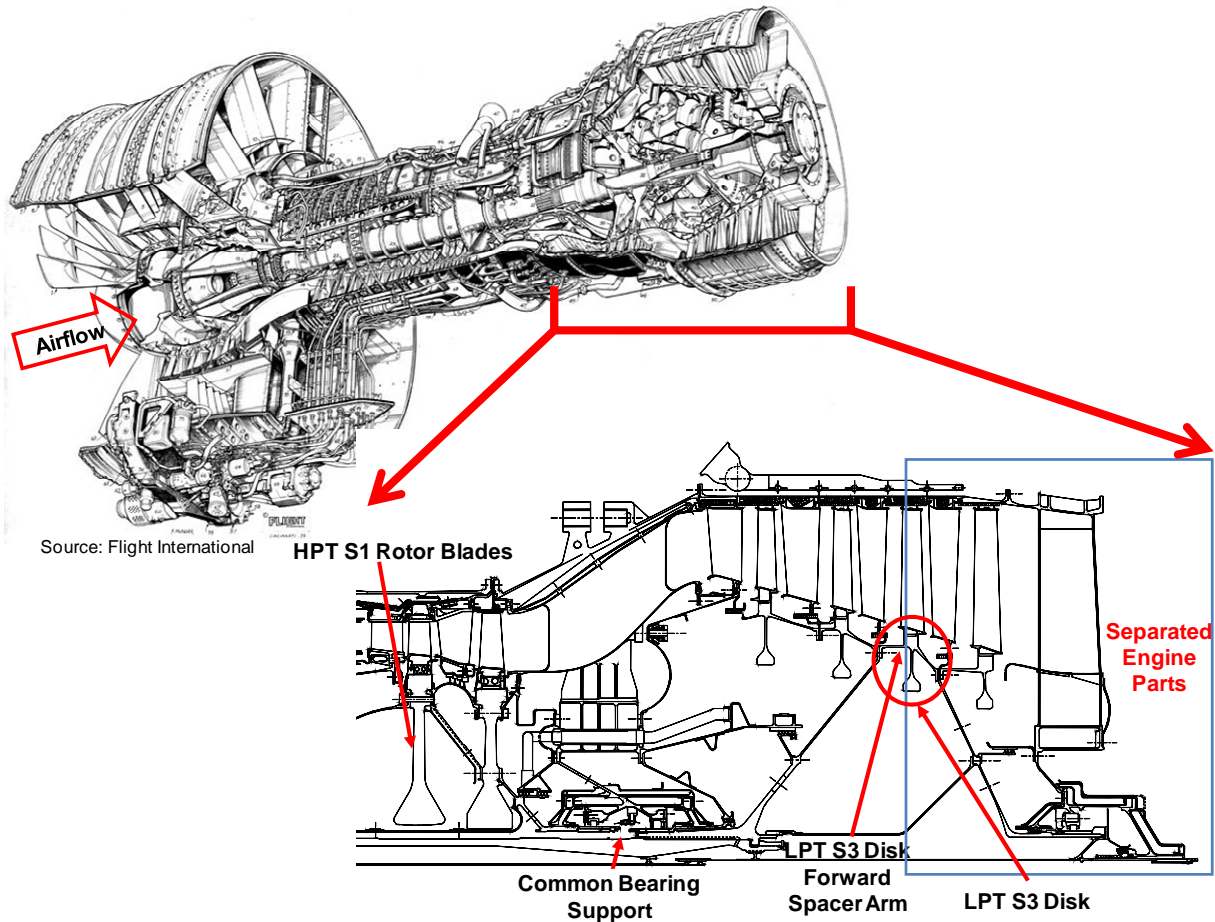
**Figure.** Diagram of CF6-50 engine.

The forward and aft portions of the LPT S3 disk were examined. The disk had separated at the fillet radius between the forward spacer arm and the rim forward face. Metallurgical examination of undamaged areas of the disk fracture surfaces found fatigue cracks initiating around the inner diameter of the spacer arm from sites spaced about 0.1 inch to 0.2 inch apart.
