# National Transportation Safety Board

## Safety Recommendation

**In reply refer to:** A-13-025 through -027

### Benefits of weather cameras in Hawaii

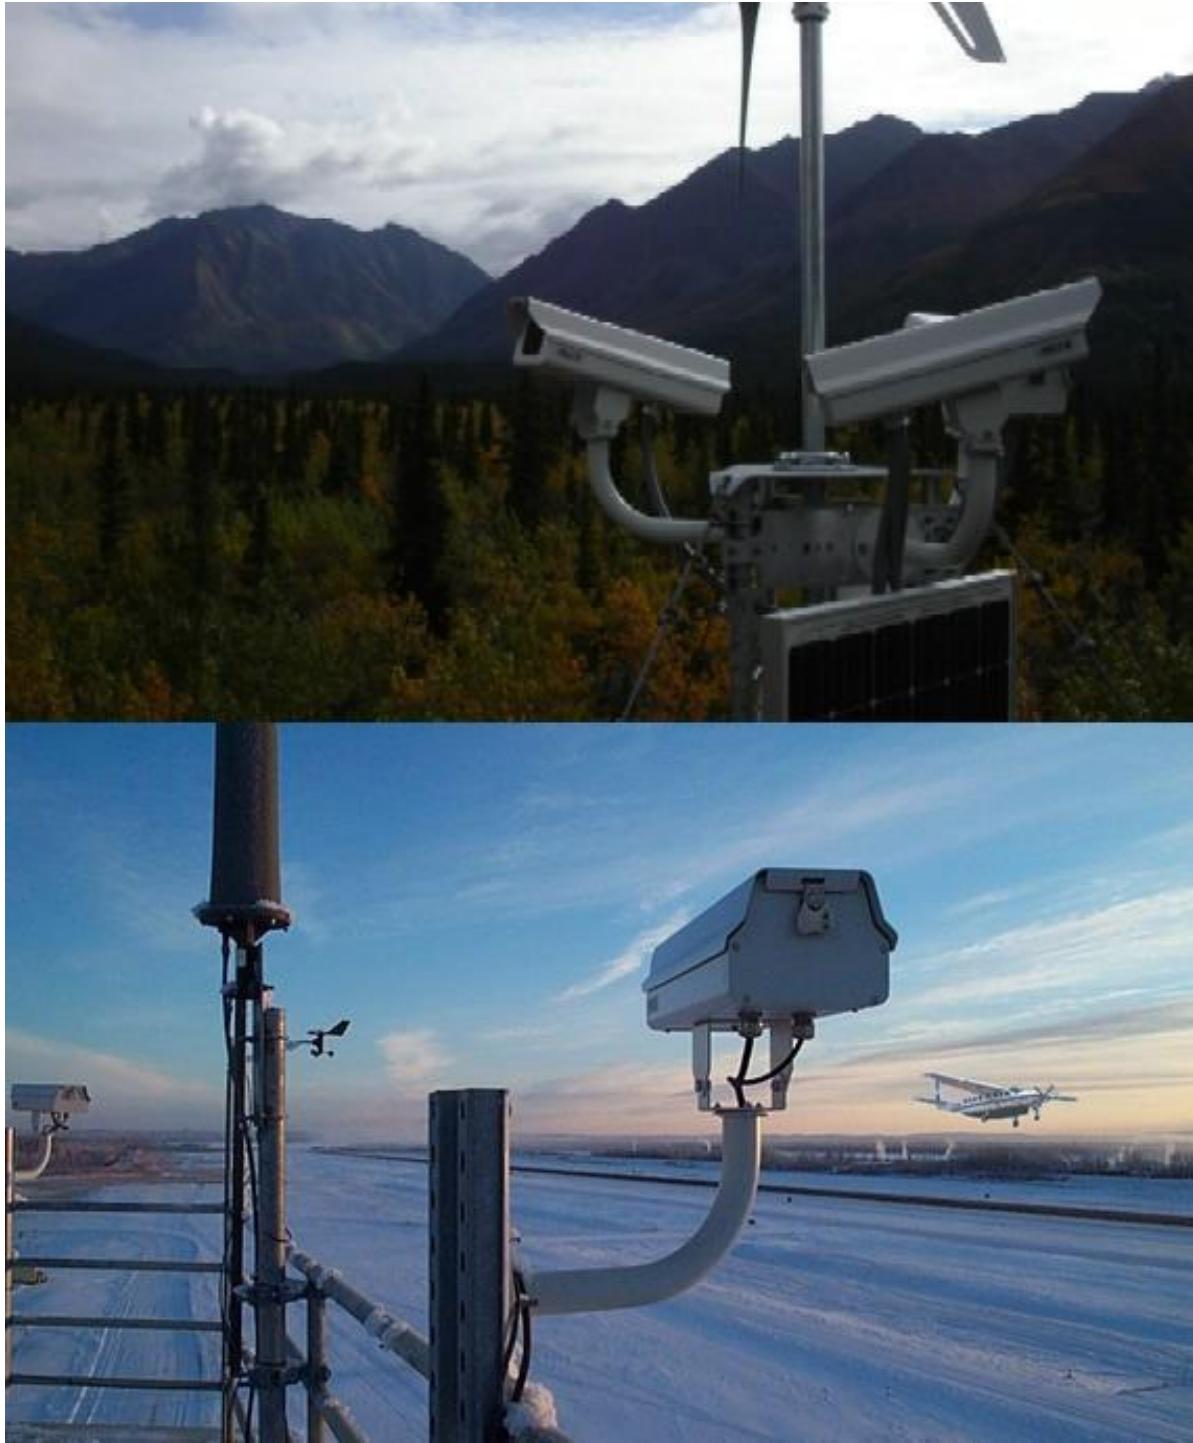
**Figure 1.** Photographs of aviation weather camera installations in Alaska.

The dangers of operating in and near adverse weather amidst challenging terrain have also been well documented in Alaska. In 1995, the NTSB conducted a safety study of Alaska's aviation environment to identify risk factors and safety deficiencies and recommend practical measures for managing the risks to flight operations.<sup>4</sup> Of the 23 recommendations issued as a result of this safety study, Safety Recommendations A-95-128 and -140, which were addressed to the FAA and the NWS, respectively, sought to determine the technical feasibility and safety benefit of remote color video weather observing systems in Alaska.<sup>5</sup> In 1999, the FAA began the Alaskan Aviation Camera Program after determining that "pilots [in Alaska] operating under [VFR] would benefit from actual views of current weather conditions."<sup>6</sup> Further, on July 31, 2008, the NTSB issued Safety Recommendation A-08-59, which asked the FAA to "install and maintain weather cameras at critical areas of air tour routes within the Misty Fjords National Monument and other scenic areas in Southeast Alaska that are frequently traveled by air tour operators."<sup>7</sup> As of September 2012, aviation weather cameras have been installed in 185 locations in Alaska under the program, with a total of 221 locations scheduled to be completed by 2014.<sup>8</sup> Each aviation weather camera site may contain up to four individual cameras positioned to provide a near-complete view of an area (see figure 1). Camera images, both live (which are

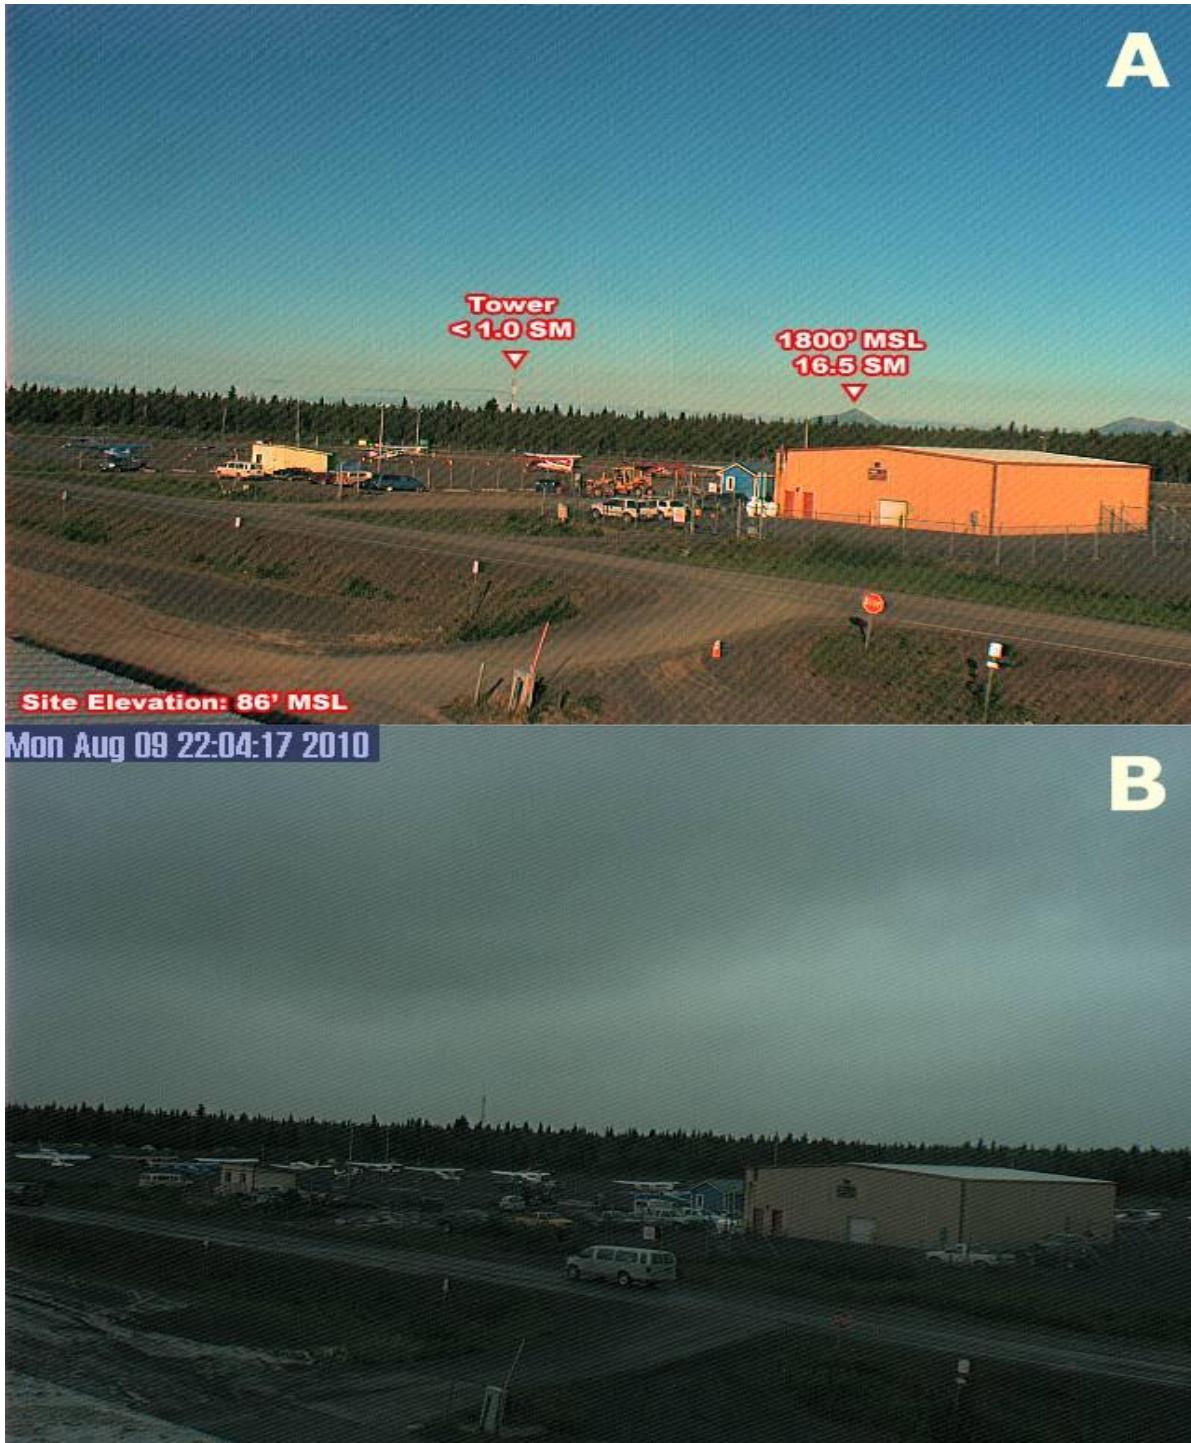
**Figure 2.** “Clear day” (A) and live (B) imagery from the Dillingham, Alaska, southwest-facing camera.

updated every 10 minutes) and “clear day,”<sup>9</sup> are available on the FAA’s website at <http://akweathercams.faa.gov> (see figure 2).
