# National Transportation Safety Board

## Safety Recommendation

**Date:** June 9, 2008

**In reply refer to:** A-08-25 through -29

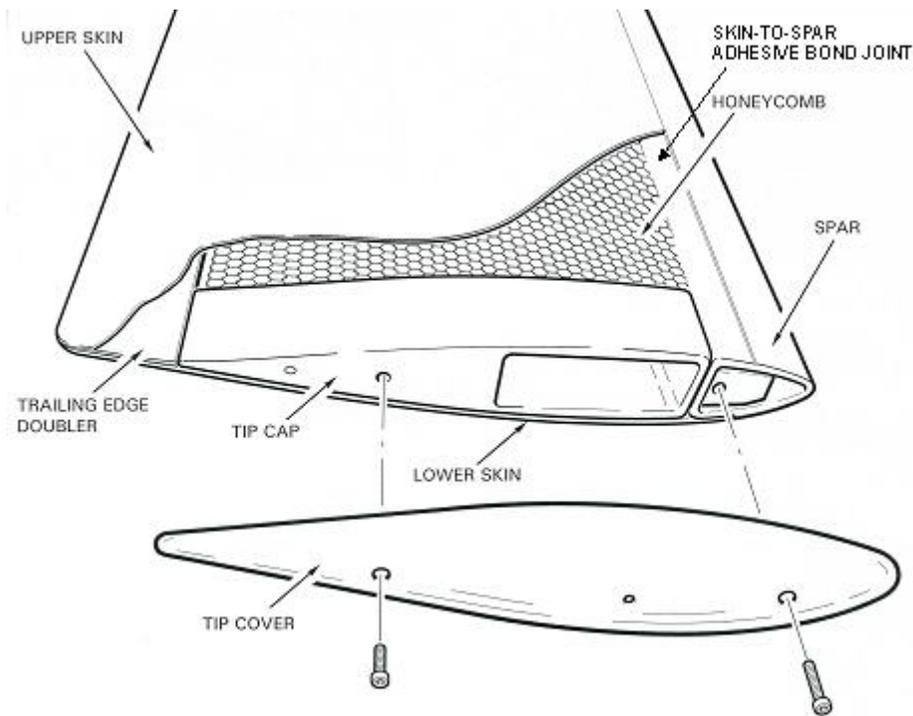
The rotor blades on both the R22 and the R44 are made of stainless steel skin with an aluminum honeycomb core and stainless steel spar.<sup>3</sup> The blades on the R22 are designated as P/N A016-4, and the blades on the R44 are designated as C016-2 or C016-5.

**Figure.** Cross-section of an RHC main rotor blade at the tip portion.
