National Transportation Safety Board

Safety Recommendation

In reply refer to: A-08-59 through -62

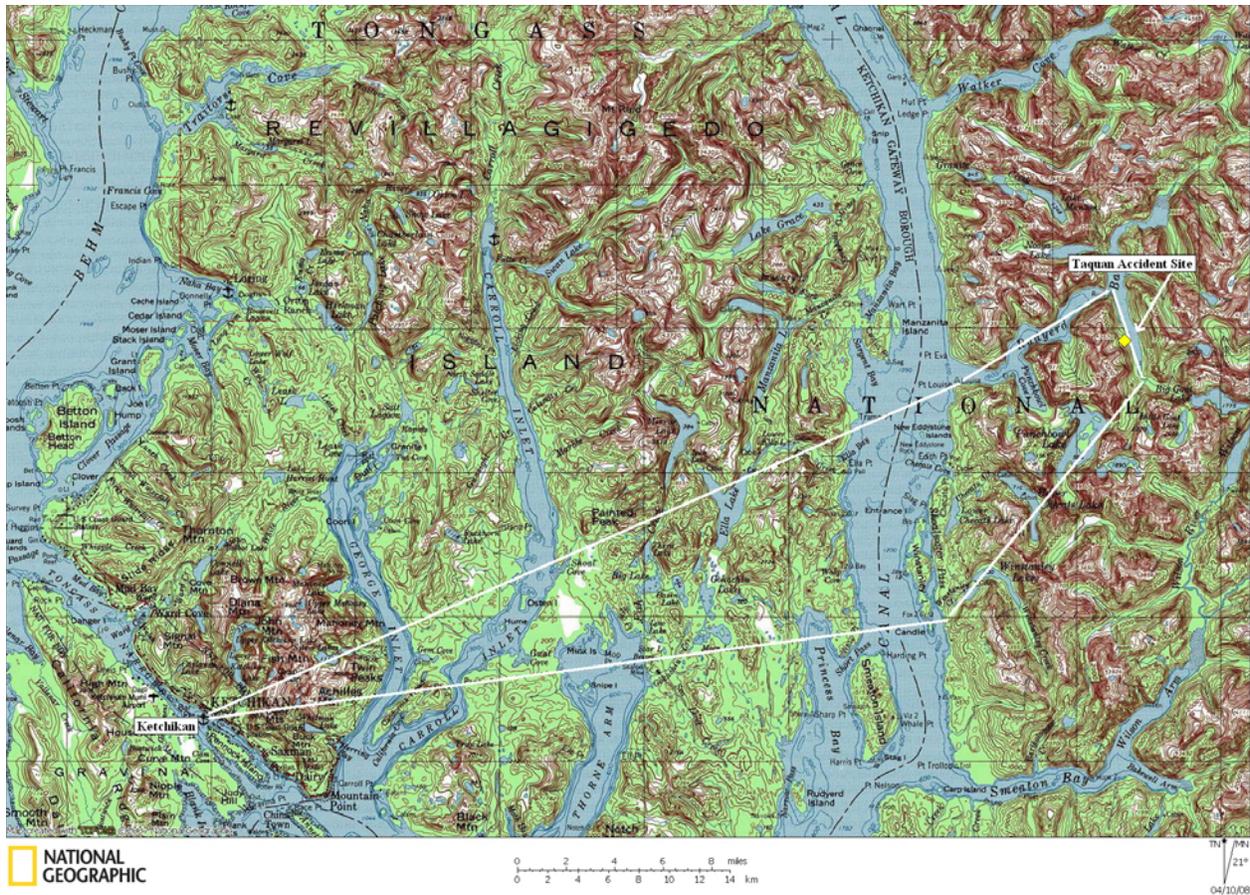
Figure. Accident location and general air tour routes.

⁶ The common flight route for operators conducting a Misty Fjords air tour flight is northeast from Ketchikan, over sea-level channels and inland ocean fjords. The flights cross over the East Behm Canal and climb into mountainous, tree-covered valleys. In most cases, the tours include a landing in Rudyerd Bay before returning to Ketchikan.
