Special Investigation Report - New York
City Transit Authority Subway System Fires

NEW YORK CITY TRANSIT AUTHORITY SUBWAY SYSTEM FIRES

NTSB/SIR-85/04

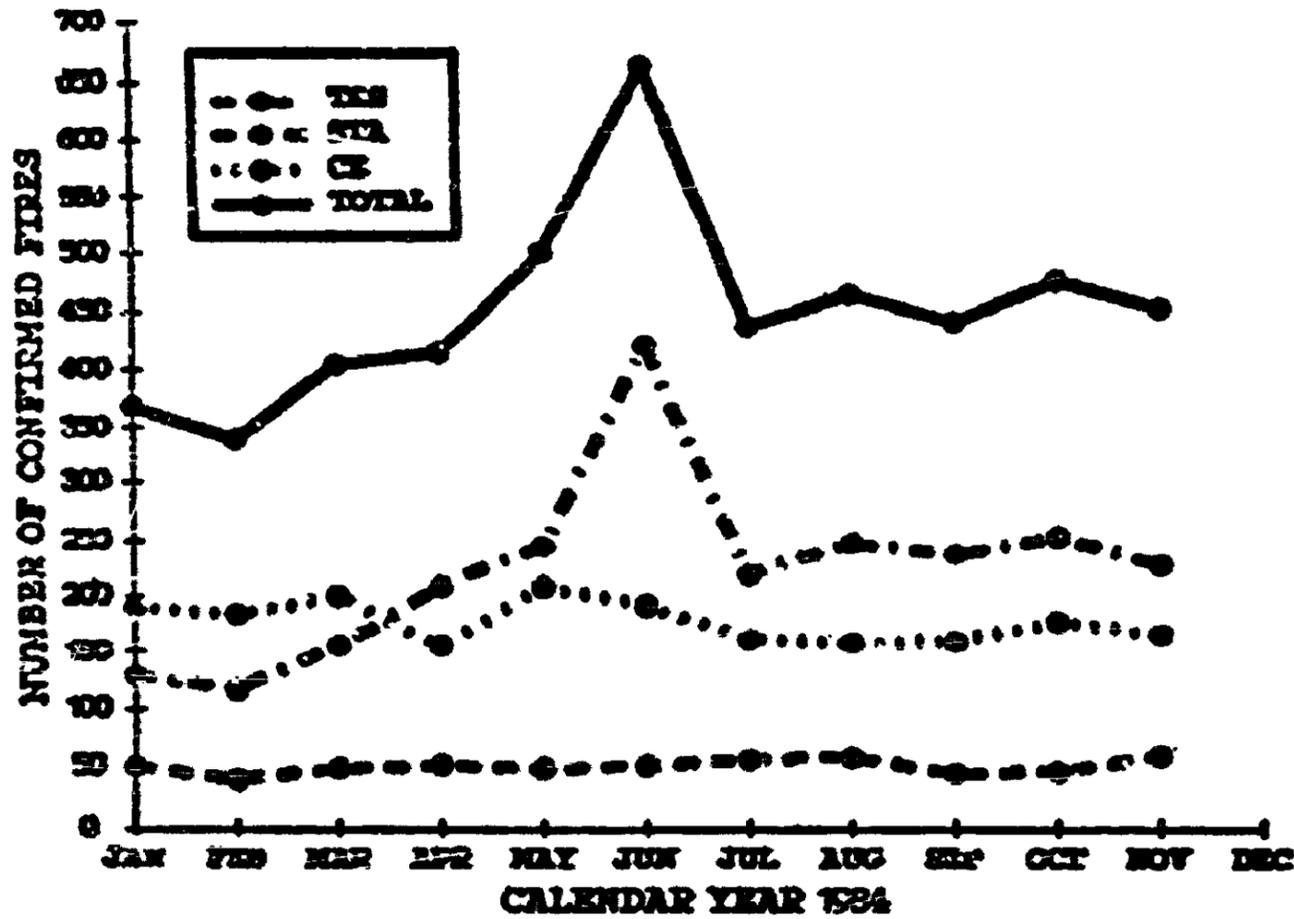
Table 1.—Confirmed track and structures fires on the NYCTA system, January through November 1984.

NEW YORK CITY TRANSIT AUTHORITY CONFIRMED FIRES

CONFIRMED FIRES			
MONTH	T&S	STA.	CE
JAN	128	50	190
FEB	116	39	184
MARCH	155	47	199
APRIL	207	51	158
MAY	244	48	208
JUNE	419	53	192
JULY	218	56	163
AUG	247	58	159
SEPT	236	45	160
OCT	253	46	177
NOV	226	55	167
TOTALS	2,449	552	1,957

T&S = Track and Structures Fires
 STA = Station Fires
 CE = Car Equipment Fires
