# NATIONAL TRANSPORTATION SAFETY BOARD

## SAFETY STUDY

COMMERCIAL EMERGENCY MEDICAL SERVICE  
HELICOPTER OPERATIONS

NTSB/SS-88/01

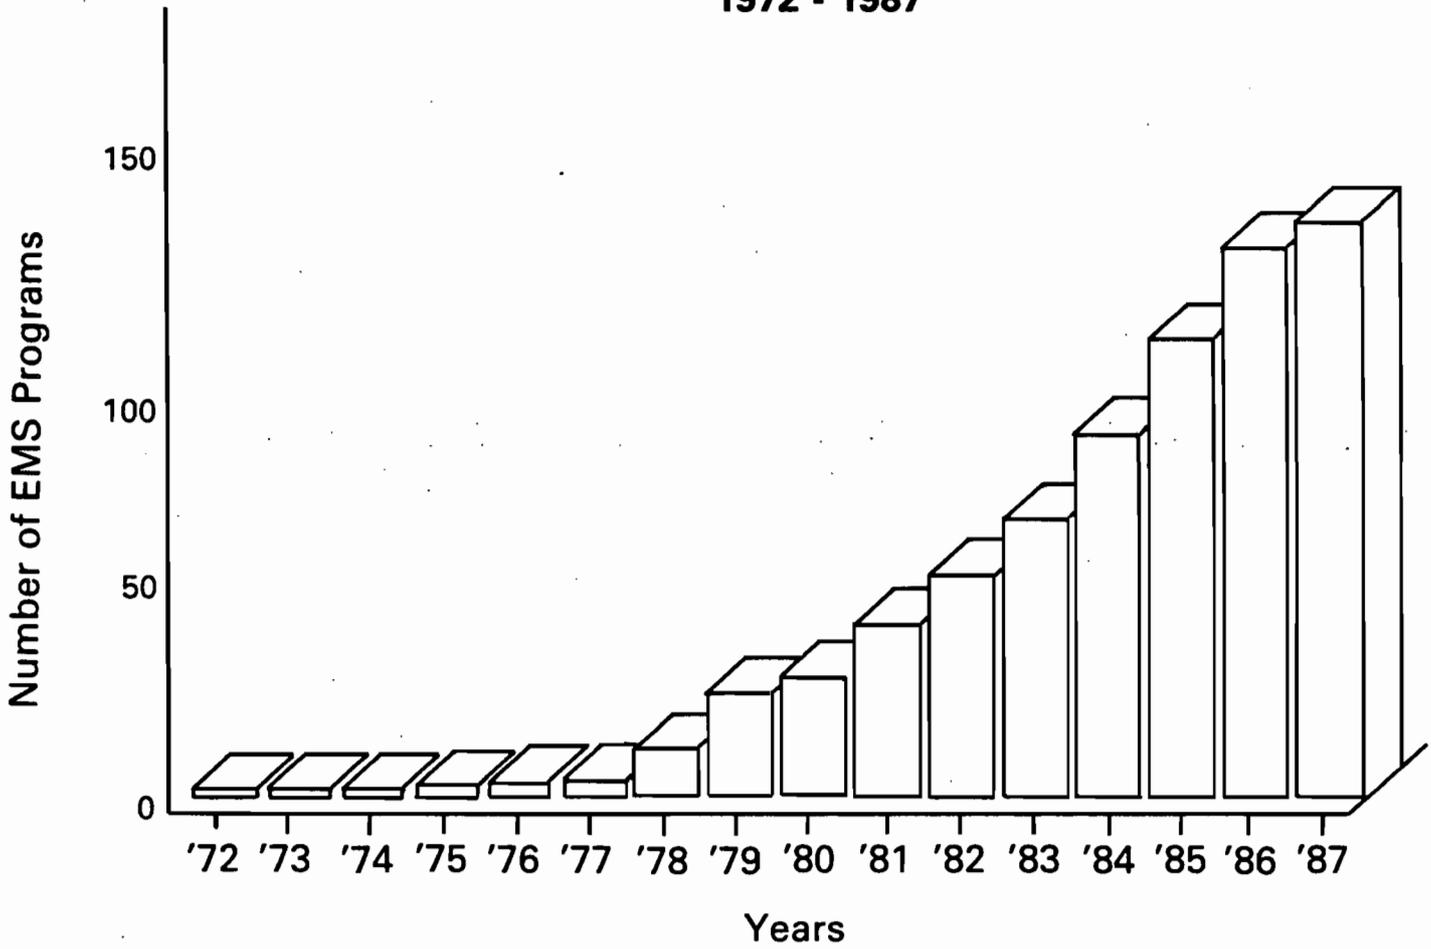
Figure 1.—Growth in U.S. helicopter EMS programs.

### GROWTH IN U.S. HELICOPTER EMS PROGRAMS 1972 - 1987

The commercial EMS helicopter industry has grown rapidly since 1978. (See figure 1.) In 1981, there were 42 commercial EMS helicopter programs in operation throughout the country. By December 1986, the total number of commercial EMS programs had more than tripled. An estimated 26 new programs started in 1987 and the total number could double within the next 5 years. 12/ Currently, there are approximately 155 commercial EMS helicopter programs, using approximately 187 helicopters. Almost 10 of these hospital EMS programs own and operate their own helicopters, while the balance of the helicopters and pilots are provided under contract to the hospital by 32 commercial operators.

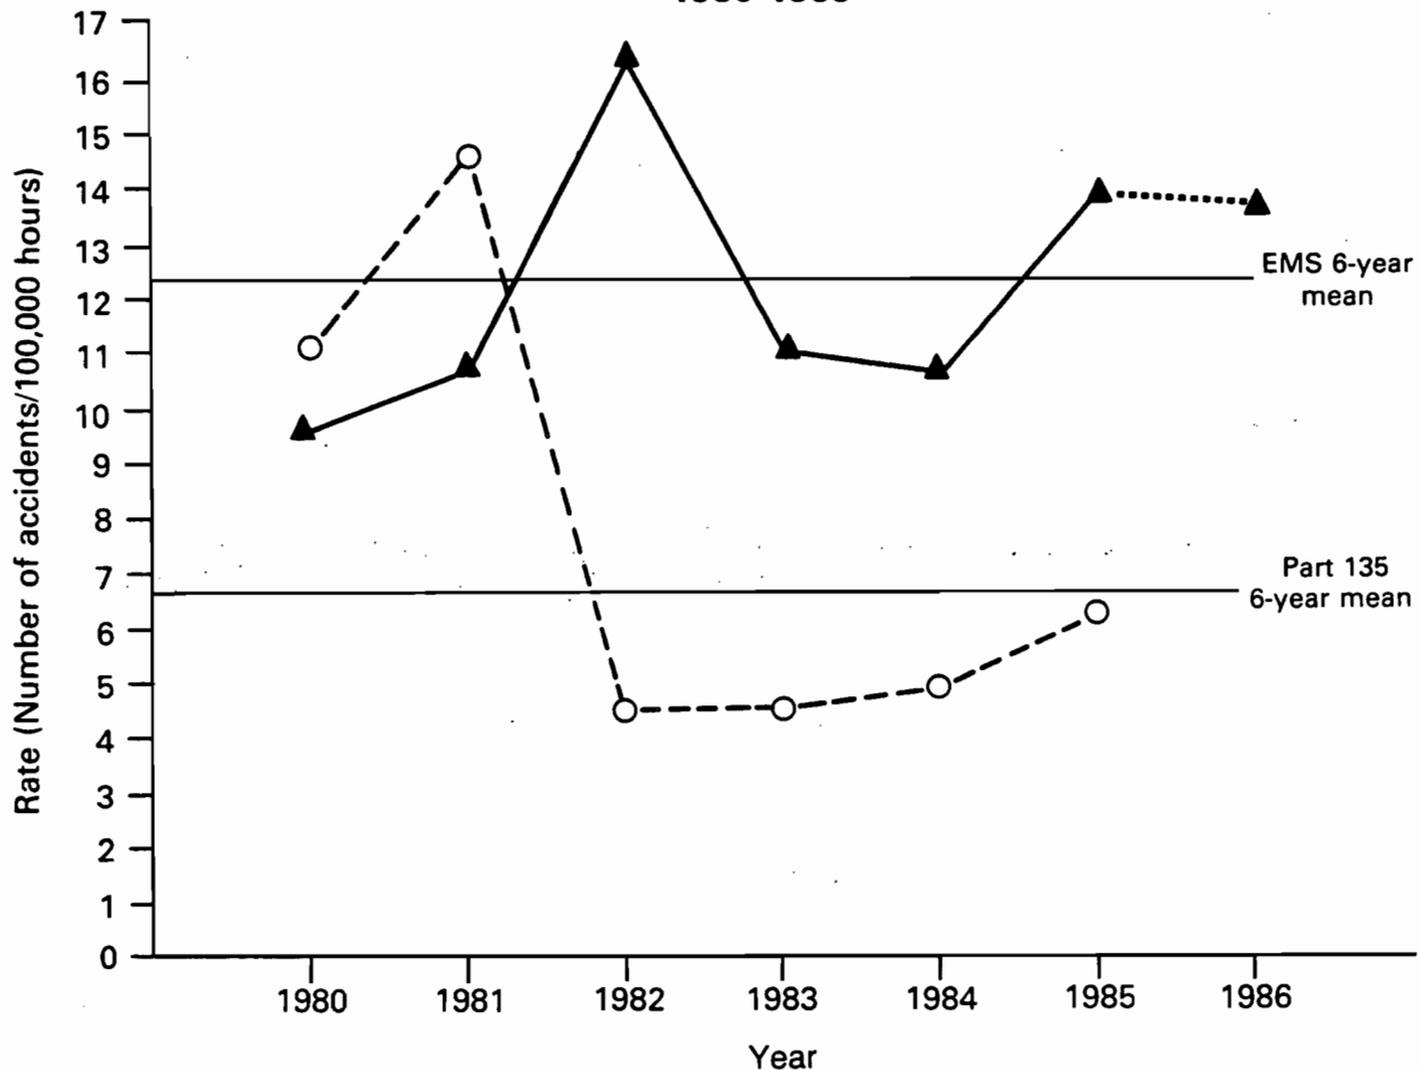
### Accident Rate\* Commercial EMS Helicopters and 14 CFR Part 135 Non-Scheduled Helicopter Air Taxis 1980-1985

- ▲ EMS Helicopters —————
- Part 135 non-scheduled helicopter air taxis - - - - -
- \* EMS helicopter data based on accidents which involved patient transportation
- ..... The 1986 data for EMS is provided for the readers information only. These data were not used in comparison to the part 135 data or in the calculation of the 6-year EMS accident rate mean.

2/ Information on the 1986 commercial EMS helicopter accident rate is provided in figures 1 through 6. This information is not included in the accident rate comparison to the Part 135 nonscheduled air taxi helicopters and all turbine powered helicopters since information on hours flown for 1986 was not available for the comparative populations on which to base the accident rate. In 1986, commercial EMS helicopters were involved in 13 while on patient transport missions. Four of these accidents were fatal and five produced injuries. The commercial EMS helicopter fleet flew approximately 95,000 hours in 1986 resulting in a total accident rate of 13.68; a fatal accident rate of 4.21; and an injury accident rate of 5.26.

Table 1 provides a comparison of accident statistics for EMS helicopters, Part 135 nonscheduled helicopter air taxis, and all turbine powered helicopters for 1980 to 1985. <sup>7/</sup> Figures 1 through 6 display the accident rates for commercial EMS helicopters for Part 135 nonscheduled helicopter air taxis and for all turbine powered helicopters.

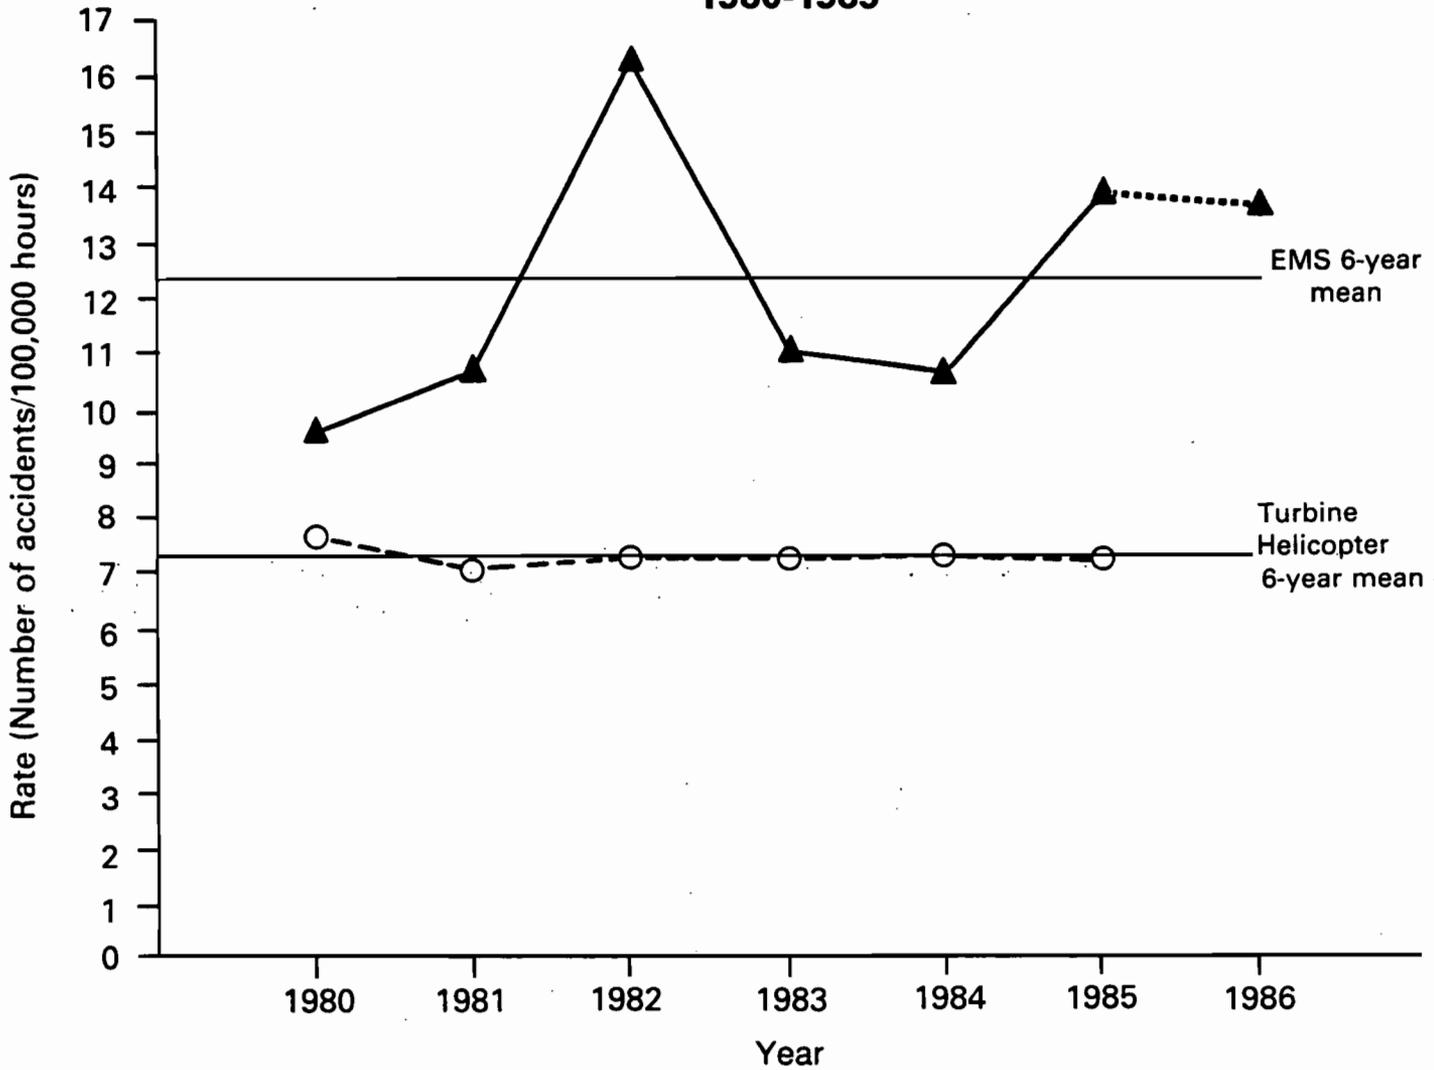
### Accident Rate\* Commercial EMS Helicopters and Turbine Engine Helicopters 1980-1985

- ▲ EMS Helicopters —————
- Turbine Engine Helicopters - - - - -

\* EMS helicopter data based on accidents which involved patient transport

..... The 1986 data for EMS is provided for the readers information only. These data were not used in comparison to the part 135 data or in the calculation of the 6-year EMS accident rate mean.

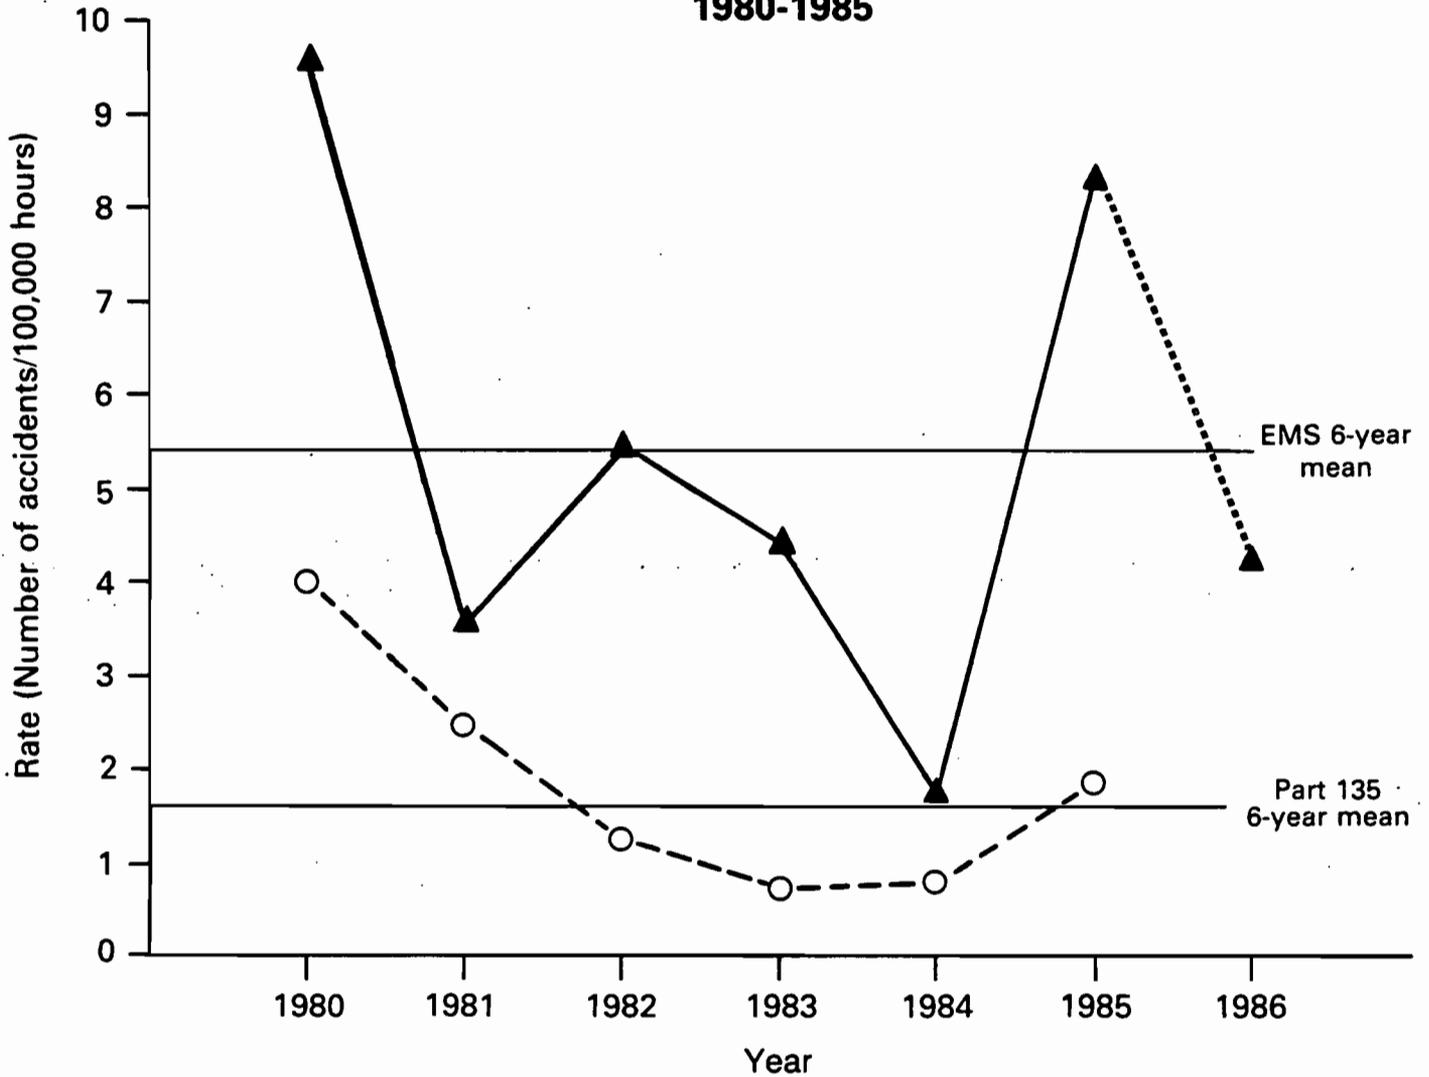
### Fatal Accident Rate\* Commercial EMS Helicopters and 14 CFR Part 135 Non-Scheduled Helicopter Air Taxi 1980-1985

▲ EMS Helicopters —————

○ Part 135 non-scheduled helicopter air taxi - - - - -

.... The 1986 data for EMS is provided for the readers information only. These data were not used in comparison to the part 135 data or in the calculation of the 6-year EMS accident rate mean.

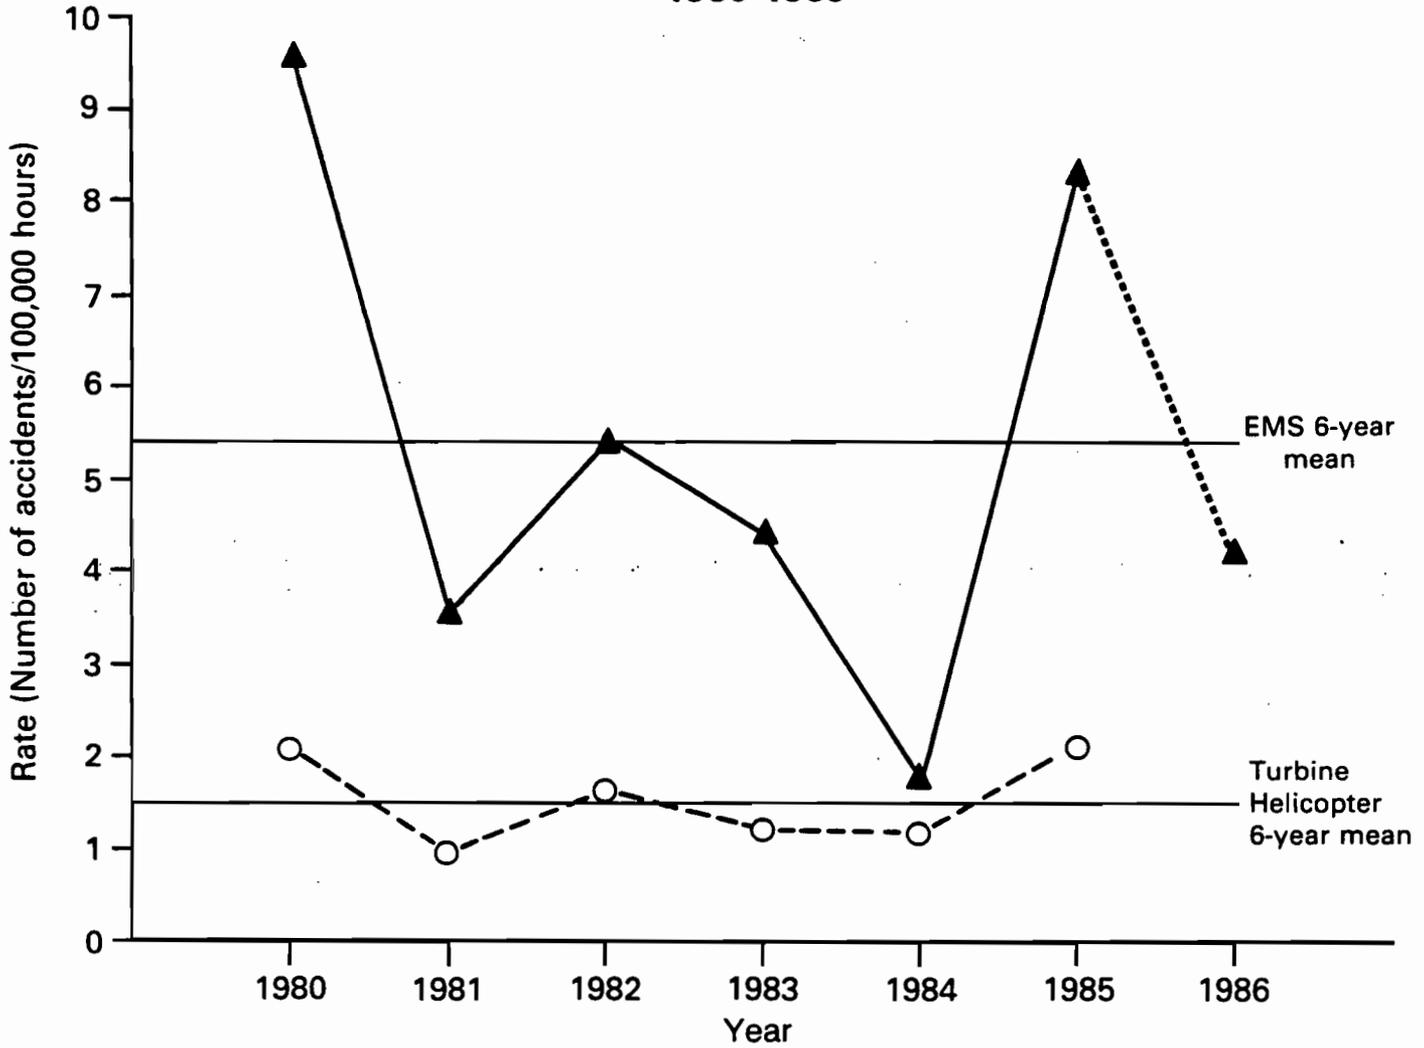
### Fatal Accident Rate\* Commercial EMS Helicopters and Turbine Engine Helicopters 1980-1985

- ▲ EMS Helicopters \_\_\_\_\_
- Turbine Engine Helicopters - - - - -

\* EMS helicopter data based on accidents which involved patient transport

..... The 1986 data for EMS is provided for the readers information only. These data were not used in comparison to the part 135 data or in the calculation of the 6-year EMS accident rate mean.

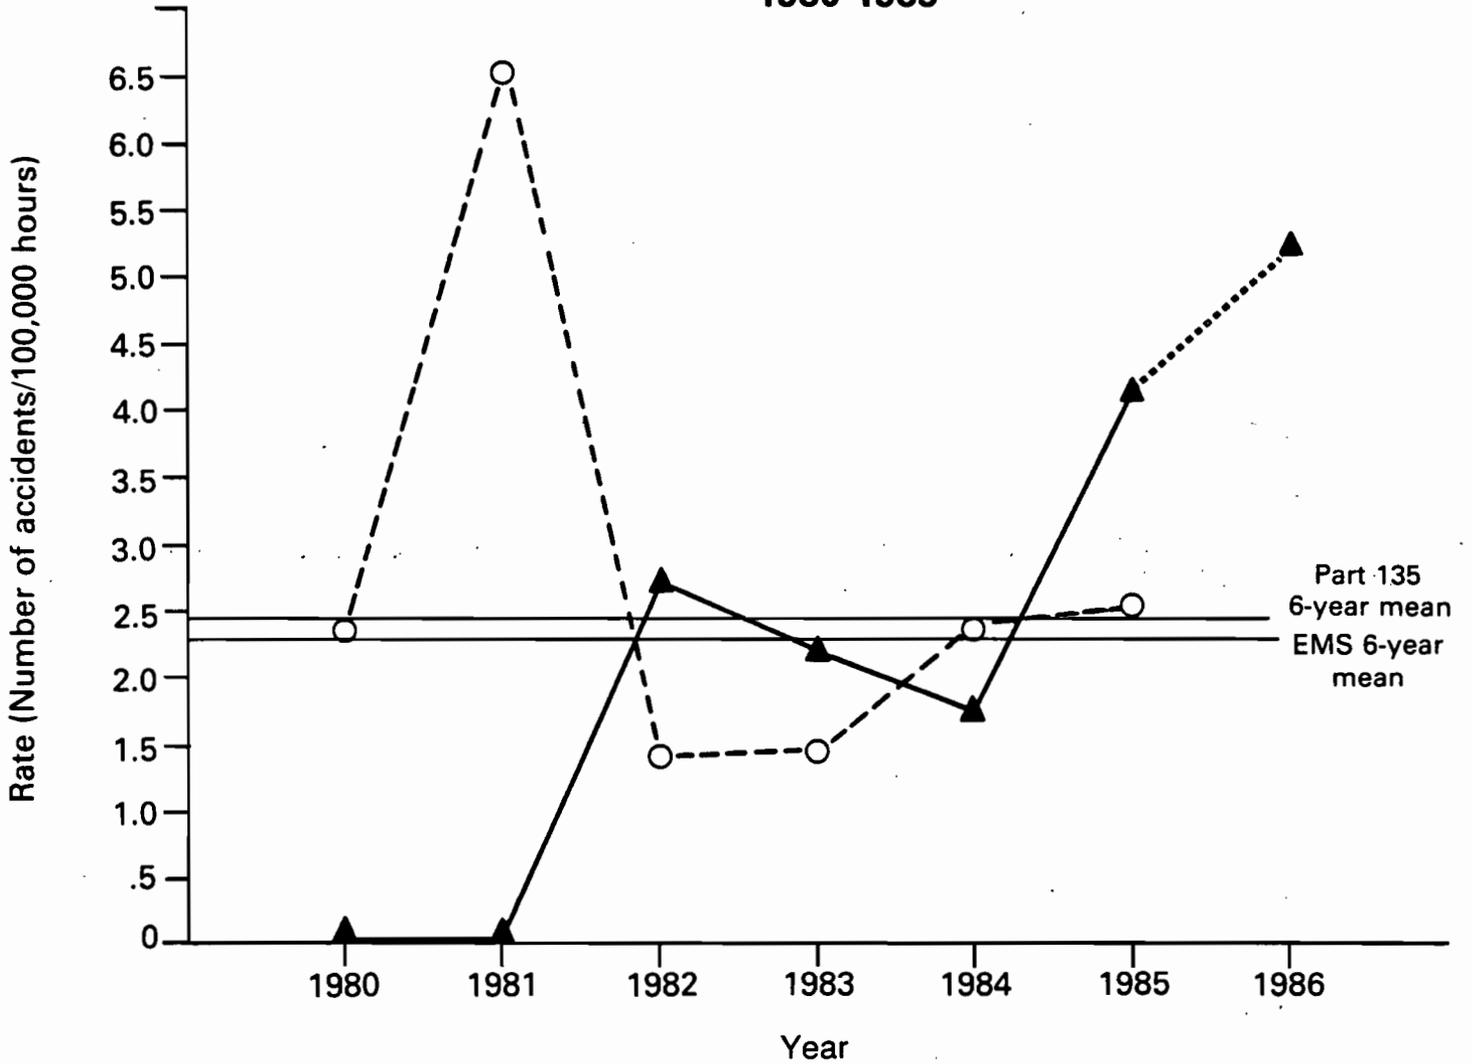
**Injury Accident Rate\*  
Commercial EMS Helicopters  
and  
14 CFR Part 135 Non-Scheduled Helicopter  
Air Taxis  
1980-1985**

- ▲ EMS Helicopters —————
- Part 135 non-scheduled helicopter air taxis - - - - -
- \* EMS helicopter data based on accidents which involved patient transport
- ..... The 1986 data for EMS is provided for the readers information only. These data were not used in comparison to the part 135 data or in the calculation of the 6-year EMS accident rate mean.

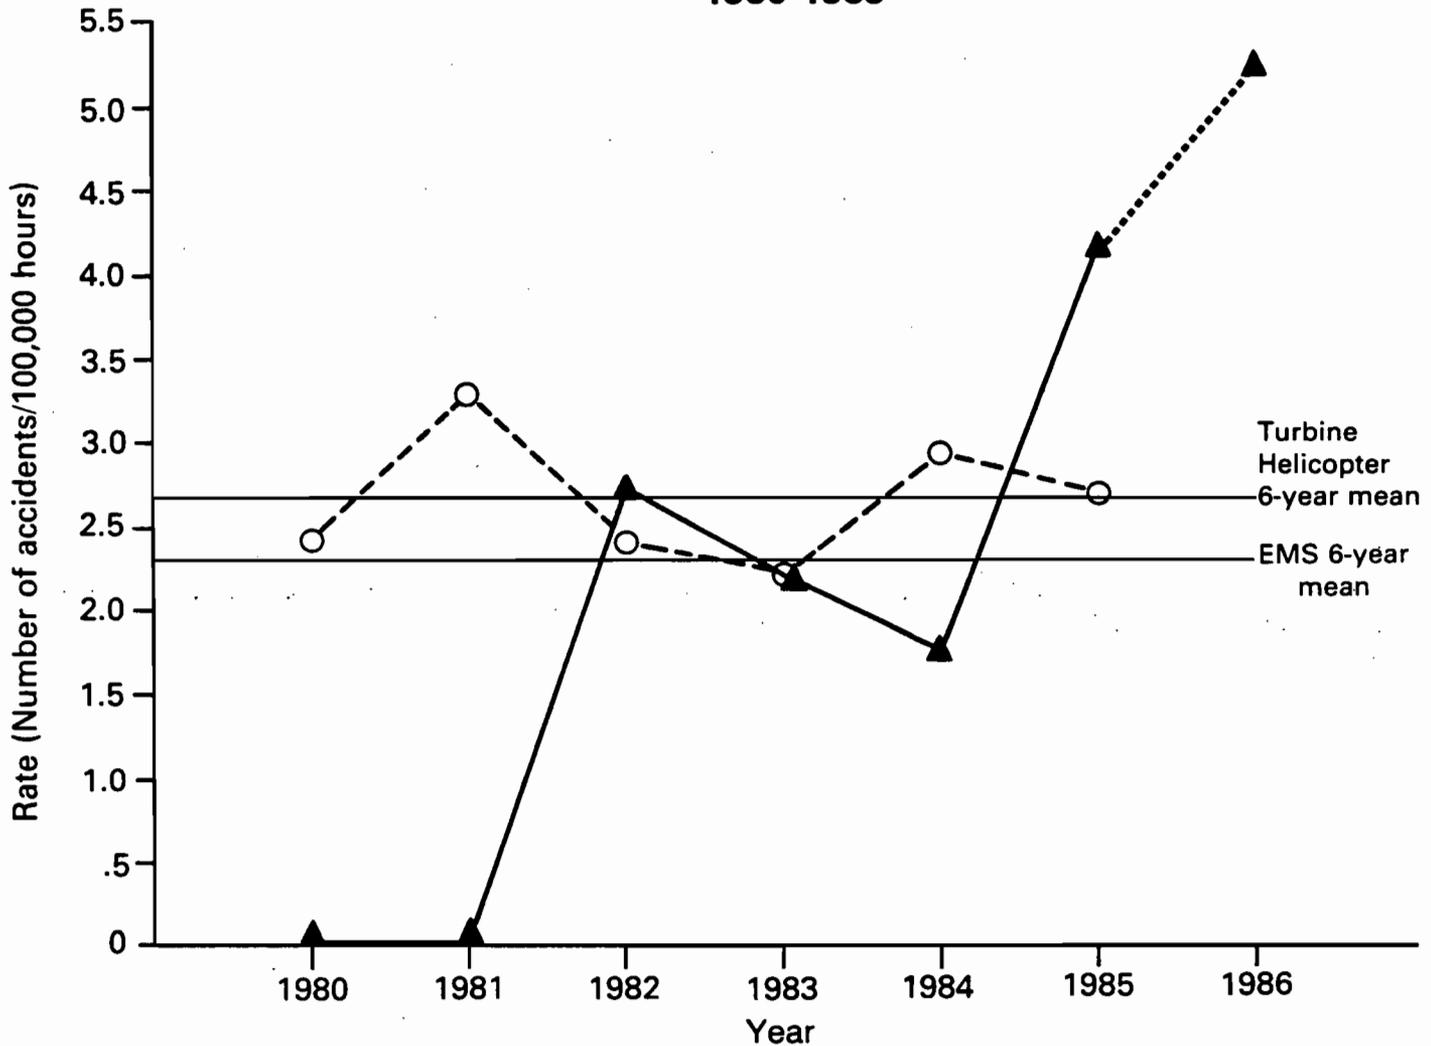
### Injury Accident Rate\* Commercial EMS Helicopters and Turbine Engine Helicopters 1980-1985

- ▲ EMS Helicopters \_\_\_\_\_
- Turbine Engine Helicopters - - - - -

\* EMS helicopter data based on accidents which involved patient transport
