NATIONAL TRANSPORTATION SAFETY BOARD

AIRWORTHINESS GROUP CHAIRMAN'S ADDENDUM

A. INCIDENT: DCA13IA037

Location:	Boston, MA
Date:	January 7, 2013, about 10:23am EST
Aircraft:	Boeing 787-8 (msn 34839), JA829J, Japan Air Lines flight 008

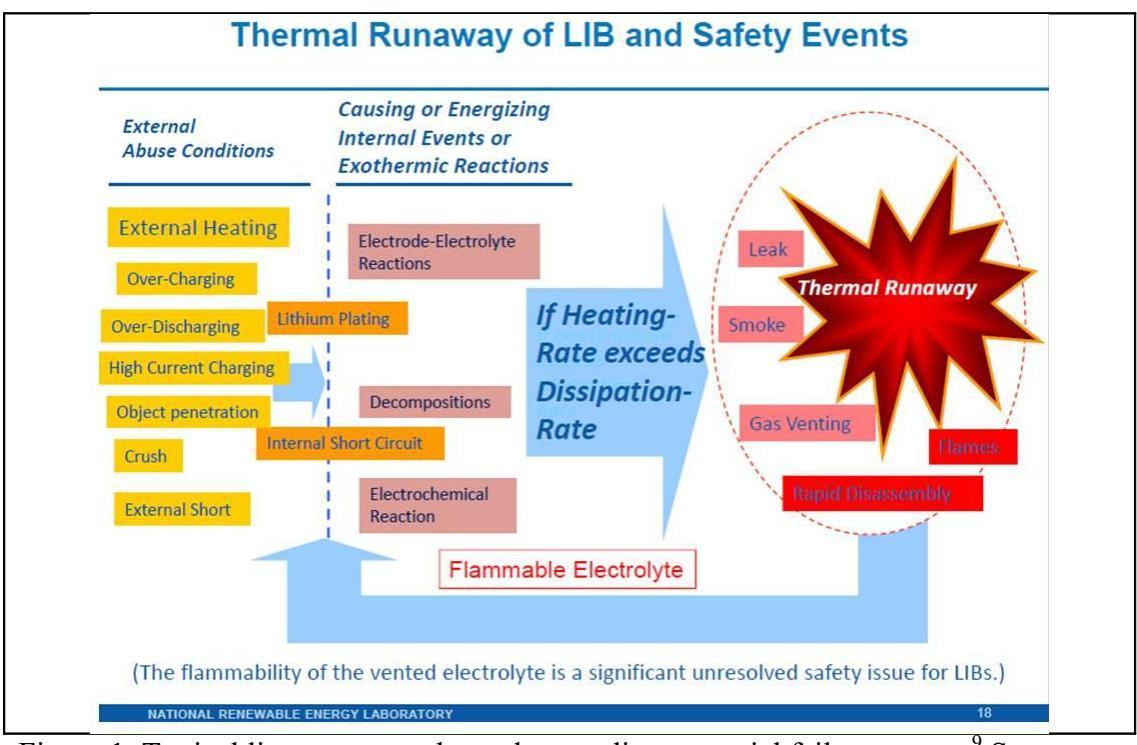
Figure 1. Typical literature search result regarding potential failure causes.⁹ Source: NREL

Literature searches revealed consistent descriptions of cell and battery failure processes that convey simplified versions of the failure processes and paths to investigate. Additionally, on April 22, 2013, the NTSB held a forum on battery safety, in which experts provided presentations about battery design, experience, and failures.⁸ One example was a summary from the National Renewable Energy Laboratory (NREL) that had been created by Dr. Daniel H. Doughty of Battery Safety Consulting, Inc. The Airworthiness investigation examined each of these paths. (See Figure 1 and Figure 2

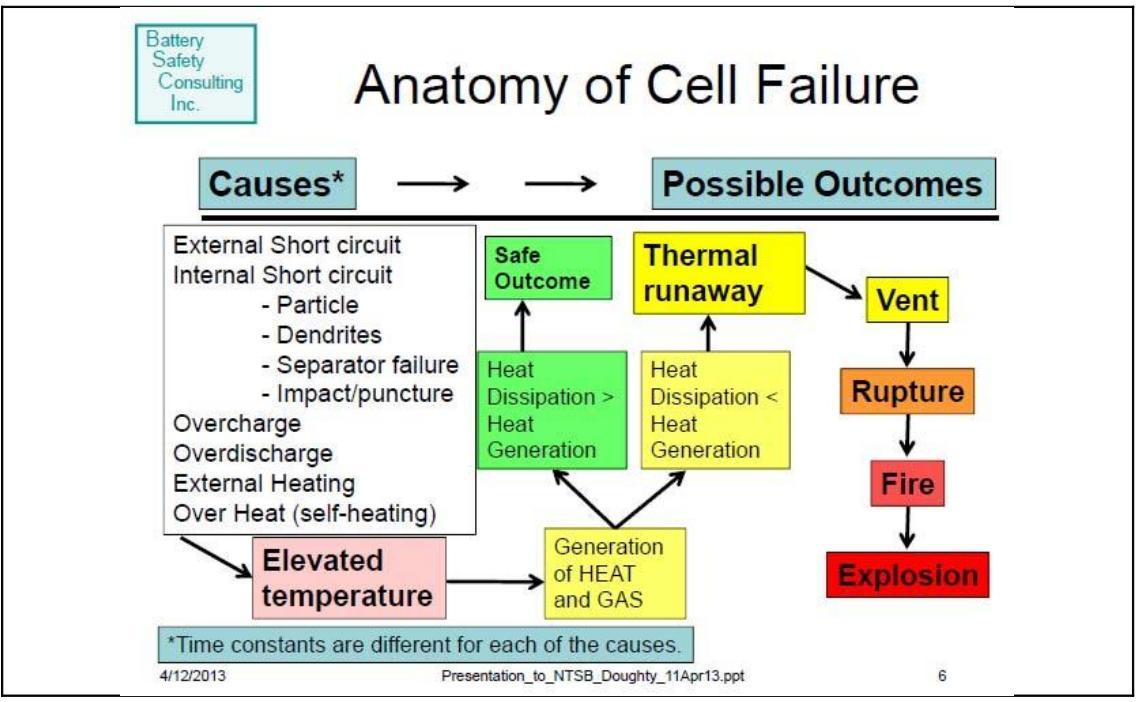
Figure 2. Cell failure scenario provided by Dr. Daniel H. Doughty, of Battery Safety Consulting, Inc.

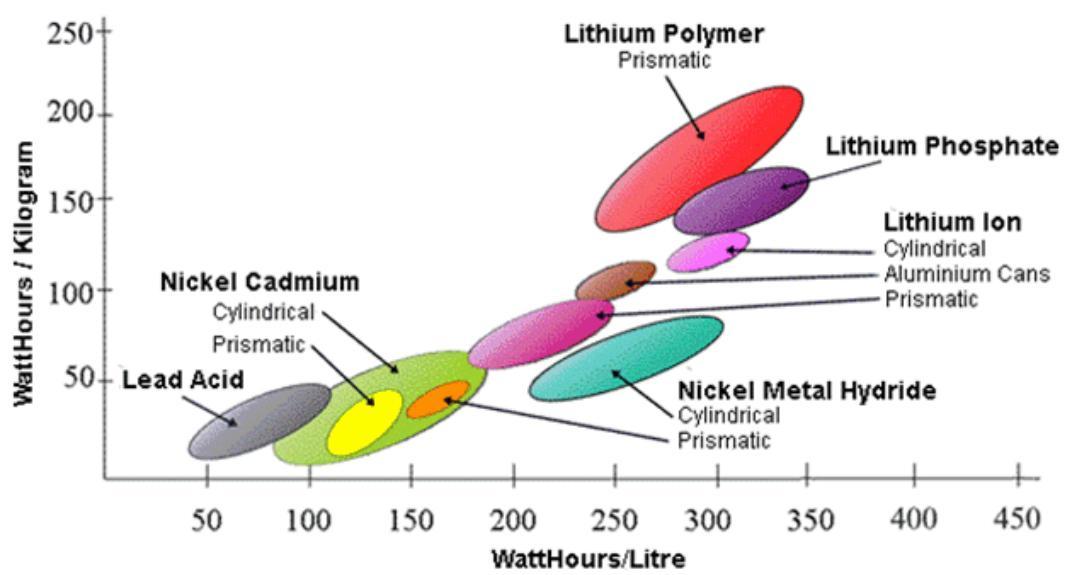
Figure 3. Illustration provided by Western Lithium Corporation compares the relative properties of battery types. Note that the illustration provides rough comparison concepts and not clear performance limits.

During meetings of June 2013, GS-Yuasa engineering personnel compared the relative properties of various battery types. Aviation applications require a unique set of battery properties, as compared with those made for industrial use. Aviation requirements are high in both power density, which is power for a certain amount of mass and are also high in energy density, which is the total kW-hrs stored in the battery per unit mass, usually expressed in Wh/kg. Electric vehicles (EV) and hybrid electric vehicles (HEV) also utilize large format lithium ion batteries, some of which have lithium ion cobalt oxide (LiCoO₂, also known as LCO) chemistry, and this is the basic chemical combination found in the prismatic cells of the LVP65. (See Figure 3 and Figure 4)

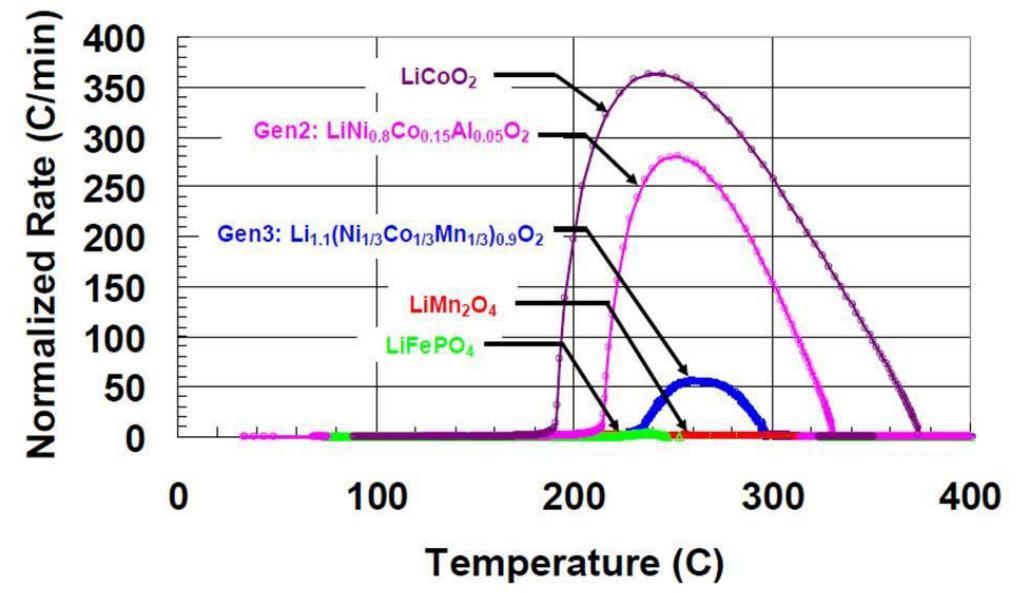
Figure 4. [Doughty Figure S-1.] Self-heating rate of the 18650 full cell as measured by accelerating rate calorimetry (ARC). Improving cathode stability results in a higher thermal runaway temperature (increased stability) and a reduced peak heating rate. Source: E. P. Roth, D. H. Doughty, Proceedings of AABC 15-19 May 2006, Baltimore, MD.

The materials comprising the cell have a profound influence on the safety and abuse tolerance of the cell and battery pack. The choice of cathode has a very significant influence on cell safety. New, high-energy cathodes are being used in commercial cells or are in development. Lithium cobalt oxide (LiCoO2, or LCO) has been the cathode of choice for the majority of consumer-level Li-ion cells produced today. Although it delivers good capacity, it is the most reactive and has poorer thermal stability than other cathodes. Much progress has been made in commercializing safer cathodes. A comparison of the thermal stability of cathodes is shown in Figure S-1. (Airworthiness Addendum Figure 4)

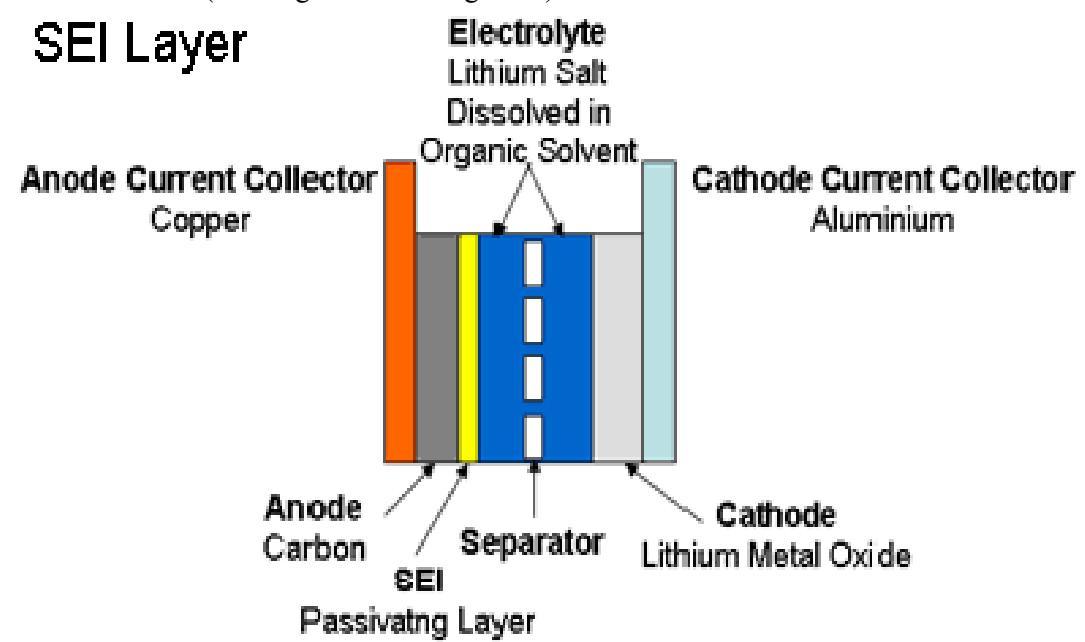
Figure 7. Constituents of a LIB cell, beyond what is shown in Figures 5 and 6. The blue color shown to be the electrolyte is a liquid in the LVP65 cells. Source: http://www.mpoweruk.com

A microporous thermoplastic film known as the separator allows movement of the ions while keeping the anode and cathode from making contact, which would short circuit the cell. (See Figure 7 and Figure 8)

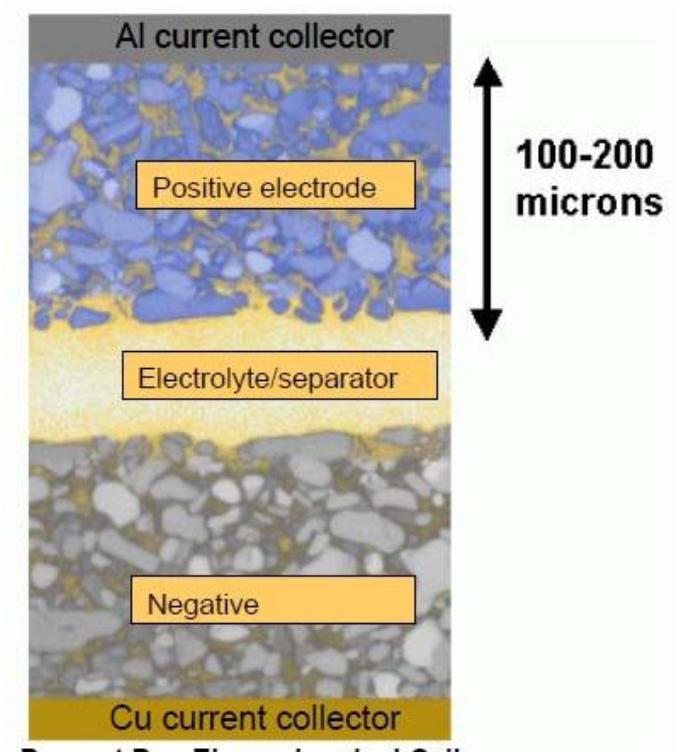
Figure 8. Graphic depicting conceptual detail about the porous nature of the electrodes. Source: ROADMAP http://www.nrel.gov/docs/fy13osti/54404.pdf

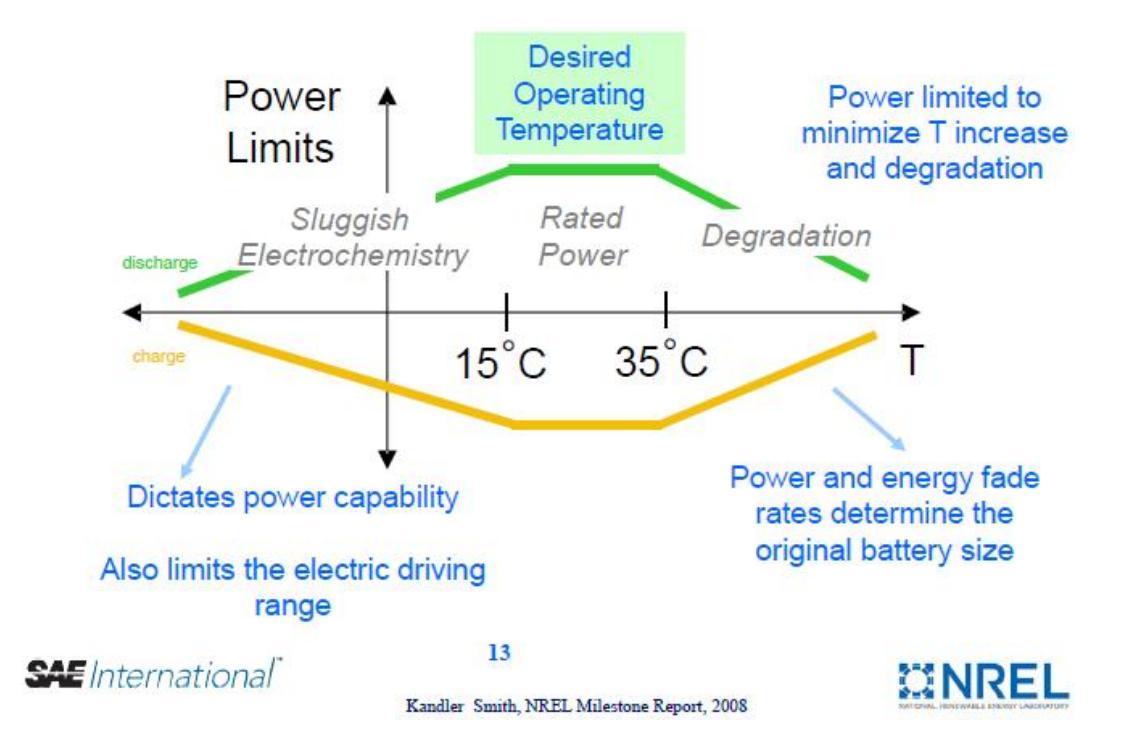
Figure 9. Charge and discharge capabilities are reduced at higher and lower temperatures, as shown in this graphic. Charge is shown in yellow (downward). Note that the temperature values shown are only applicable to the battery model for which this graphic was created.

In June 2013, GS-Yuasa engineers described how the limits of a battery's charge and discharge capability would decrease as temperature departed from an optimal range. A similar description was found in a NREL presentation. (See Figure 9)

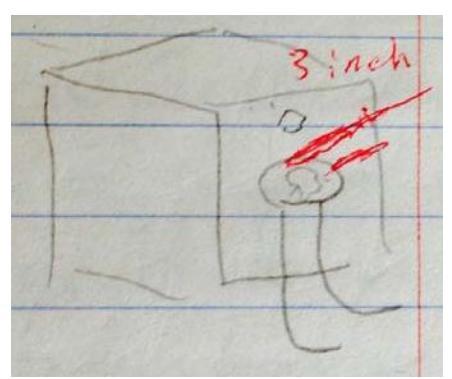
Figure 10. From the Airworthiness Group Chairman's on-scene notebook, this shows a sketch of battery box and flames made by the mechanic and his supervisor. For scale, the height of the original sketch is 1.25 inches.

The mechanic on the scene and his supervisor were interviewed Immediately following the battery failure at Boston by the Airworthiness Group Chairman. The mechanic spoke less English and the supervisor provided translation assistance. Asked about the flames seen, the two worked together to make the following sketch in the Group Chairman's notebook, noting that the flames were at the connector and not from the lid of the battery box. (See Figure 10)

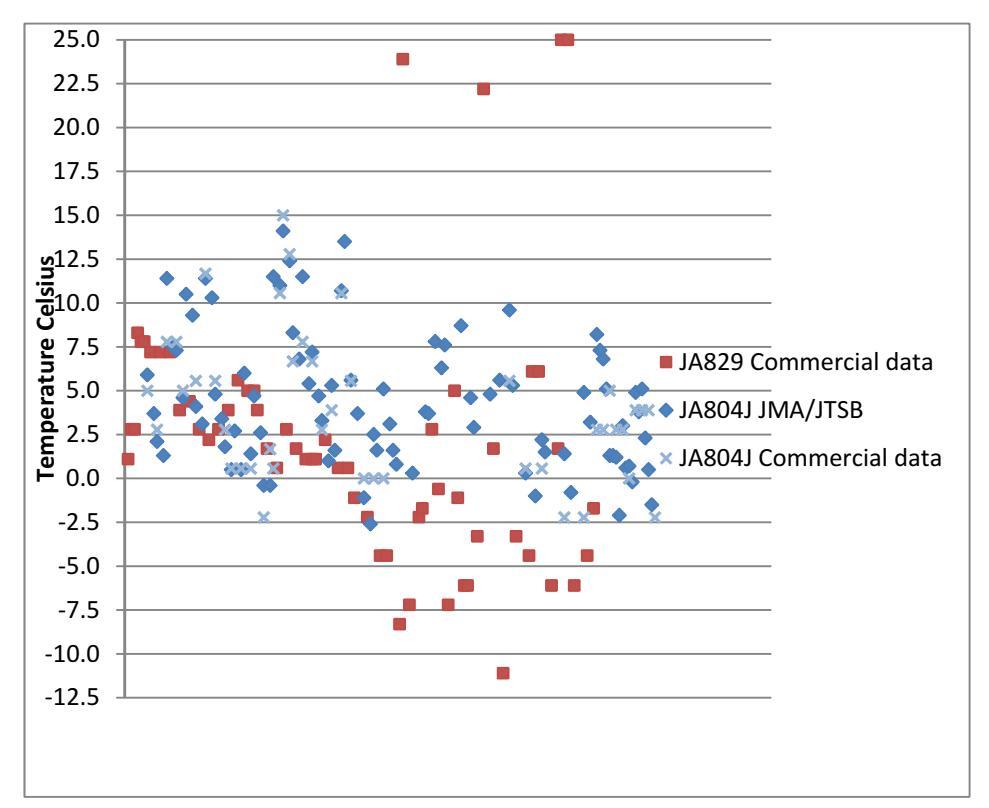
Figure 12. JAL and ANA 787 coldest daily outdoor temperatures for exposure of the JA829J and JA804A airplanes. Data is from Appendix A with the X-axis representing November 26, 2012, to January 7, 2013. The axis is not labeled to account for two potential separate cold data points in a 24 hour period. For example, one may be a morning data point and the second during the evening.

The lowest temperature for an approximate location where JA829J transited was -11.1C and for JA804A was -2.6C. The lowest temperature for a location where JA829J stayed for more than four hours was -8.3C and for JA804A was -2.6C.

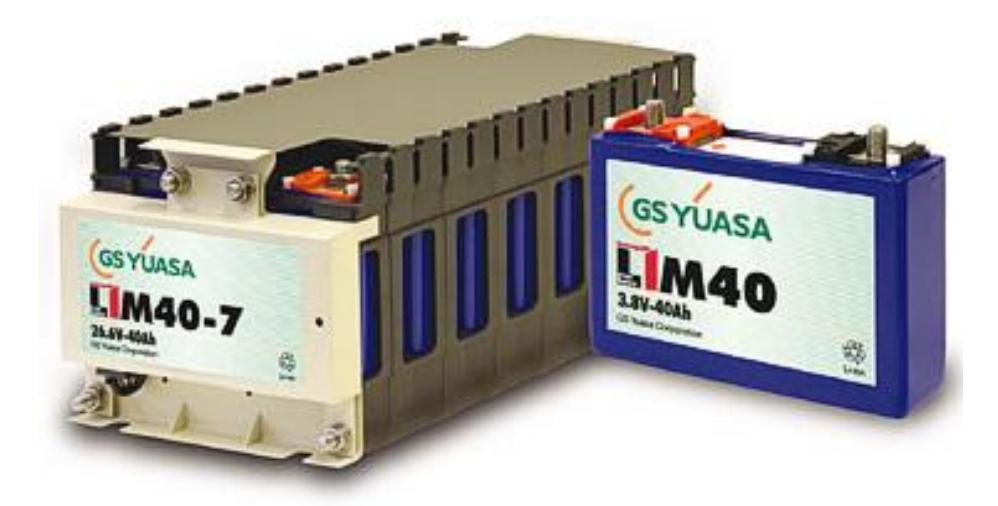
Figure 13. GS-Yuasa Lithium ion individual cell and group of seven cells as a battery.

The LVP65 cells are a rectangular shape that is termed a prismatic cell shape. (See Figure 13 and Figure 14) The LVP65 has three windings within a metal can that resembles the GS-Yuasa LIM series of industrial batteries in general shape and construction. The LIM series pre-dates the LVP65 series. Cell Model LVP65-8-402 "with improved lithium cobalt dioxide" was the design in the LVP65-8-402 battery aboard the 787 involved in the Boston battery failure of January 7, 2013.

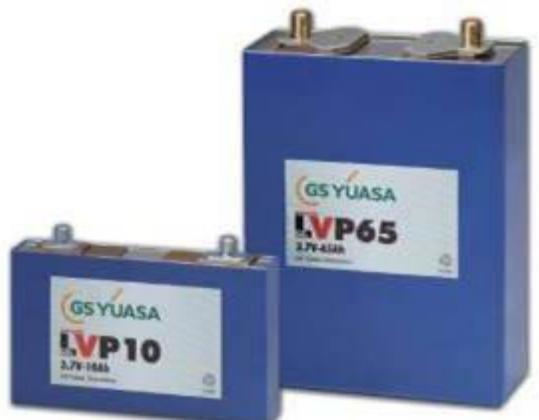
Figure 14. The shape of the eight LVP65 cells used in each main and APU battery.

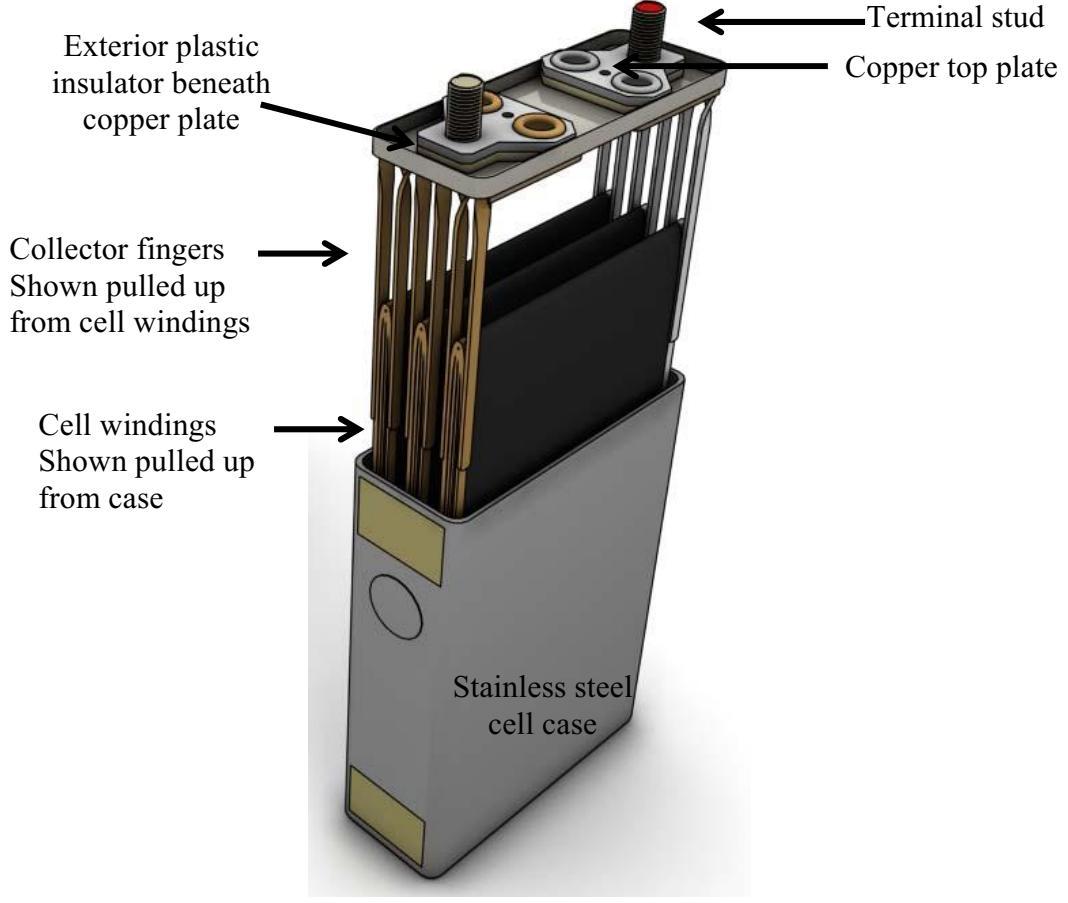
Figure 15. Exploded view of cell to show current collectors and other cell components.

The anode/separator/cathode foil sets in each are rolled into windings and within each cell are three windings. The external positive and negative terminals at the top of the cell connect internally to the individual winding foils with finger-like collectors. (See Figure 15 and Figure 16).

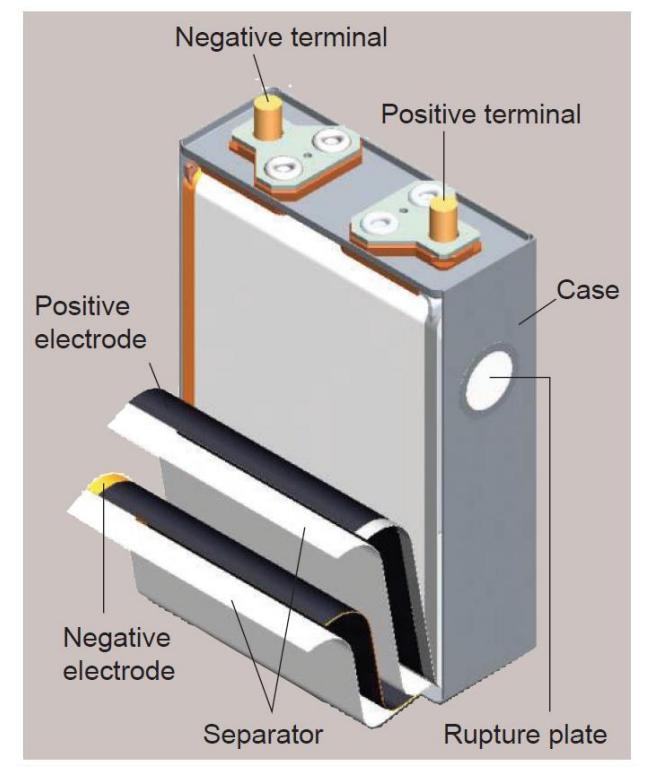
Figure 16. Major cell components and electrode layering.

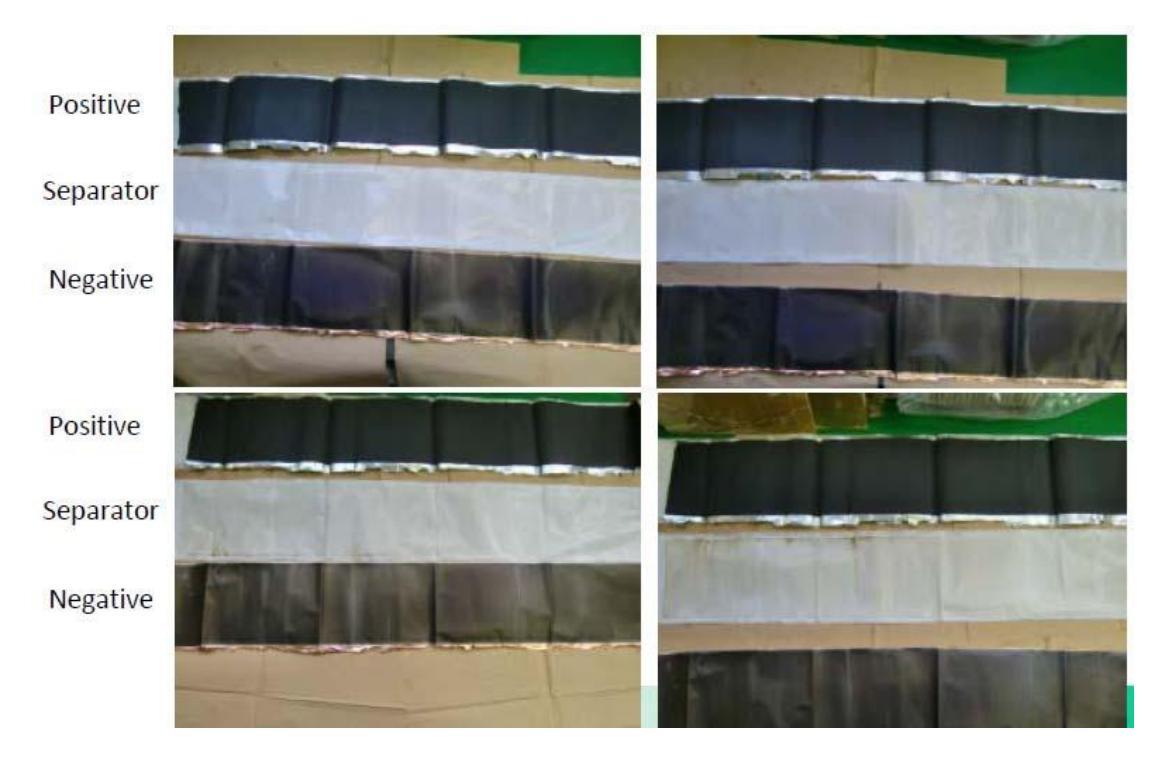
Figure 17. Examination of the disassembled LVP65-002 cell windings after the endurance test. (GS-Yuasa)

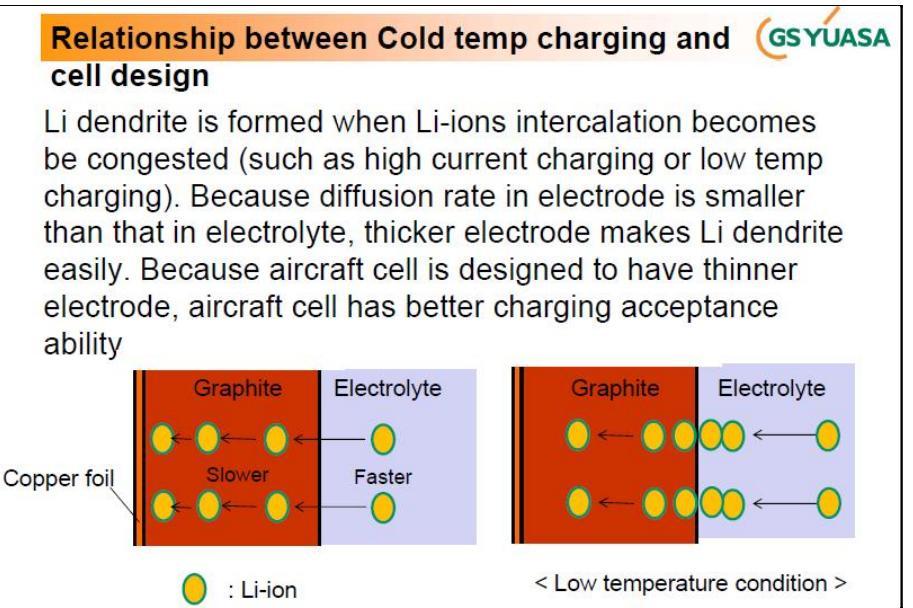
Figure 18. The above is a GS-Yuasa explanation about dendrites which was provided in meetings of June 2013.

During meetings at GS-Yuasa in June 2013, GS-Yuasa engineering personnel provided the following description about lithium dendrite formation: (See Figure 18)

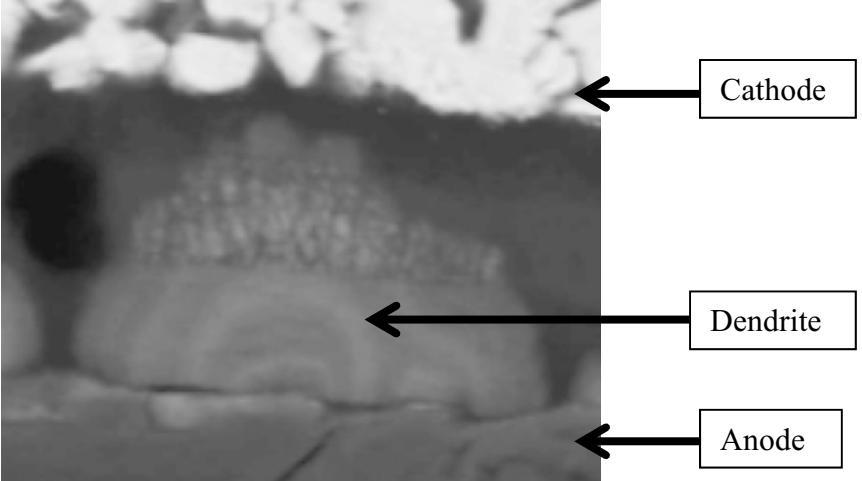
Figure 19. A sectioned single dendritic growth, projecting upward from the anode. Ring-like growth patterns are visible. Photo: Quinn Horn, Exponent.

Microphotographs of a sectioned dendritic growth may show tree-like rings, as shown by Exponent. (See Figure 19).

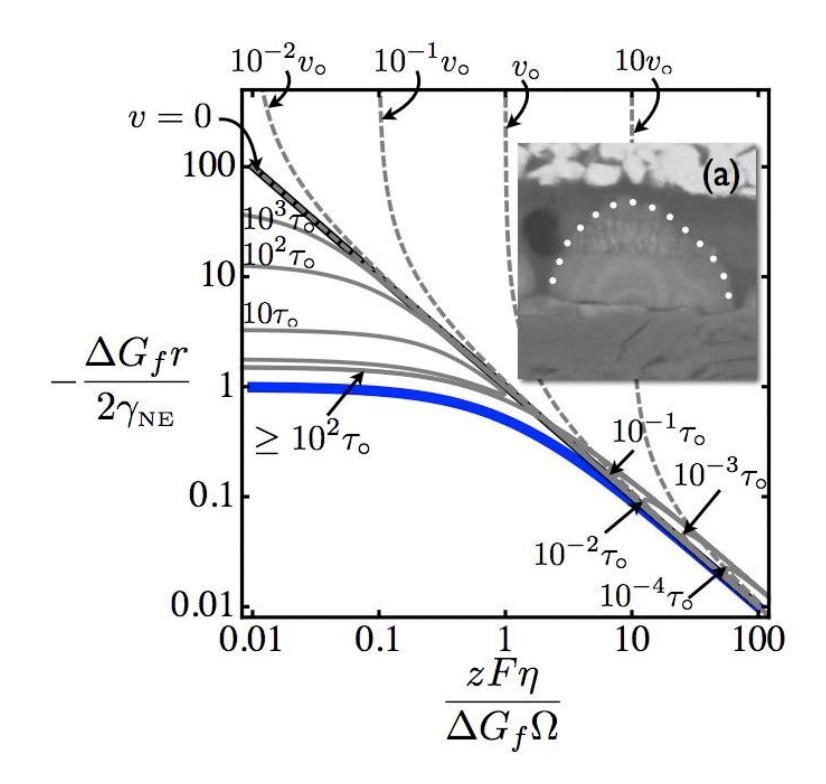
Figure 20. Lithium dendrite formation map developed by Dr. David Ely and Prof. R. Edwin Garcia at Purdue University.

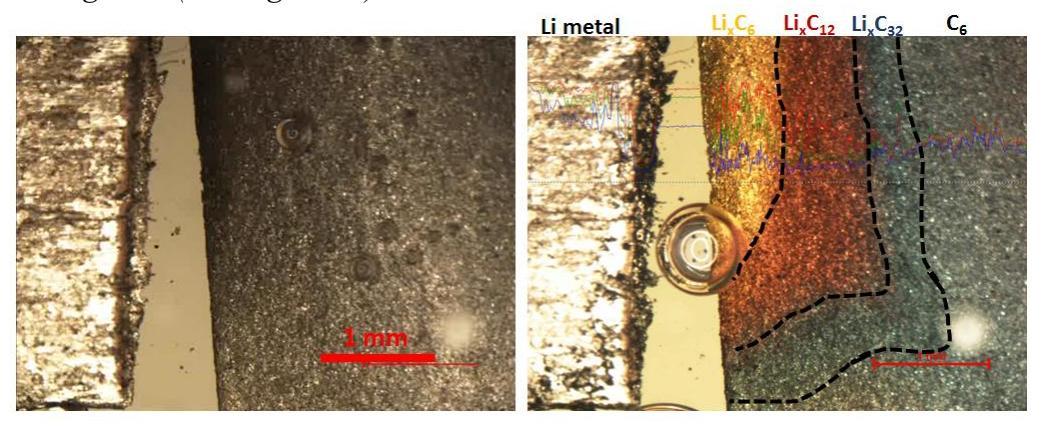
Figure 21. Distribution of charge as color change of a lithiated carbon anode. The bubble seen in the electrolyte [of the right microphotograph] formed after charging and impeded ion mobility during the discharge process. The bubble could be thought of as unoccupied free volume within a cell, such as a void left behind by a wrinkle in the electrode foils. Source: Dr. Corey Love, Naval Research Laboratory.

The dendrites originate from areas of full state-of-charge and extend into areas of lesser lithium concentration. Lithium ion is reducing to lithium dendrites at the steep lithium ion concentration gradient between the gold and red-brown sections of the anode. Below is a figure from my data which shows the color change of a carbon anode when it becomes lithiated. The figure at left shows an experimental cell of lithium metal (left) vs. carbon anode (right) before lithiation. The figure at right shows the various stages of lithiation as evident by color changes to the carbon anode. The varying levels of lithium concentration are given by color: high concentration (gold), moderate concentration (red-brown), low concentration (dark blue) and non-lithiated carbon (gray). The dotted lines are provides to aid in the distinction of these regions. (See Figure 21)

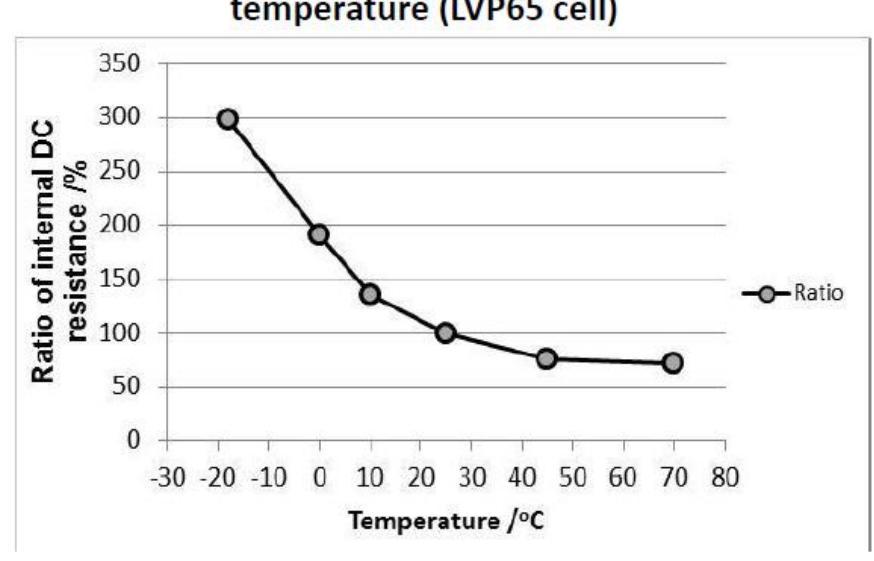
Plots of ratio of internal DC resistance versus temperature (LVP65 cell)

In meetings of June 2013, GS-Yuasa personnel provided data relating the electrical resistance properties of the LVP65 electrolyte over a range of temperatures. The electrical resistance of the electrolyte did not exhibit a straight relationship to the temperature, becoming increasingly more resistive as the temperature decreased. (See Figure 22)

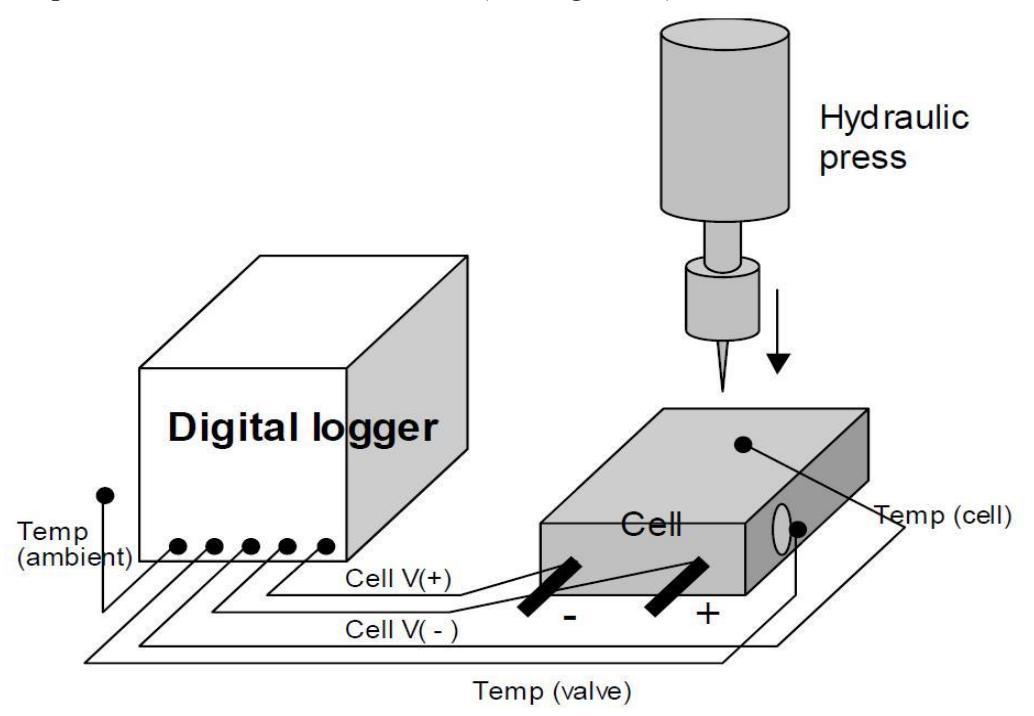
Fig. 5.3-1 Setup of nail penetration test of cell

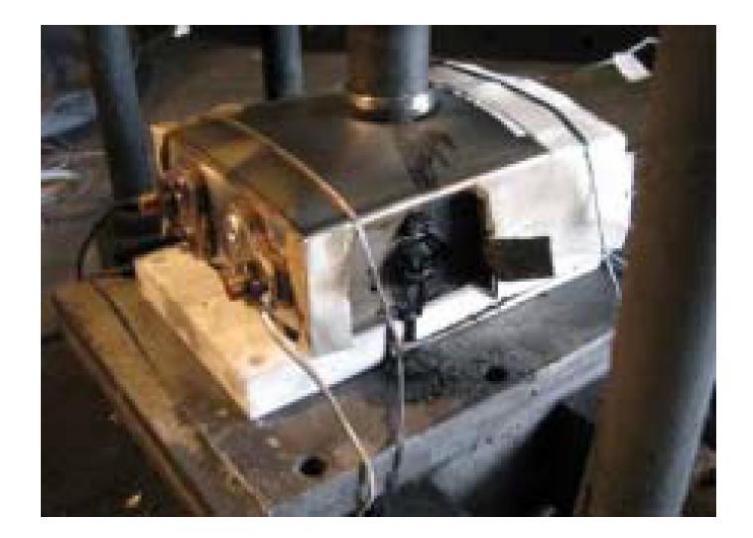
Fig. 5.3-2 Appearance of cell in nail penetration

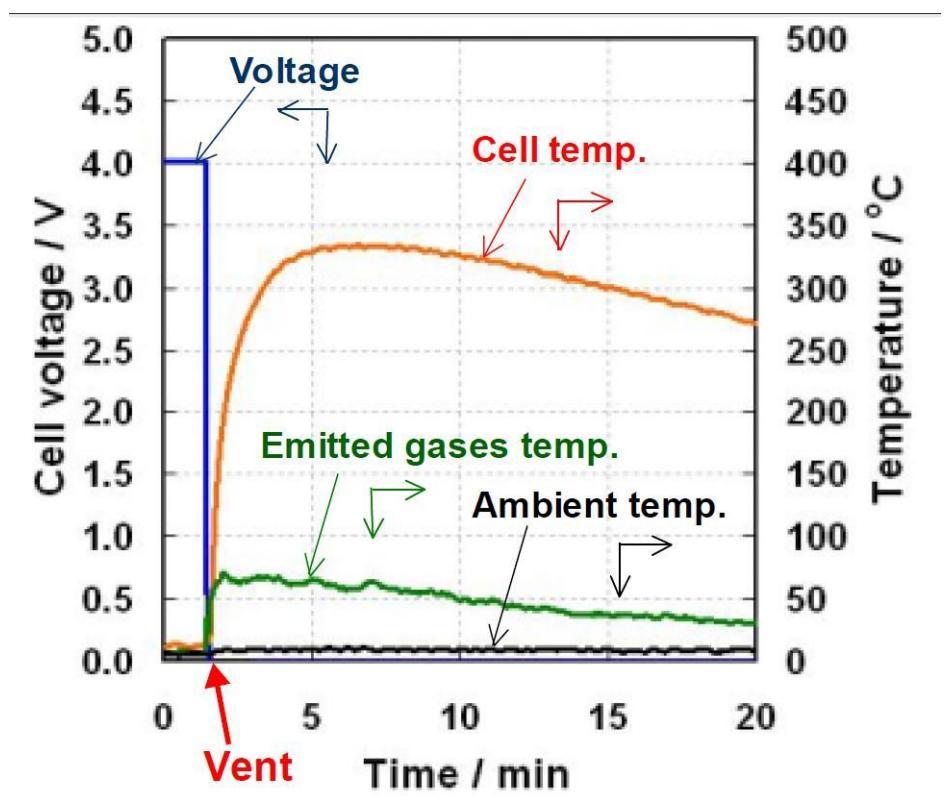
Figure 25. GS-Yuasa record of the cell voltage, cell temperatures during nail penetration test.

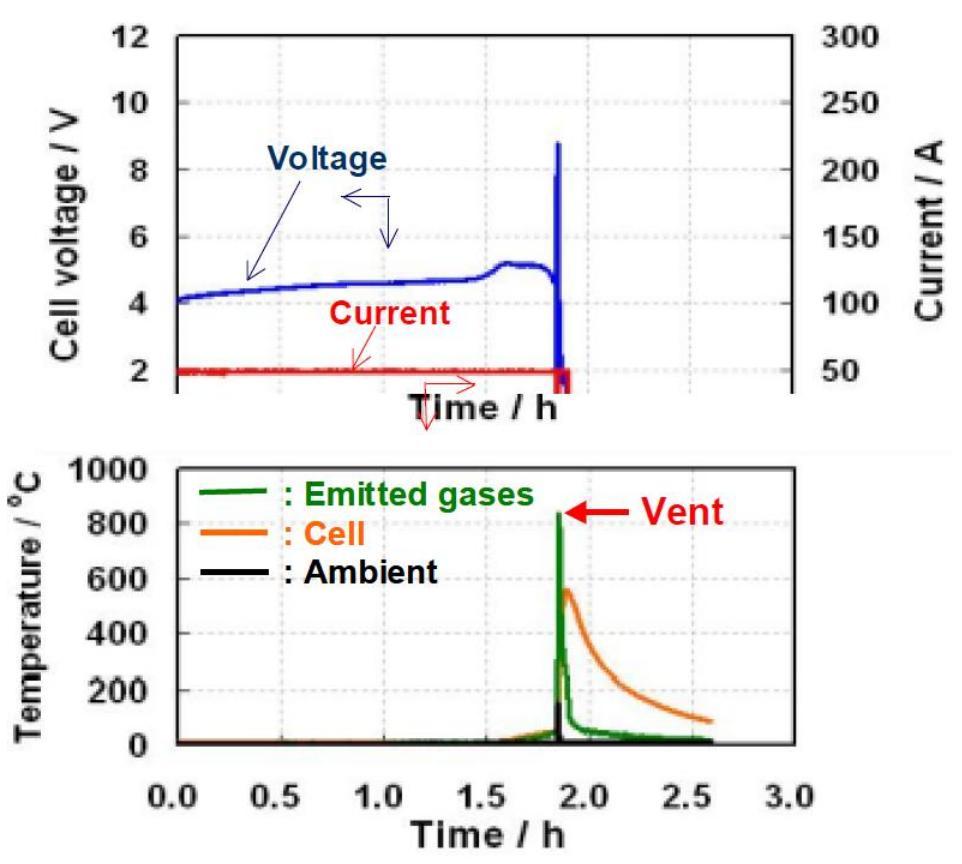
Figure 26. Temperature and venting of cells during intentional overcharge abuse testing.³¹

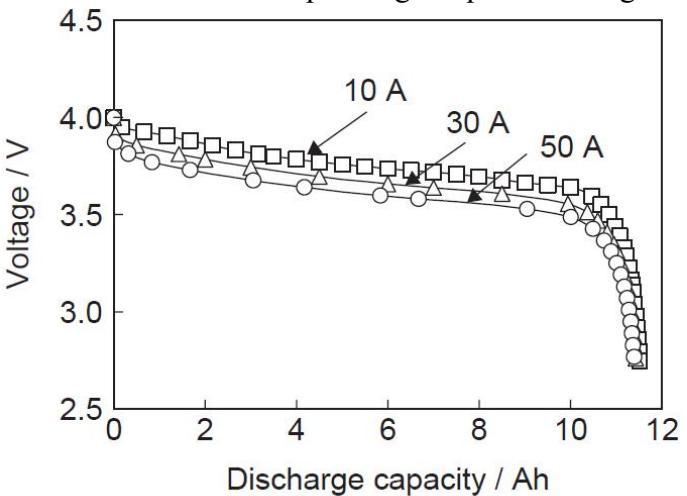
Fig. 4 Discharge characteristics at various currents of 10 A (\Box), 30 A (\triangle), and 50 A (\bigcirc) at 25 °C for LVP10 type lithium-ion cells. The cells were discharged to 2.75 V after charged at 10 A to 4.0 V for 3 hours in total at 25 °C.

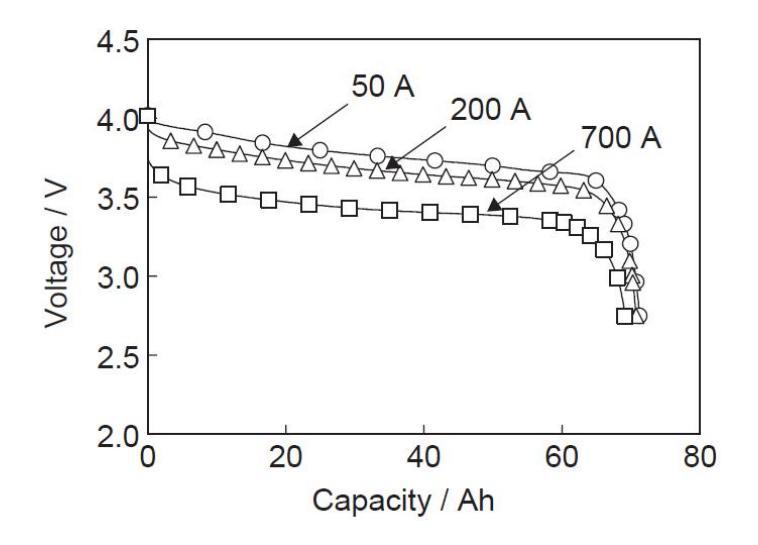
Fig. 5 Discharge characteristics at various currents of 50 A (\bigcirc), 200 A (\triangle), and 700 A (\square) at 25 °C for LVP65 type lithium-ion cells. Cells were discharged to 2.75 V after charged at 70 A to 4.025 V for 3 hours at 25 °C.

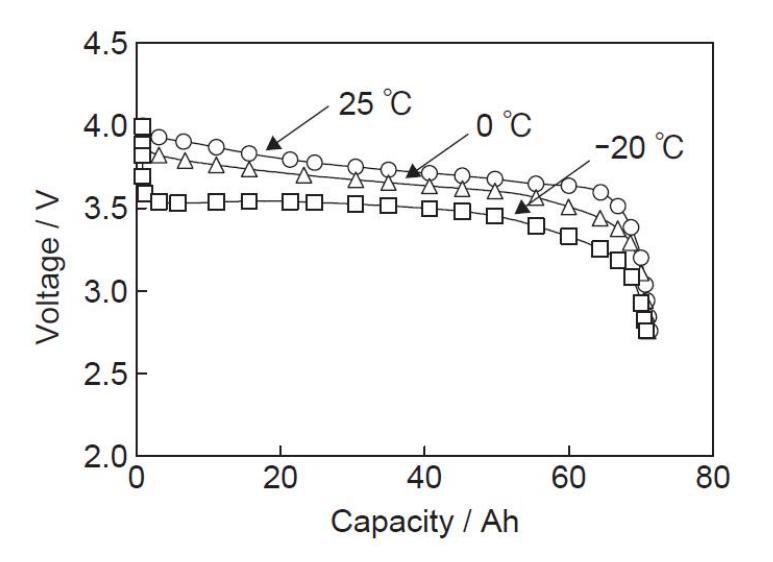
Fig. 6 Discharge characteristics at 50 A under various temperatures of 25 °C (\bigcirc), 0 °C (\triangle), and -20 °C (\square) for LVP65 type lithium-ion cells. Cells were discharged to 2.75 V after charged at 70 A to 4.025 V for 3 hours at 25 °C.

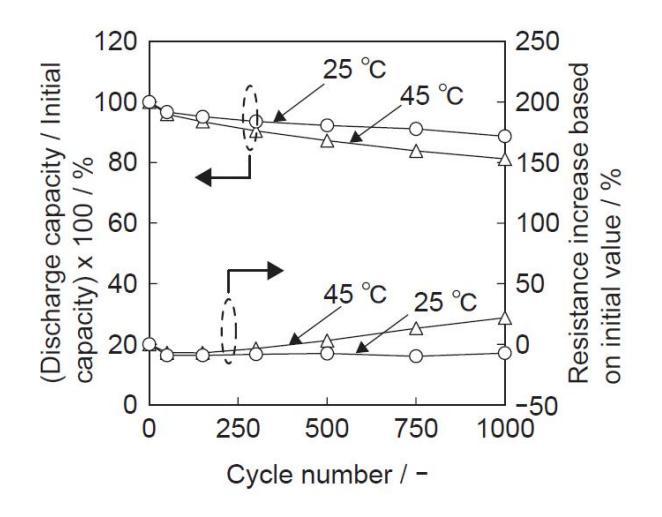
Fig. 7 Charge and discharge cycle life performance for LVP65 type lithium-ion cells with cycling under 25 °C (\bigcirc) and 45 °C (\triangle). The cells were discharged to 2.75 V at 70 A after charged at 70 A to 4.025 V for 3 hours in total at 25 and 45 °C.

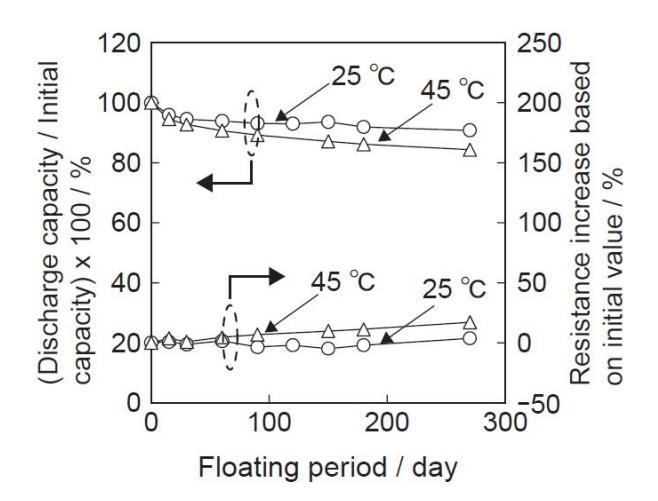
Fig. 8 Calendar life performance for LVP65 type lithium-ion cells under floating conditions of 4.025 V at 25 °C (\bigcirc) and 45 °C (\triangle). The cells were charged at 70 A to 4.025 V at 25 and 45 °C. Capacity was checked periodically to confirm the retained cell capacity at the discharge condition of 70 A to 2.75 V at 25 °C.

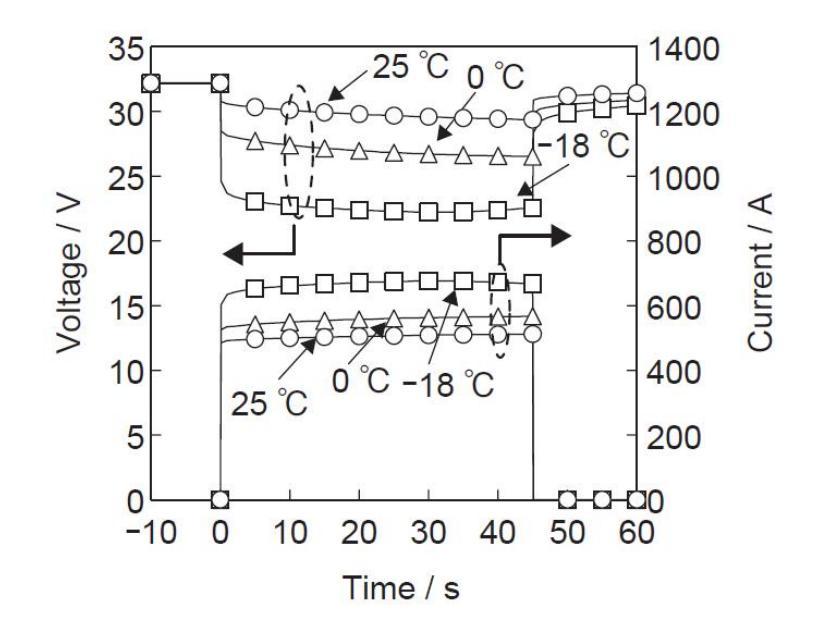
Fig.11 Discharge performances of LVP65-8 type lithium-ion batteries for engine start under various temperatures of 25 °C (\bigcirc), 0 °C (\triangle), and -18 °C (\square). Fully charged batteries were discharged at constant power of 15 kW.

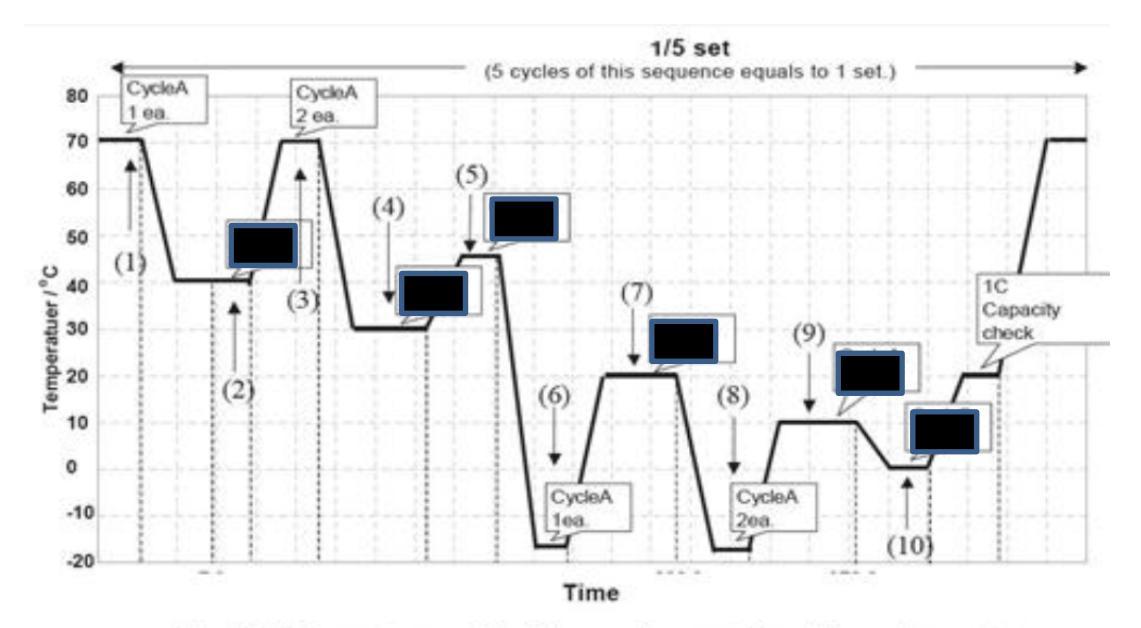
Fig. 4.2-1 Temperature profile of the standby operation of the endurance test

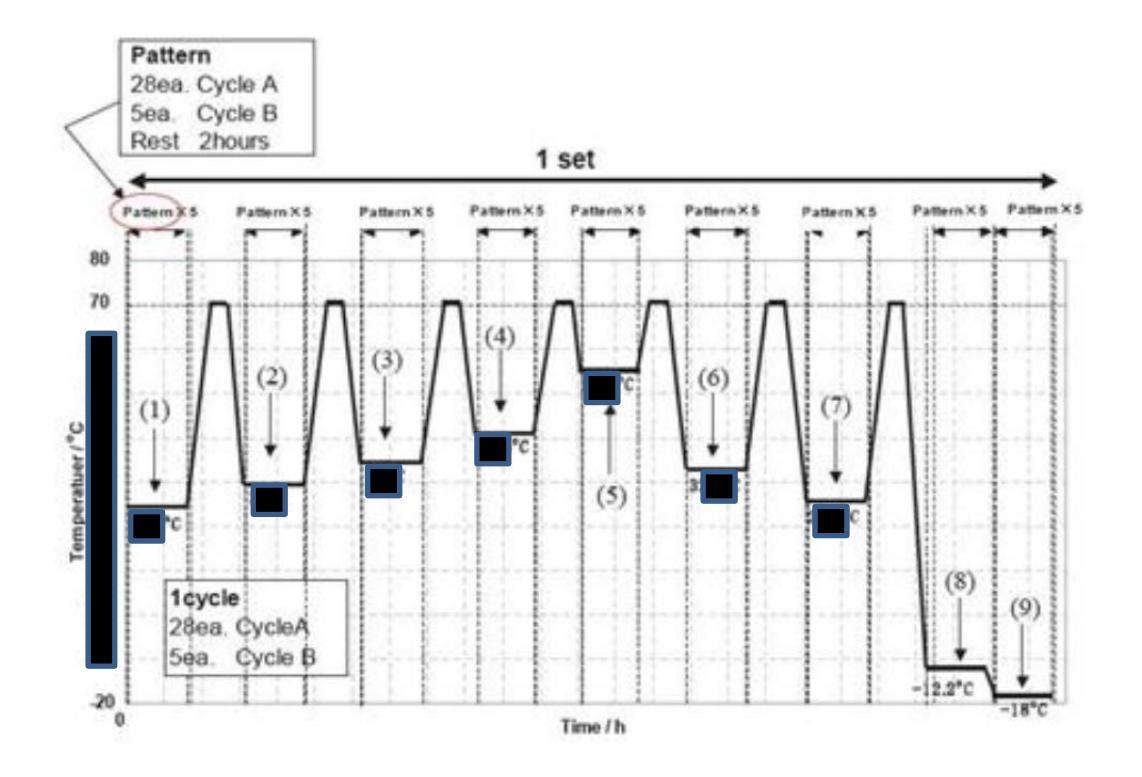
Fig. 4.2-2 Temperature profile of the standby operation of the endurance test

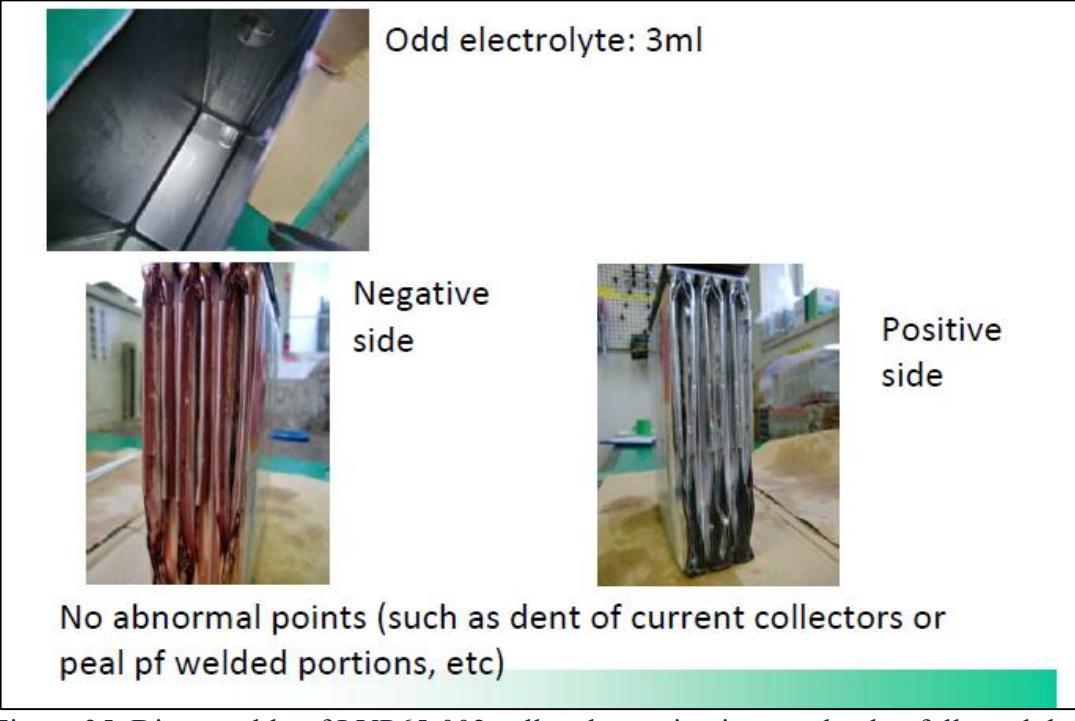
Figure 35. Disassembly of LVP65-002 cell and examination results that followed the endurance test. (GS-Yuasa)

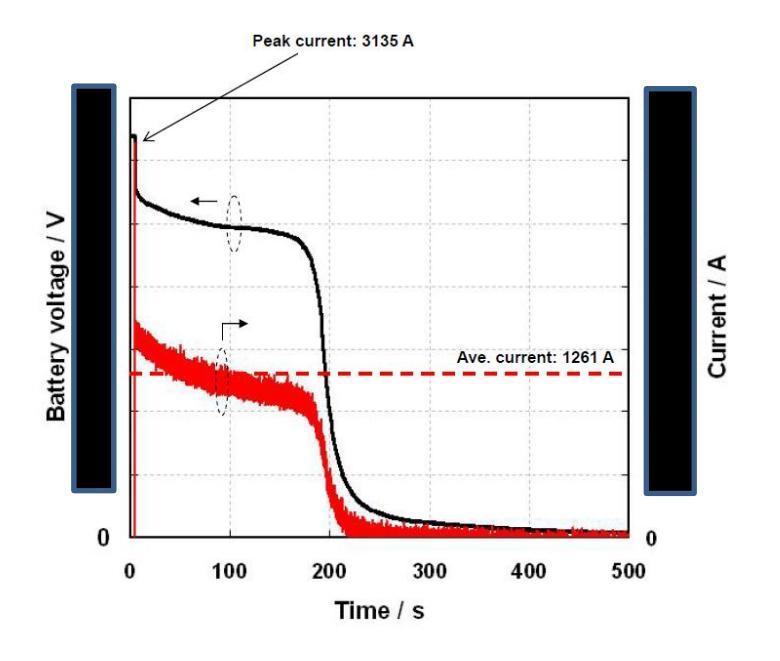
Fig. 7.13-5 Battery voltage and short circuit current profiles during the external short circuit test
