NATIONAL TRANSPORTATION SAFETY BOARD

AIRWORTHINESS GROUP CHAIRMAN'S ADDENDUM

A. INCIDENT: DCA13IA037

Location:	Boston, MA
Date:	January 7, 2013, about 10:23am EST
Aircraft:	Boeing 787-8 (msn 34839), JA829J, Japan Air Lines flight 008

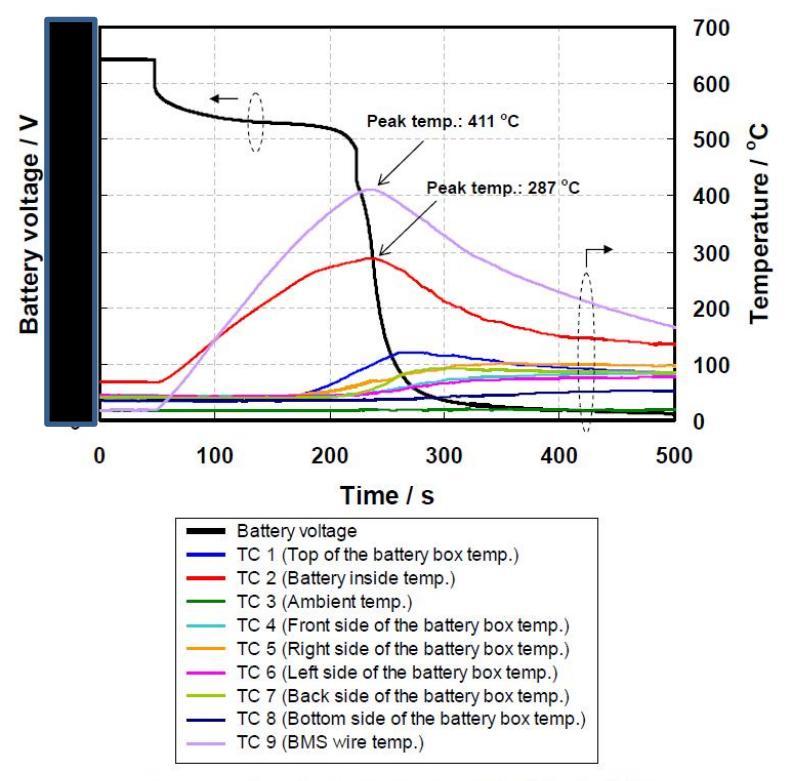
Fig. 7.13-6 Profiles of the battery voltage and temperature during the test

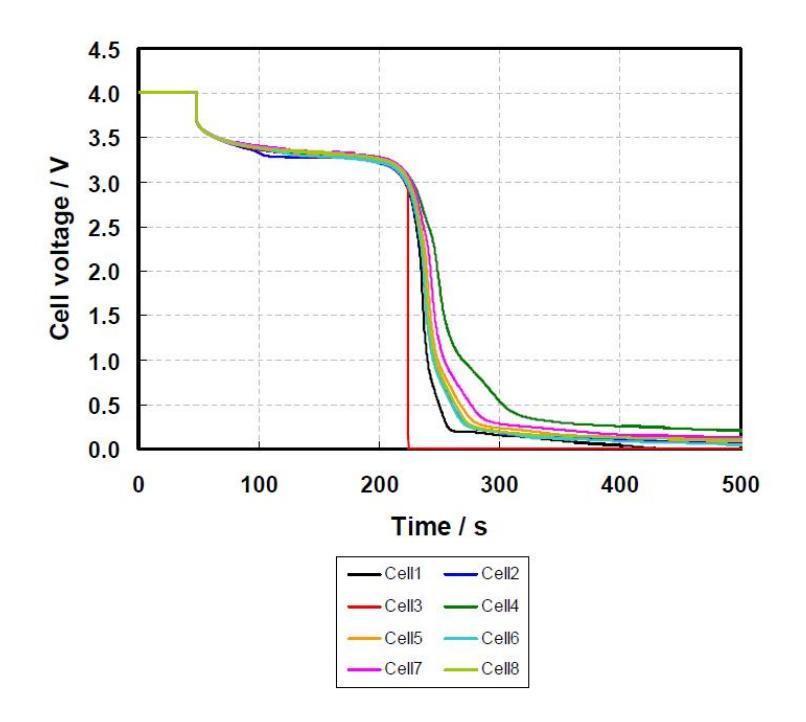
Fig. 7.13-7 Profiles of cells during the test

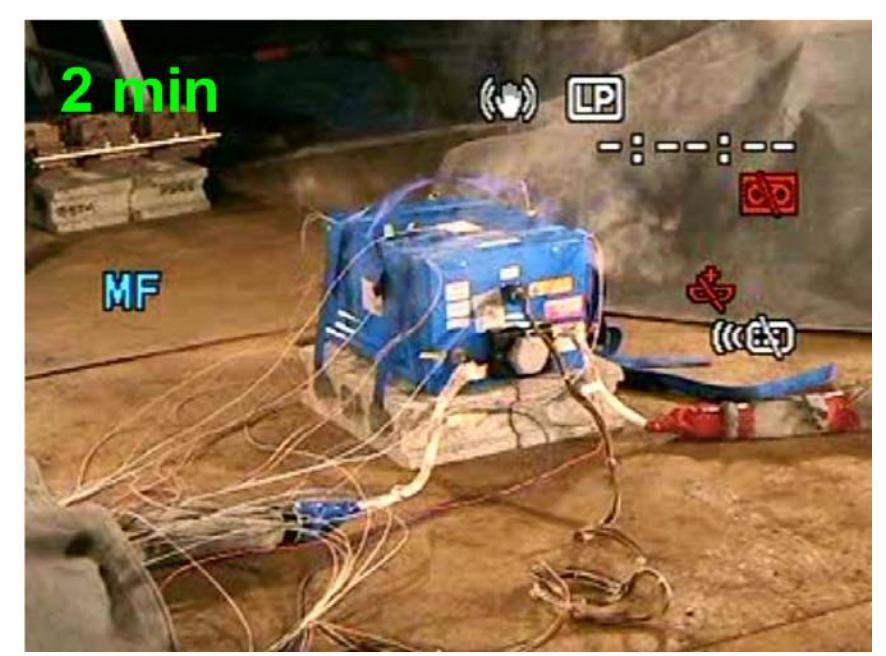
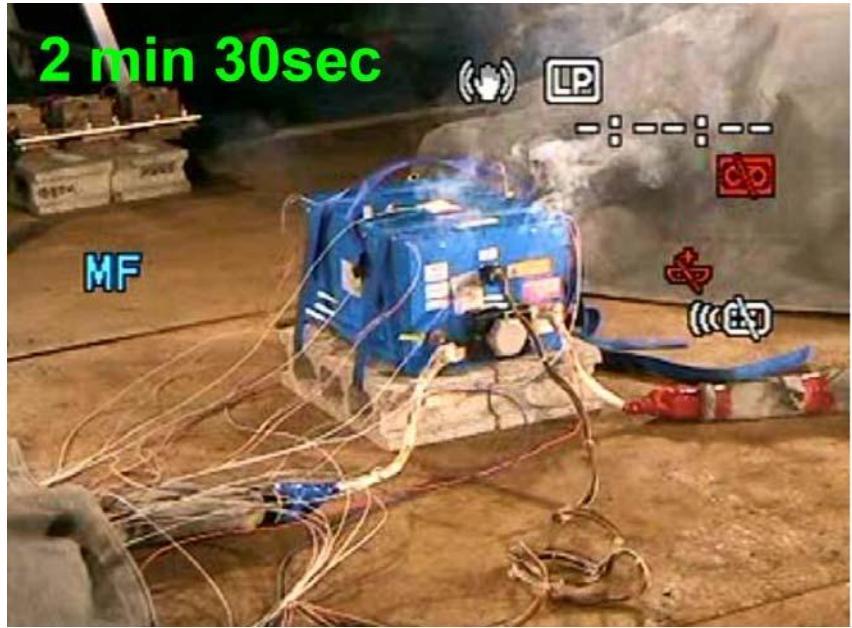
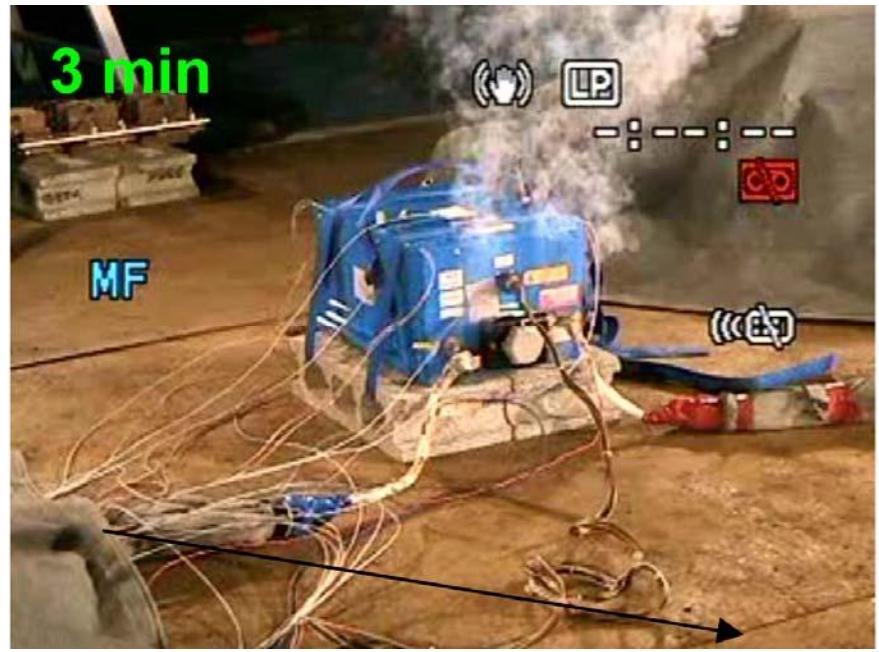
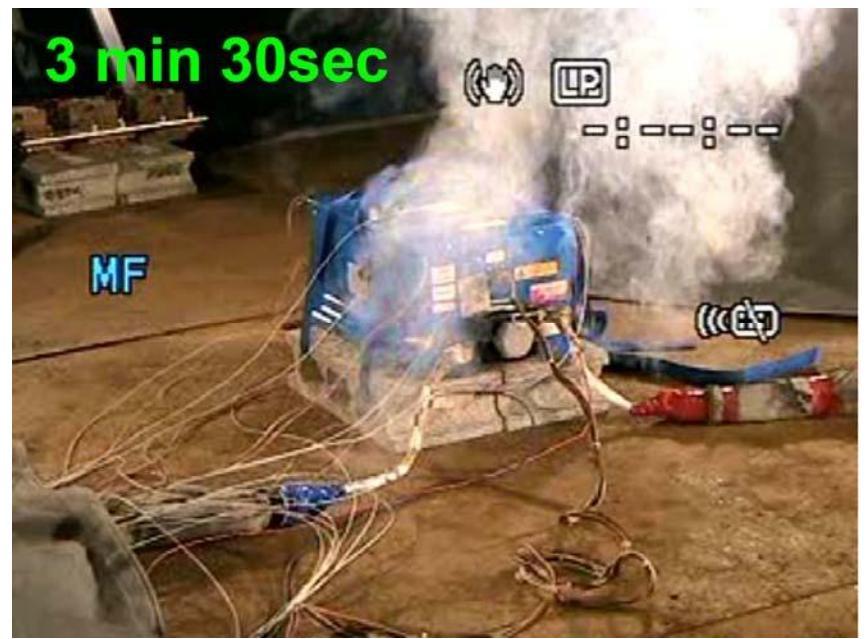
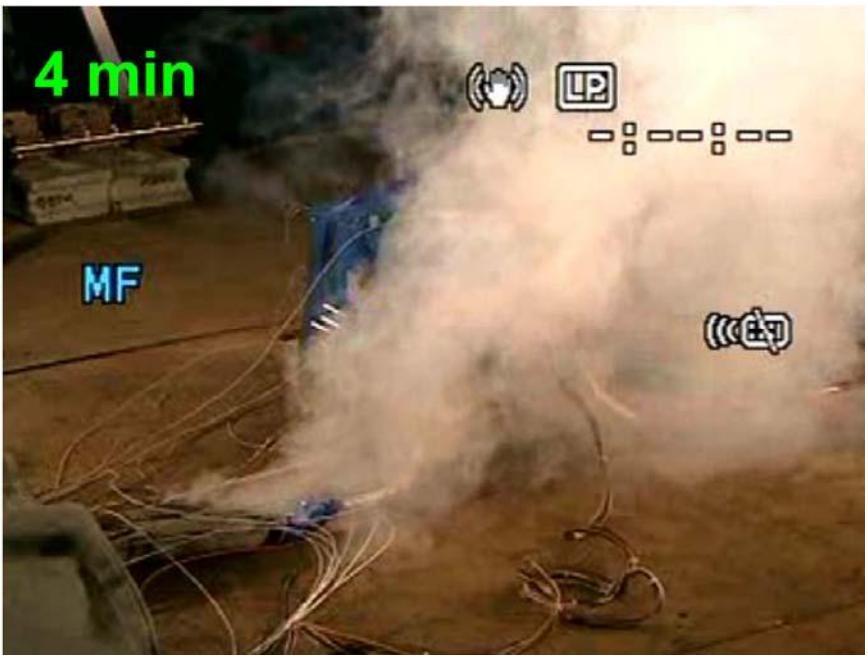
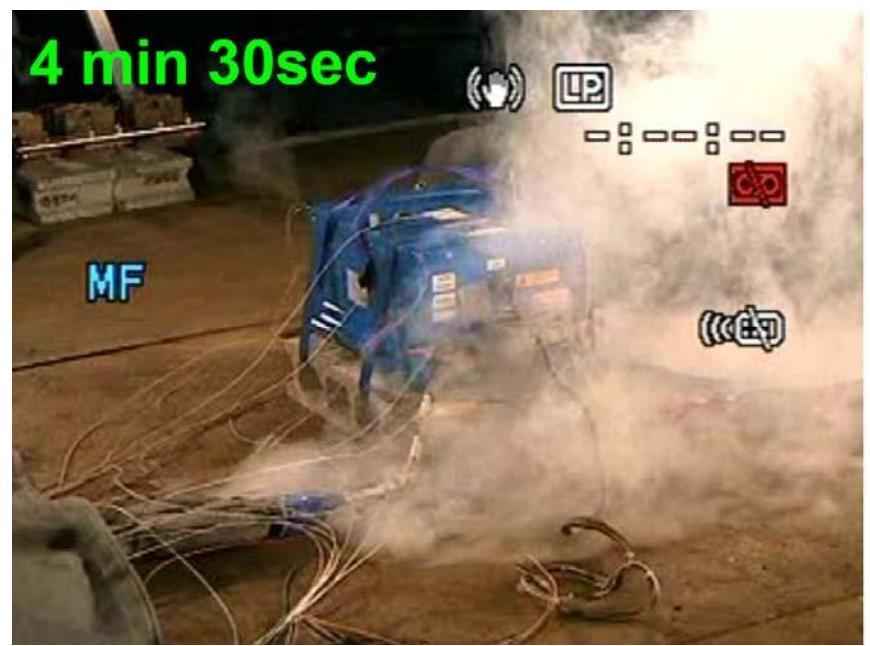
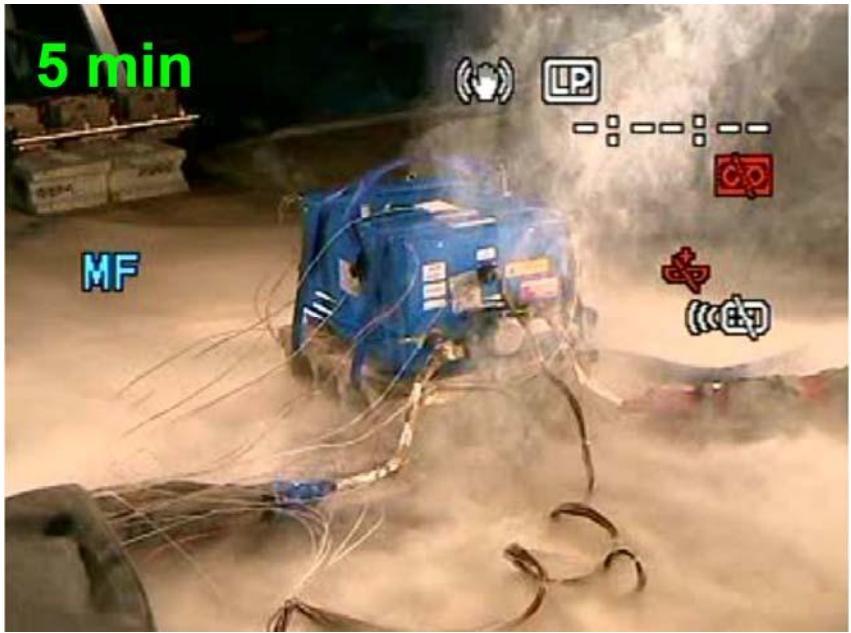
[Figure 39] Two minutes after start of test.

[Figure 40] Two and a half minutes after start of test.

[Figure 41] Three minutes after start of test.

[Figure 42] Three and a half minutes after start of test.

[Figure 43] Four minutes after start of test.

[Figure 44] Four and a half minutes after start of test.

[Figure 45] Five minutes after start of test.

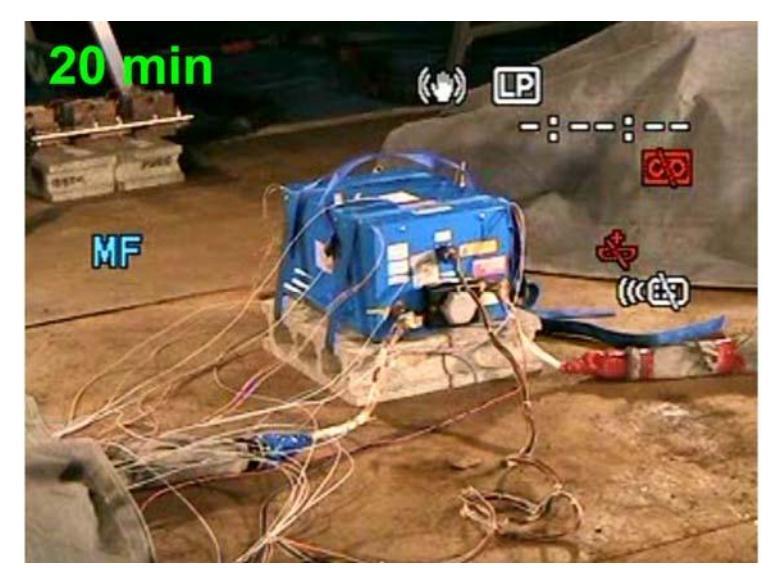
Fig. 7.13-9 The battery behavior during high impedance external short circuit test.

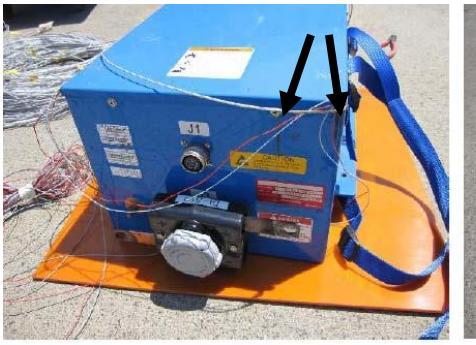
Front side of the battery box

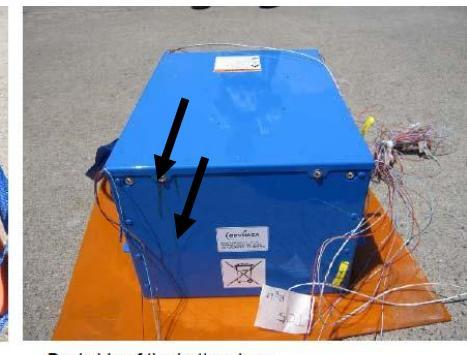
Backside of the battery box

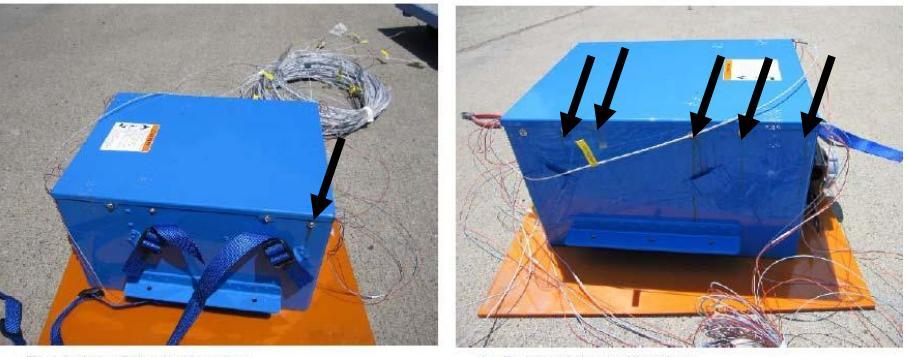
Right side of the battery box

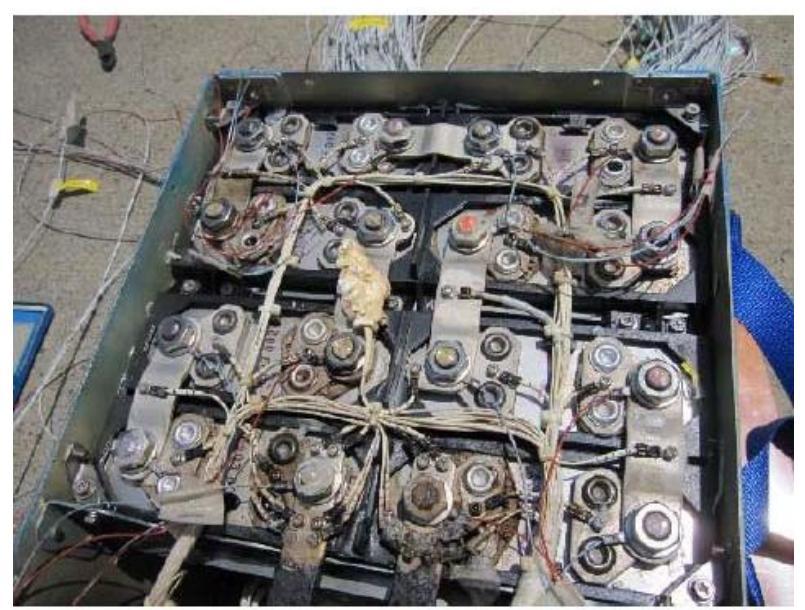
Fig 7.13-14 Tear down inspection after high impedence short circuit of the battery. Addendum Figure 48. Appearance of the top of the battery after short circuit test.

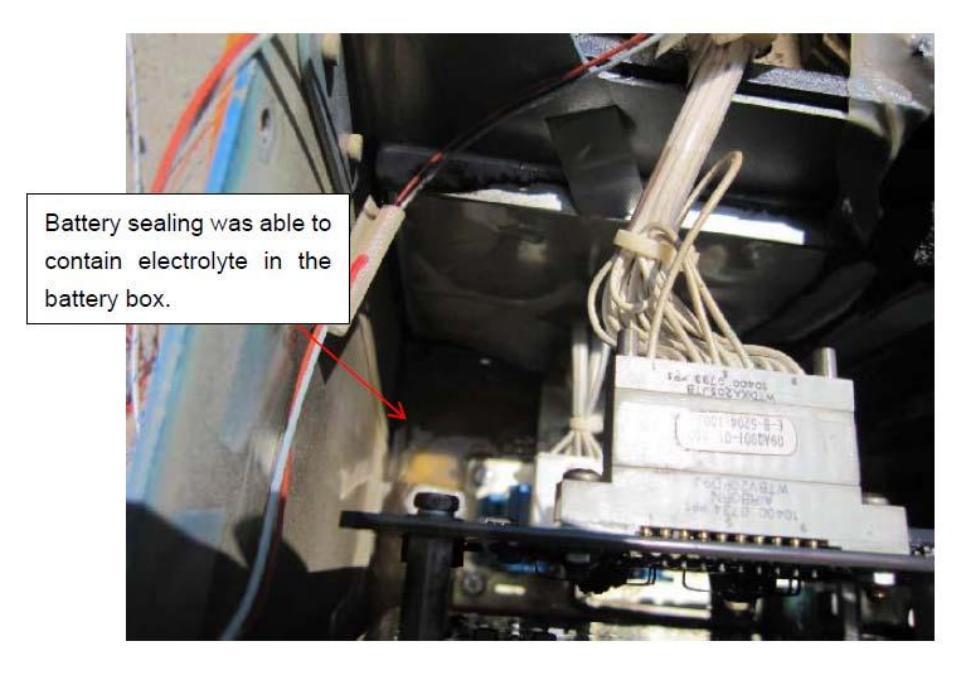
Fig. 7.13-16 Appearance of the front side of the battery box Addendum Figure 49. Appearance of battery box interior after test.

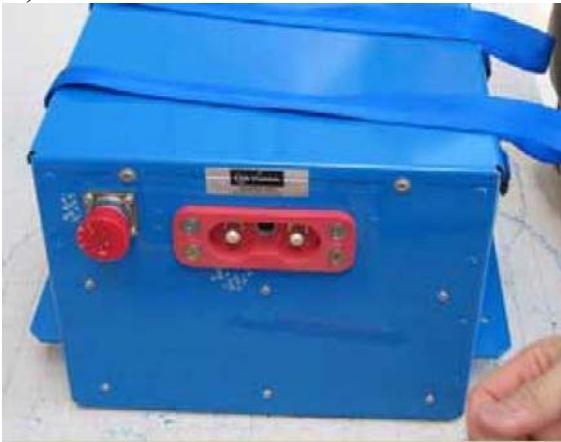
Figure 50. Exterior of LVP65-8-400 battery (B3856-800)

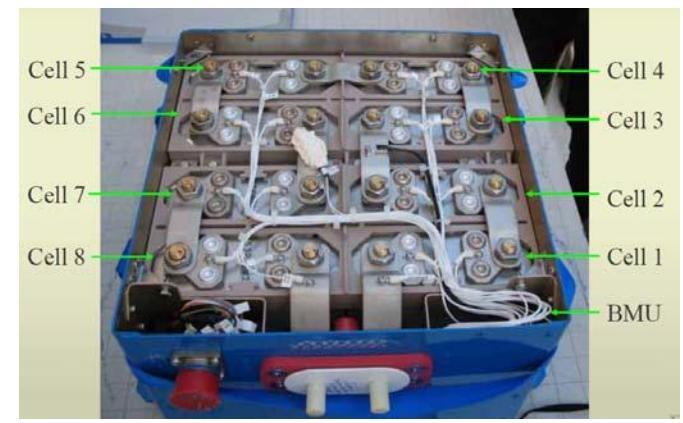
Figure 51. Cell and BMU arrangement in LVP65-8-400 battery (B3856-800). Note early cell numbering reversed to current nomenclature.

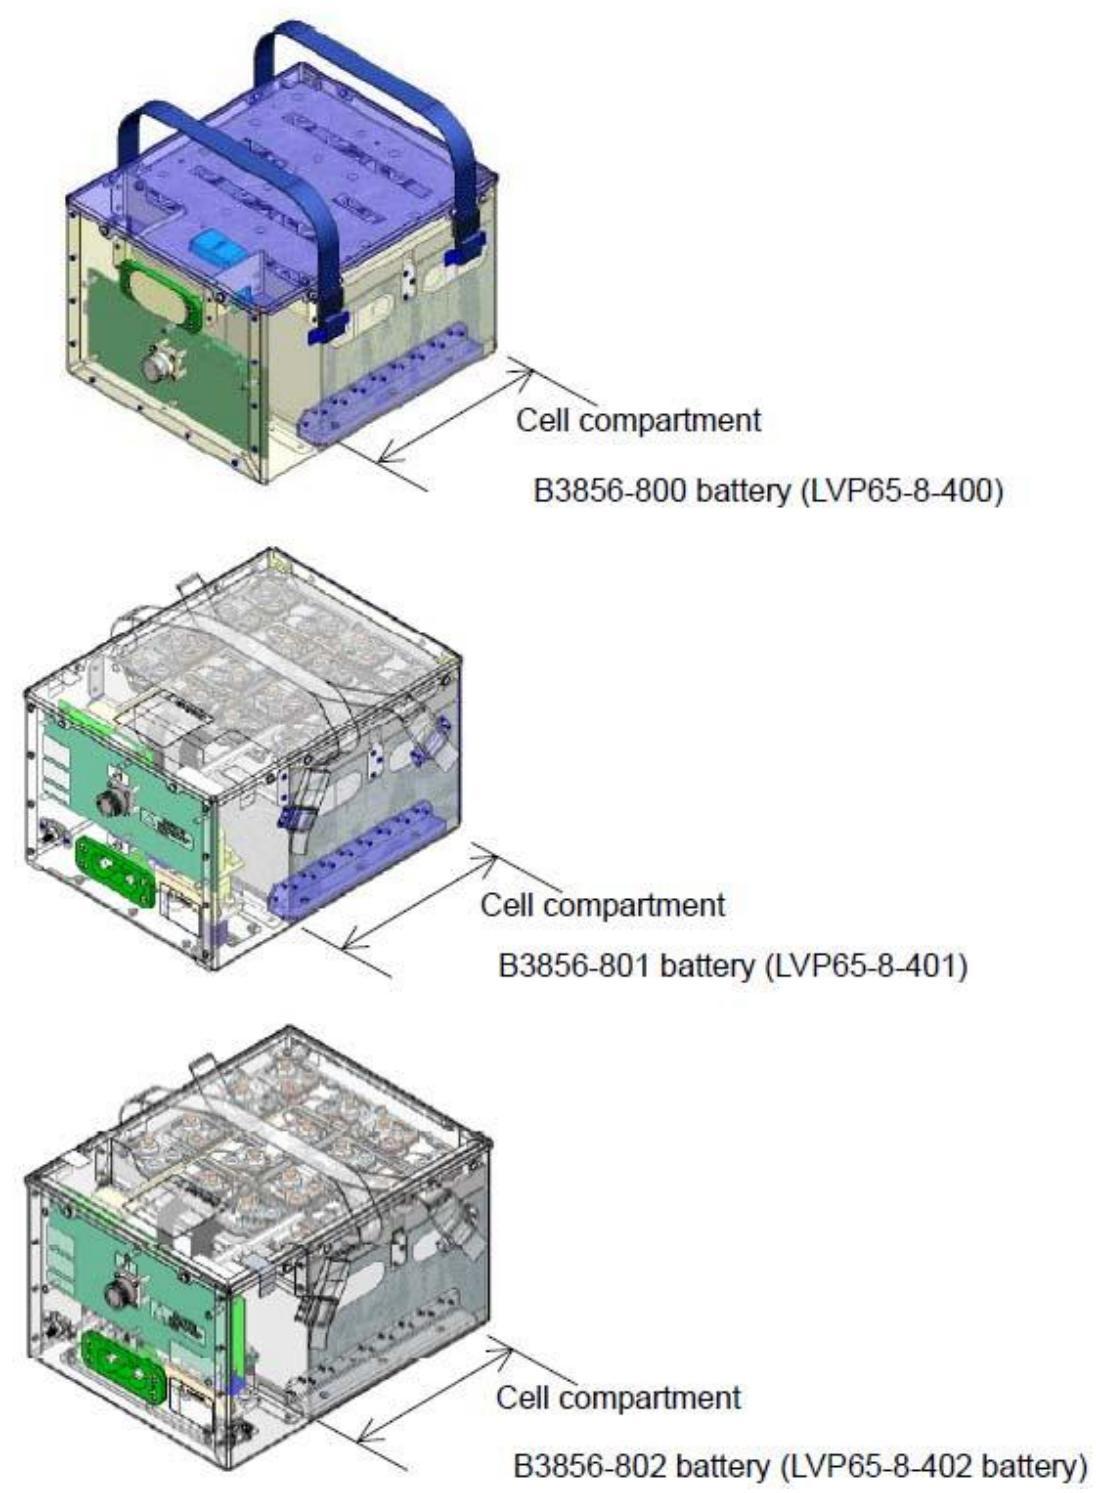
Figure 52. Evolutionary development of the LVP65 series battery from top to bottom.

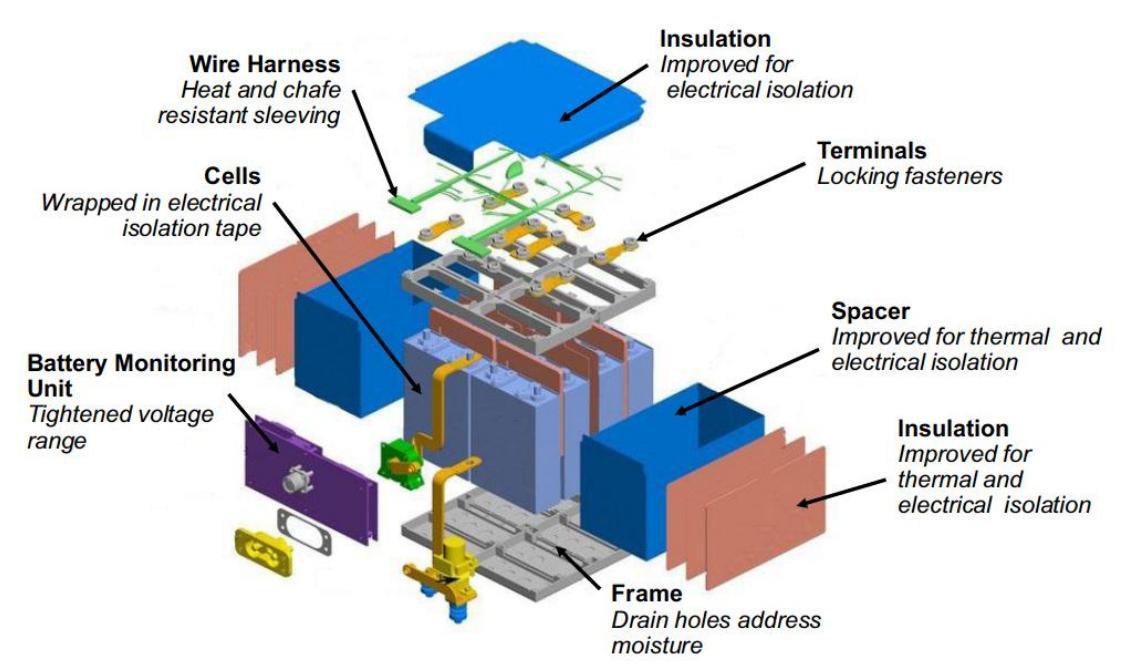
Figure 53. Battery design modifications for LVP65-8-403 configuration. Source: Boeing

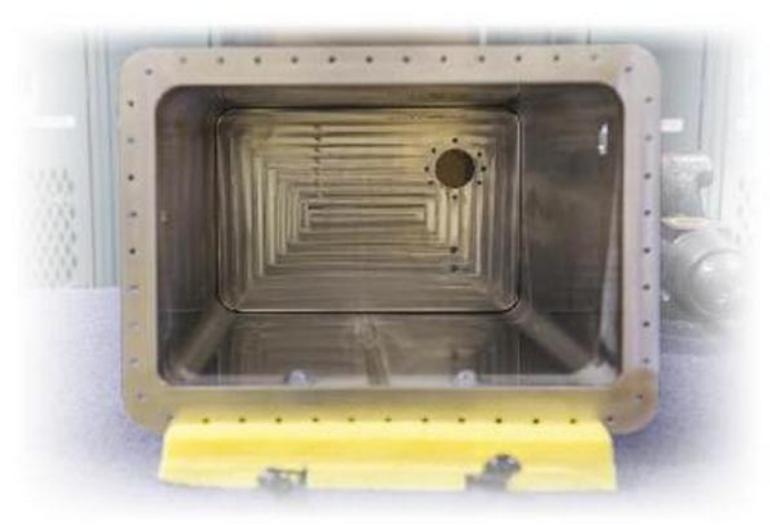
Figure 54. Redesigned battery mounting and enclosure. The hole in the rear of the case is where potential vented cell materials would pass through a rupture disc then a tube to go overboard. Source: Boeing

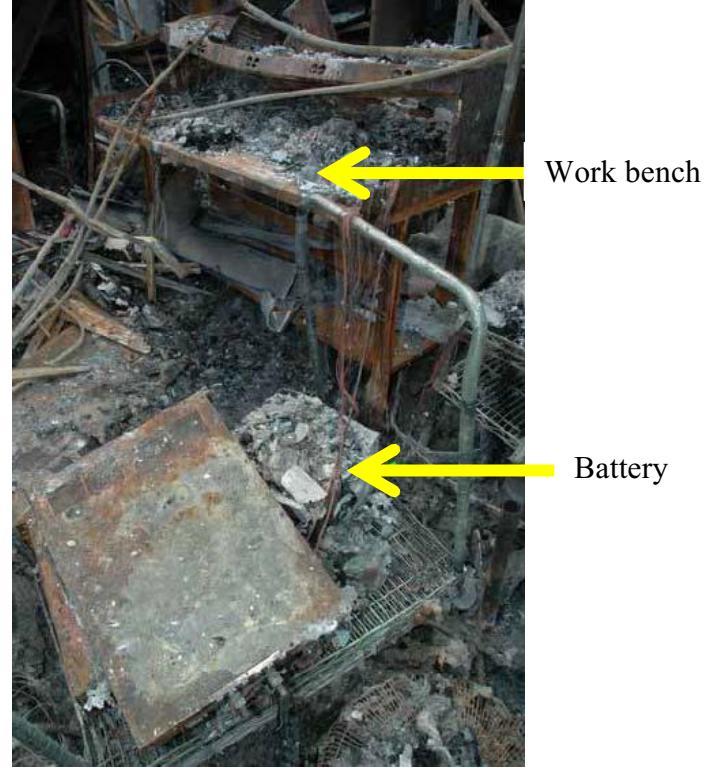
Figure 56. Work station and destroyed battery.

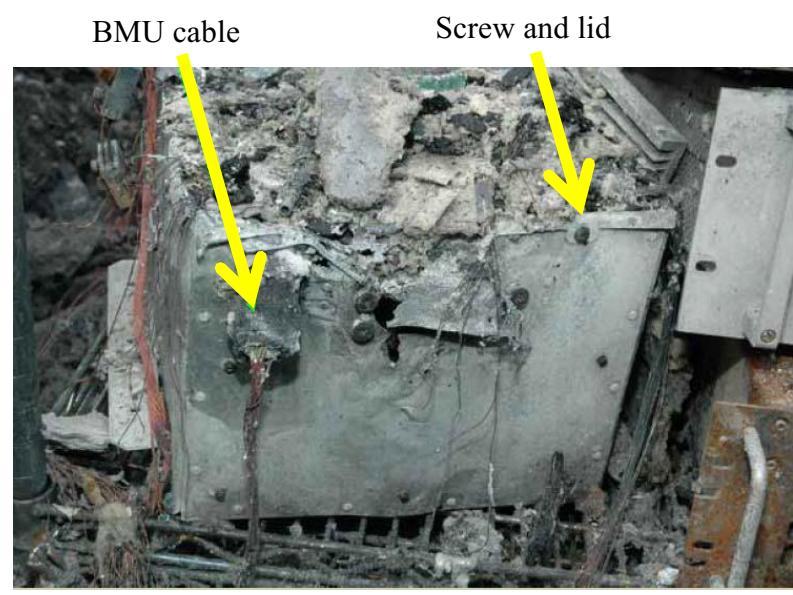
Figure 57. Remnant of battery under test at time of Securaplane fire.

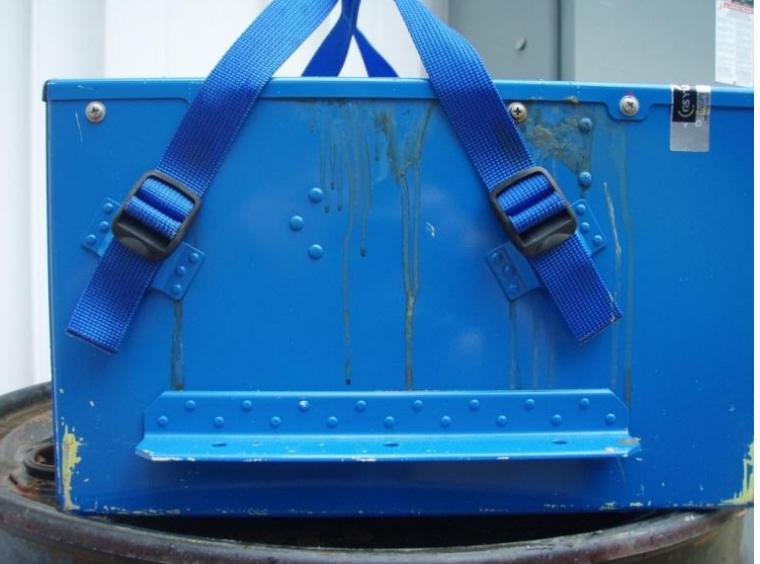
Figure 58. The leakage of electrolyte from beneath the lid of the battery that failed at the APSIF laboratory.

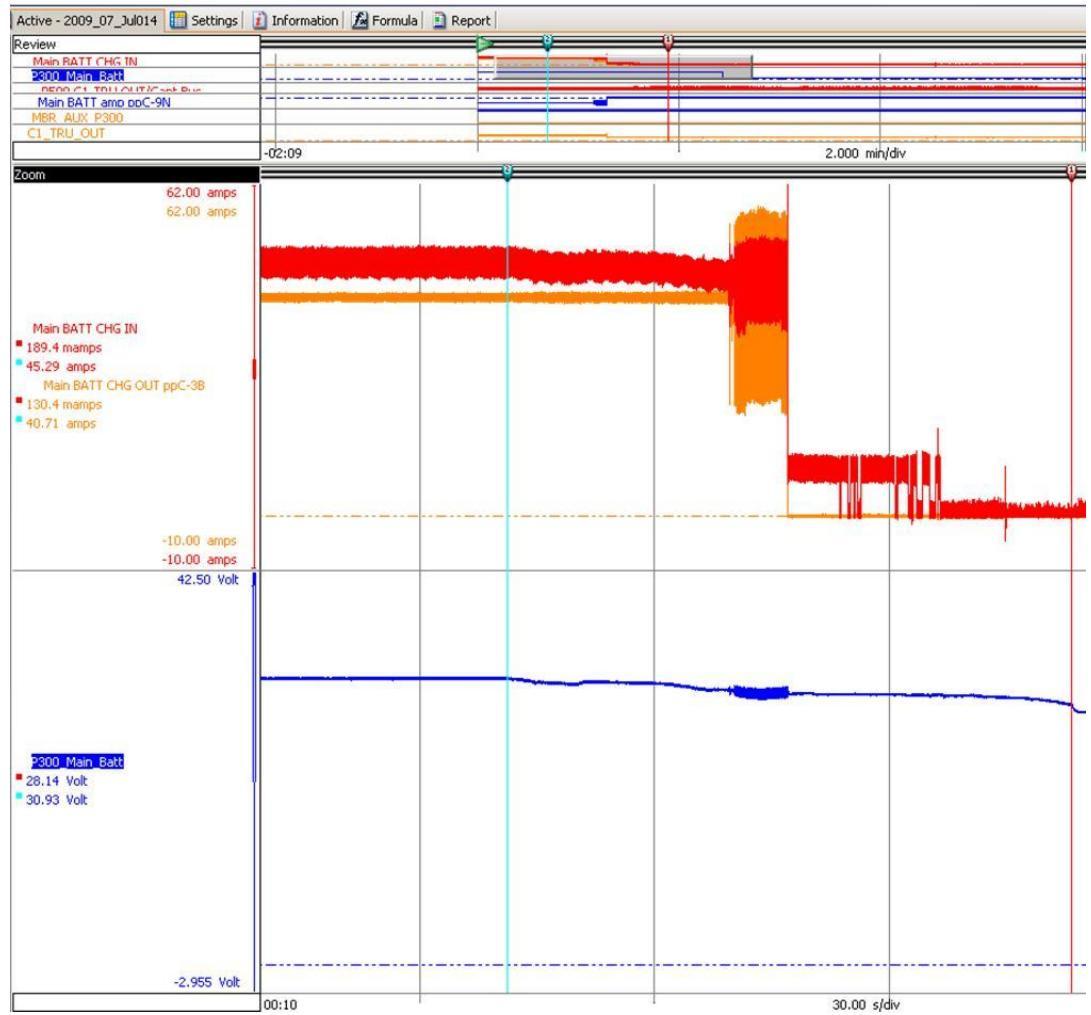
Figure 59. Electrical voltage reduction and fluctuations recorded during the APSIF battery failure. Red and orange depict amperage. Blue depicts voltage.

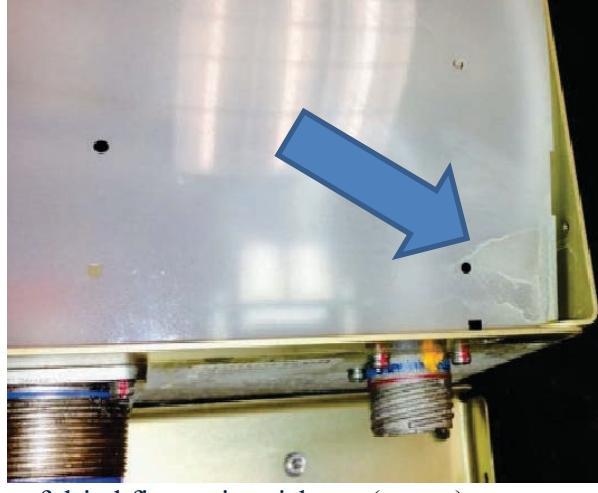
Figure 61. Evidence of dried fire extinguishant. (arrow)

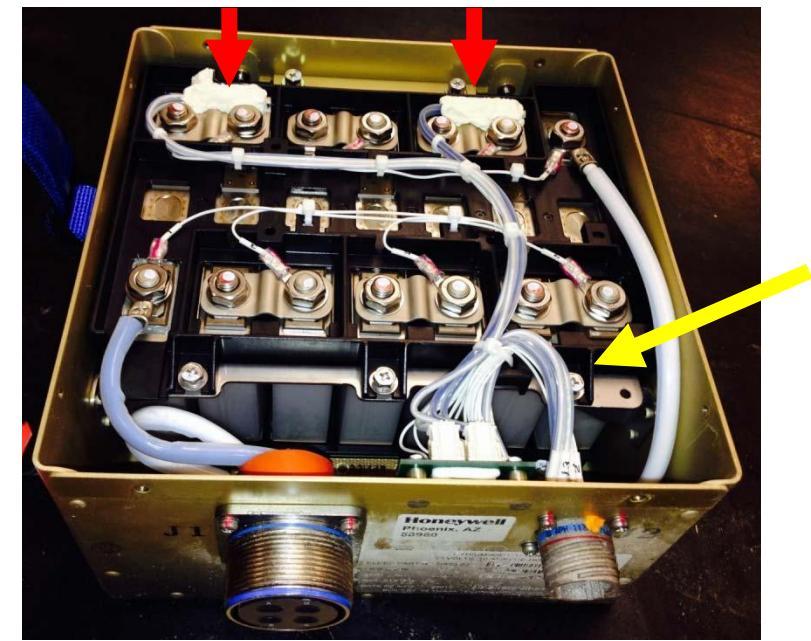
Figure 62. Chafe of wire on screw head found in FCE battery. (yellow arrow from right). Two temperature sensors. (Two arrows from top)

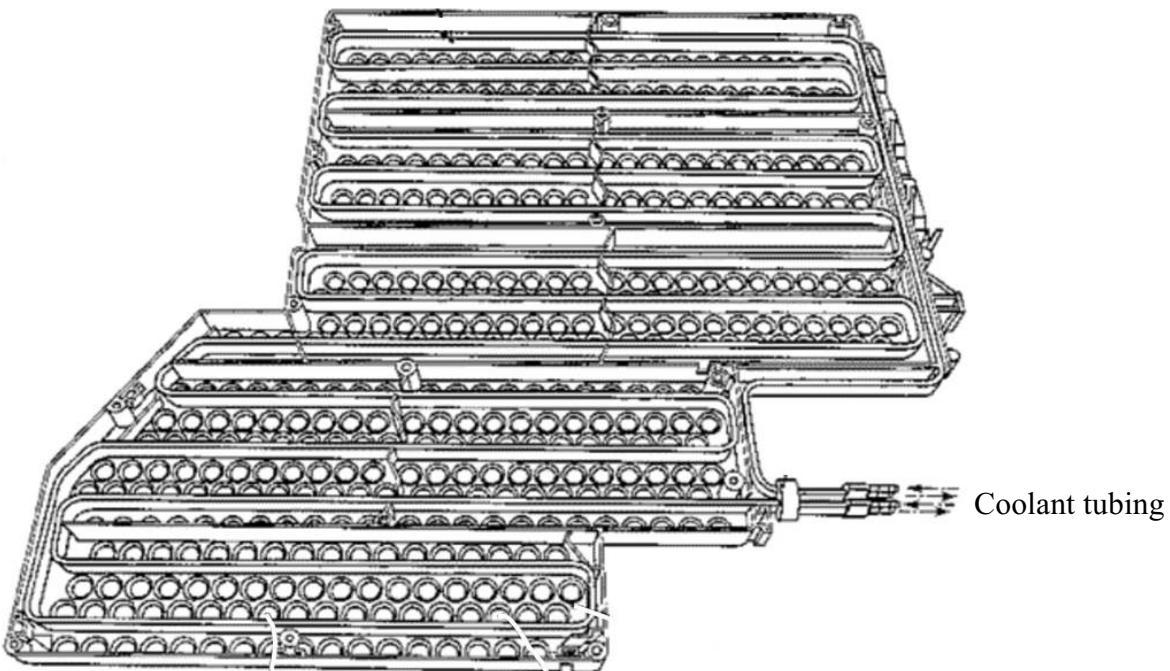
Figure 63. Cooling tubes pass each cell in this automotive battery.
