Personal Locator Devices: Improve Your Chance of Rescue

National Transportation Safety Board

Safety Alert • Personal Locator Devices

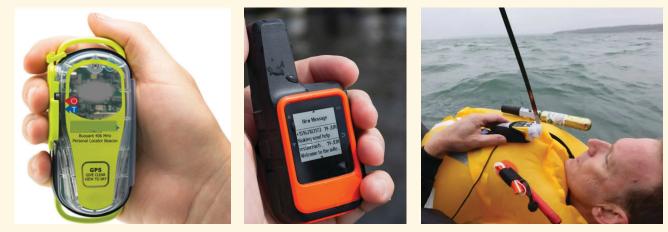
Figure 1. Exemplar PLB (*left*) and SEND (*center*), and PLB attached to lifejacket (*right*). (Sources: bluewatersailing.com [*left*], powerandmotoryacht.com [*center*], and Varen [*right*]).

- Determine the best type of personal locator device for your crew. Some devices transmit via satellite, while others transmit on terrestrial frequencies. Not all devices notify the Coast Guard directly.
- Provide each crewmember a personal locator device and ensure they carry it. Devices can be worn in a zipped clothing pocket or a bag attached to a belt or attached to personal flotation devices.
- Register each crewmember's personal locator device with the appropriate organization. PLBs must be registered through the National Oceanic and Atmospheric Administration, while SENDs and other similar devices should be registered through the manufacturer or operating company.
- Ensure crewmembers are aware of the capabilities and limitations of their personal locator devices and understand how to operate their devices, as well as how each type transmits location information.
