Aluminum Propeller Blades: Prevent Fractures with Proper Inspections and Maintenance

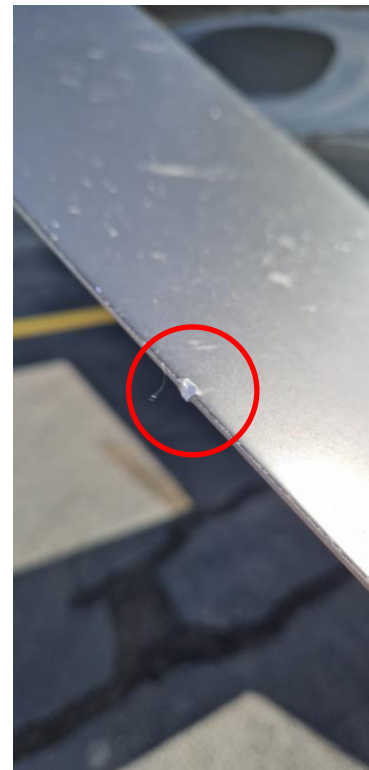
- Aluminum propeller blades can be susceptible to fatigue cracking and fracture if a small nick, pit, or corrosion on the surface or edge is not found and repaired during preflight inspection or maintenance. Such damage can concentrate stress from normal airplane operation loads, resulting in fatigue crack initiation and growth followed by propeller blade fracture. Aluminum is more commonly used for airplane propeller blades than composite propeller blades or wood.
- Fatigue cracking and fracture of a propeller blade can lead to airframe and engine damage and a possible loss of control.
- Airplanes that are used for aerial application and coastal operations may be at higher risk for propeller blade damage because they can be exposed to chemicals or salt-laden moisture, which can cause corrosion that leads to a propeller blade fracture from fatigue cracking.

Figure 1. Nick in aluminum propeller blade. (Source: Hartzell Propellers)

- **During preflight inspections, inspect all areas of the propeller blade for damage such as nicks or corrosion. Include the back/face side of the blade and pay particular attention to the leading edge. Refer any findings to a qualified mechanic for inspection and repair before further flight.**
- **Following any propeller work, have a second person inspect the work. If any propeller blades need to be repaired, ask another mechanic to inspect the work if they are available or inspect the work yourself. Depending on the type of repair, another pilot may also be able to inspect the work.**
- **Consider increasing the frequency of propeller blade inspections by maintenance personnel for airplanes that are used for backcountry, aerial application, and coastal operations because they may be at higher risk for propeller blade damage.**

- Always properly and comprehensively inspect aluminum propeller blades:
 - Follow the maintenance manual and use appropriate checklists.
 - Inspect all areas of the propeller blade, including the back/face side of the blade, and pay particular attention to the leading edge.

- Inspect the propeller blades section by section; consider marking off sections of large propellers to ensure complete coverage.
 - Use the best possible light and at least 10 times magnification for any questionable areas (as indicated in [Advisory Circular \(AC\) 43.13-1B section 5-18](#)).
