PRELIMINARY REPORT

MARINE

DCA18MM028

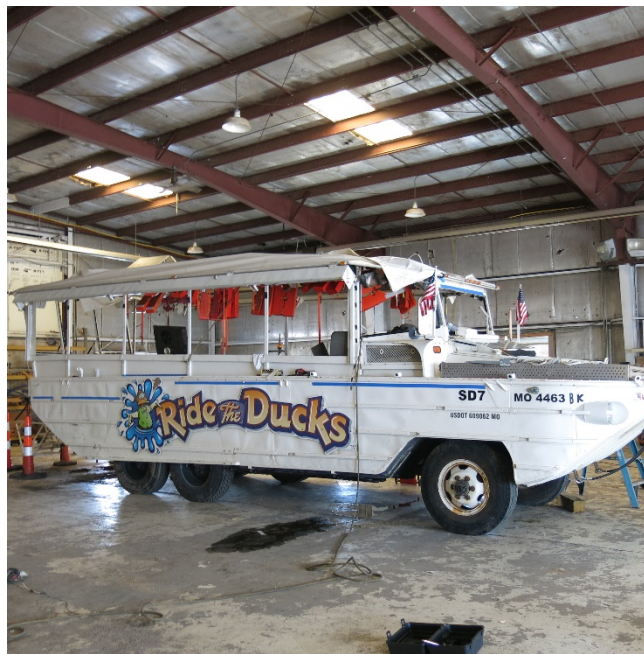
Postaccident photo of *Stretch Duck 7*.
