PRELIMINARY REPORT

HIGHWAY

HWY17MH005

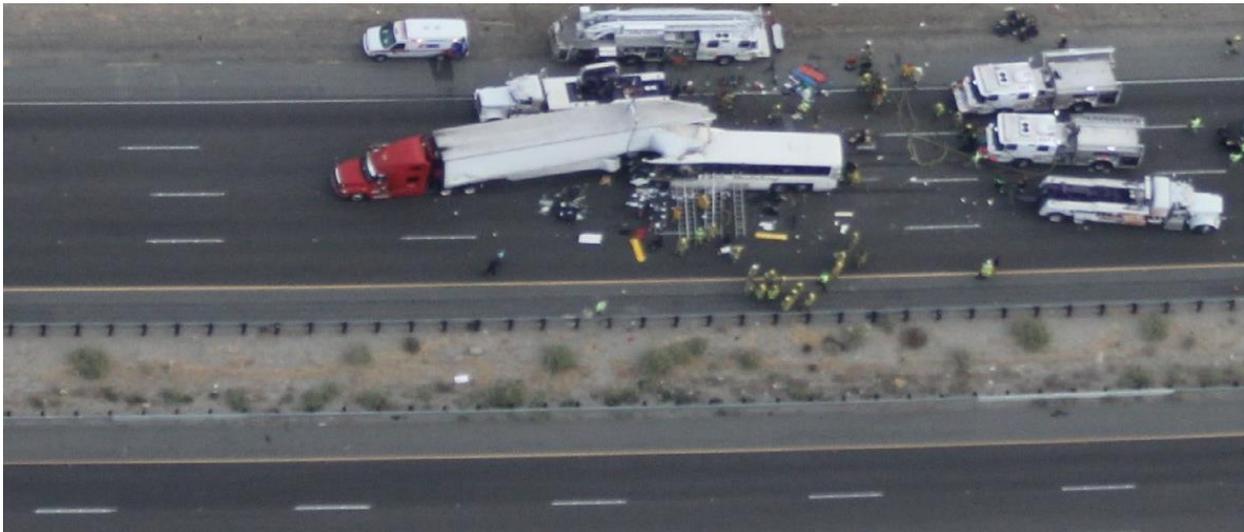
Figure 1. Aerial view of the truck tractor and semi-trailer and the motorcoach at final rest in the center right lane, (Source: California Highway Patrol).

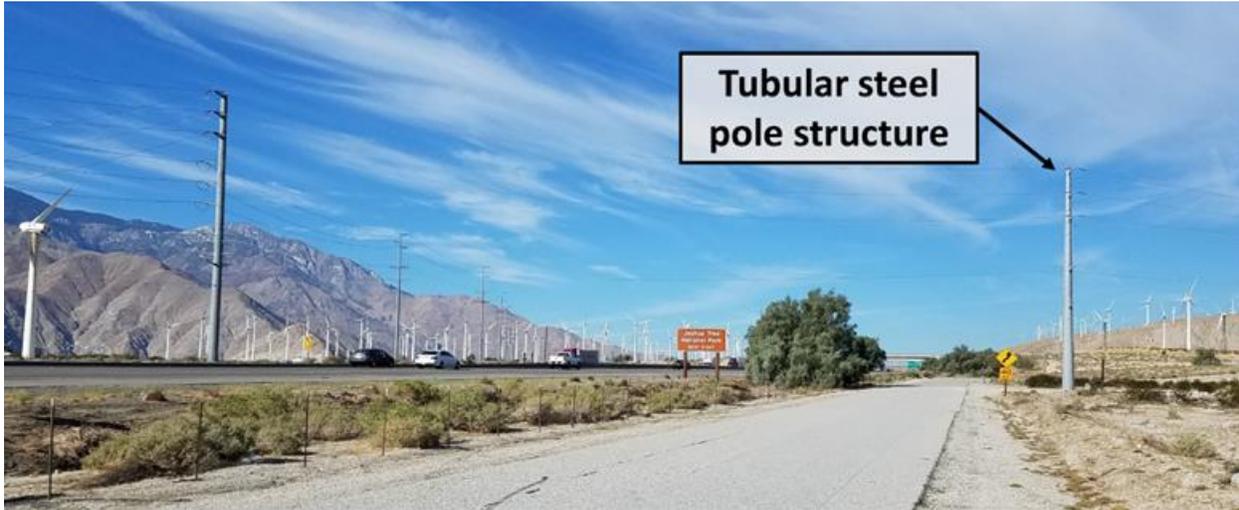
Several minutes before the crash, east and westbound traffic queues had formed as a result of utility work that Southern California Edison Company was performing over I-10. The work consisted of moving electrical wires that crossed the road from a wooden pole structure to a steel pole, (see figure 2). California Highway Patrol (CHP) conducted simultaneous traffic breaks for east and westbound traffic to facilitate the work.

Figure 2. Westbound view of the new tubular steel pole structure at the intersection of the northwest corner of 20th Avenue and Diablo Road.
