Selected Issues in Passenger Vehicle Tire Safety

Special Investigation Report

NTSB/SIR-15/02
PB2016-100009

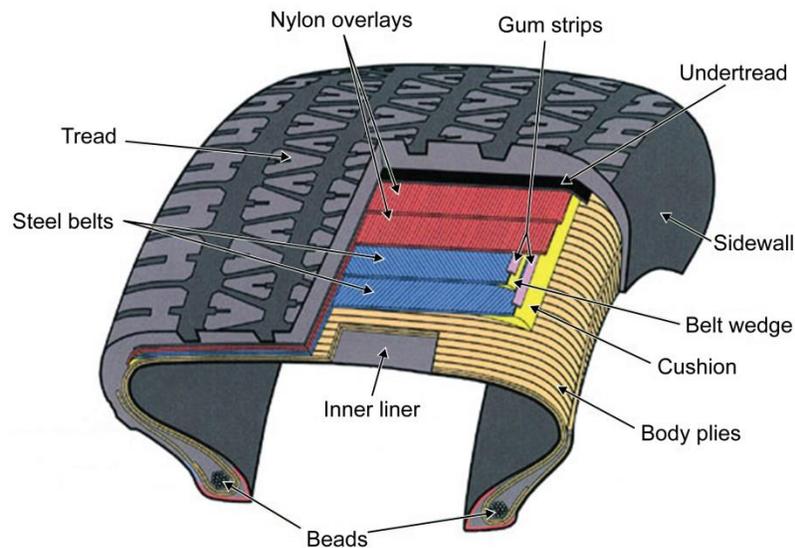
Figure 1. Cross-section of a passenger vehicle tire, indicating the locations of structural components.

This section provides background on tire structure to help the reader understand the factors that can lead to tire failure (Gent and Walter 2006). It focuses on radial tires, which account for virtually all the passenger vehicle tires sold in the United States.⁵

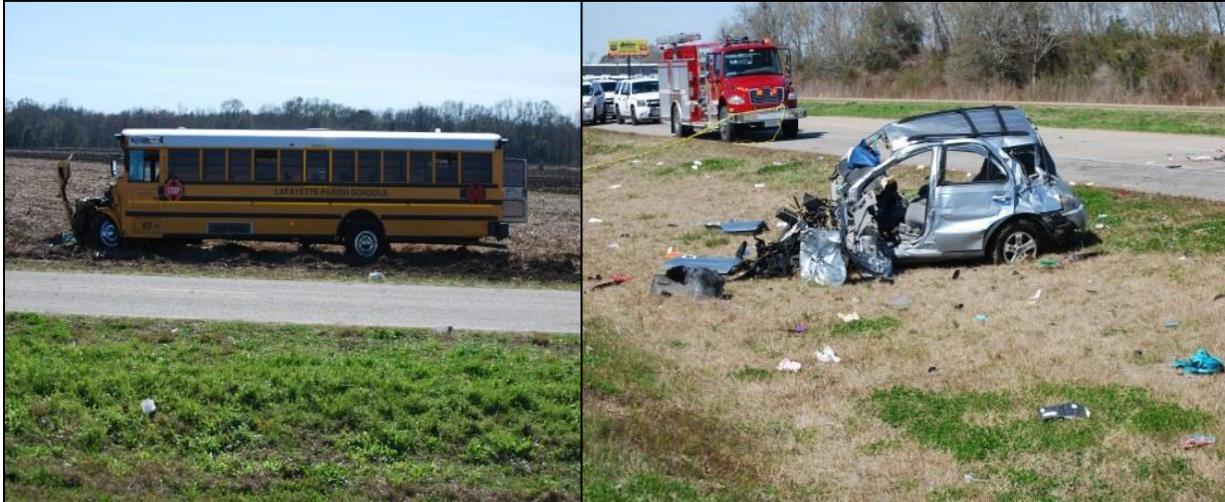
Figure 2. Centerville school bus and SUV at final rest. (Source: Louisiana State Police)

Based on the evidence, the NTSB established that the probable cause of the Centerville, Louisiana, crash was the Kia SUV driver's loss of control due to the tread separation and rapid air loss of the left rear tire, which altered vehicle-handling characteristics. Contributing to the crash was the deteriorated condition of the tire due to inadequate maintenance.

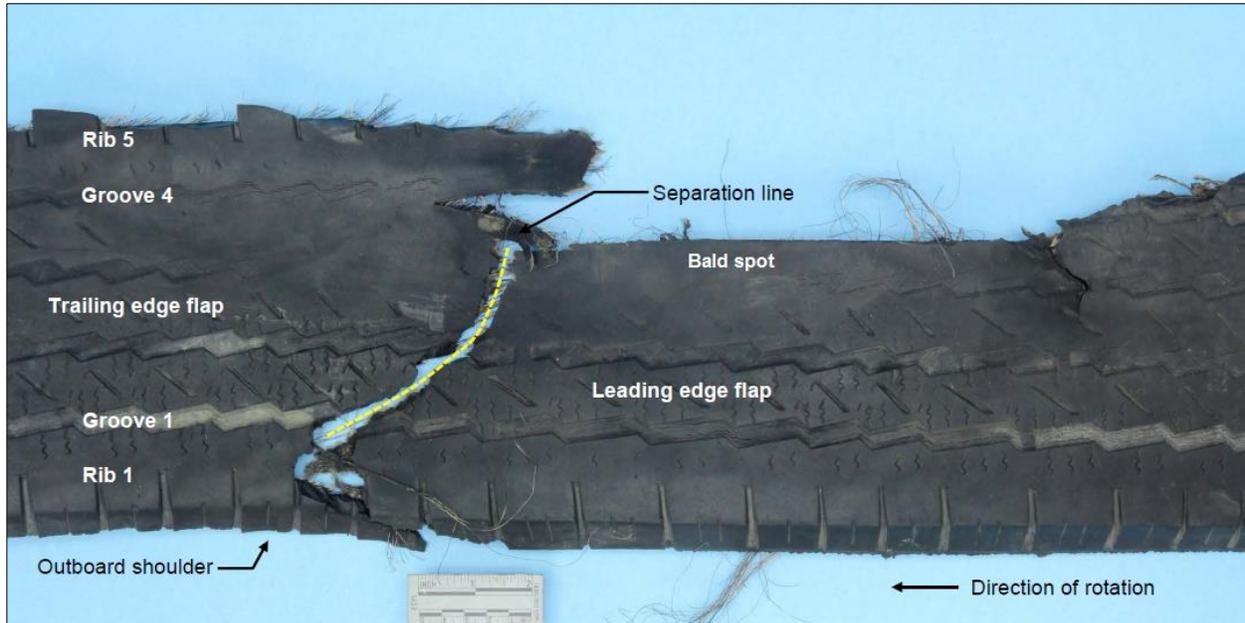
Figure 3. Delaminated tread from the left rear tire of the Centerville SUV. The two flaps created by the tear are in their approximate pre-separation positions. A narrow section of tread is missing near the location of a bald spot in the tire.

¹¹ The “leading edge flap” is the side of the tread that forms a triangular wedge of tread pointing toward the direction of rotation, as indicated in figure 3.

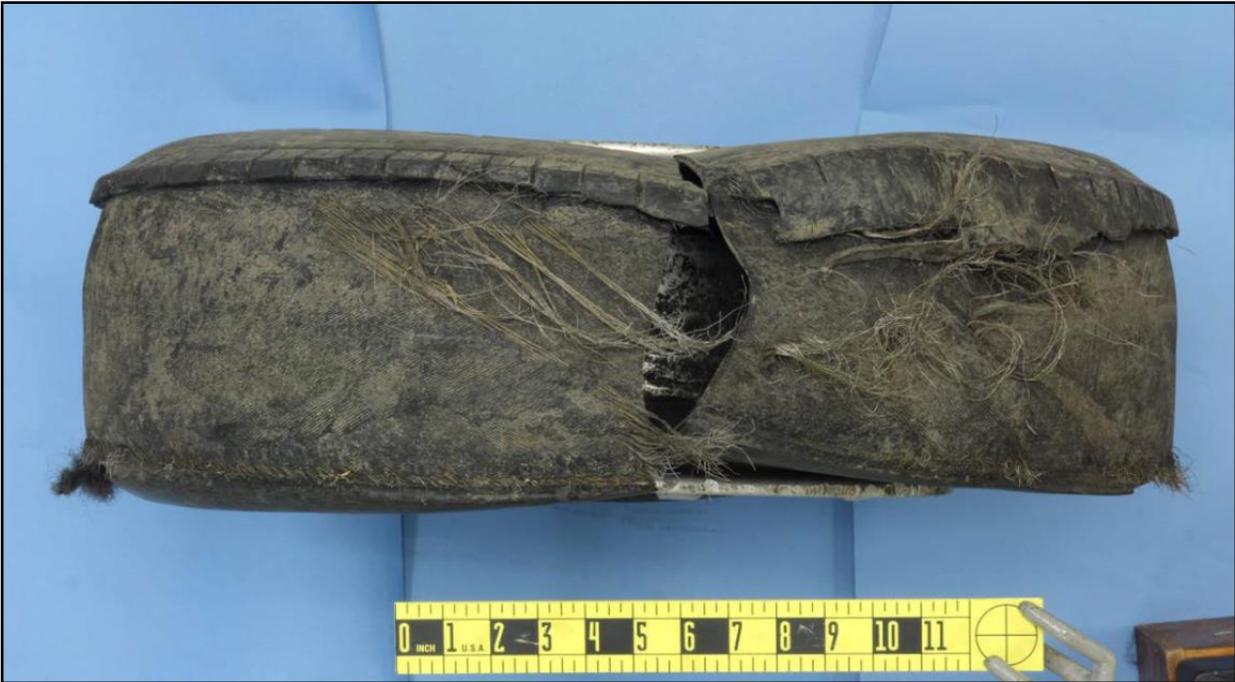
The tread separated from the tire carcass near the bald spot. The tread separation started as a delamination between the inner and outer steel belts on the inboard side of the tire.¹⁰ Over time, the delamination formed a thumbnail-shaped pocket between the belts, which extended along the shoulder of the tire. The difference in treadwear between the delaminated region and the remainder of the tread indicates that the pocket was probably present for at least hundreds, if not thousands, of miles. Additional delamination formed along the outboard shoulder and progressed toward the inboard shoulder. The tread separated from the tire when the delaminations merged. The tire carcass subsequently split in the radial direction (from the outboard to the inboard shoulder), and the tire lost pressure. (See figure 4.)

Figure 4. Detreaded tire carcass from the Centerville SUV.

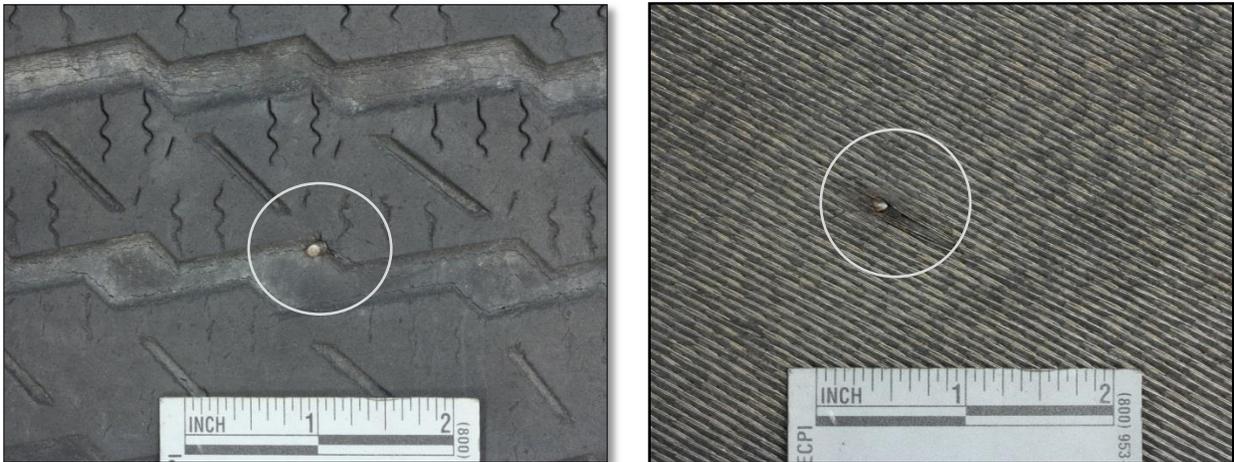
Other physical damage to the subject tire included three foreign objects that penetrated the tread and the outer steel ply. One object, found approximately 46 inches clockwise from the tip of the leading edge flap, is shown in figure 5.¹¹ The steel wires in the outer ply were deformed where the objects had penetrated the tread.

Figure 5. Tread image (left) and separation side image (right) of a foreign object that penetrated the Centerville SUV tire's tread approximately 46 inches from the separation. (Area of object penetration is circled on both images.)

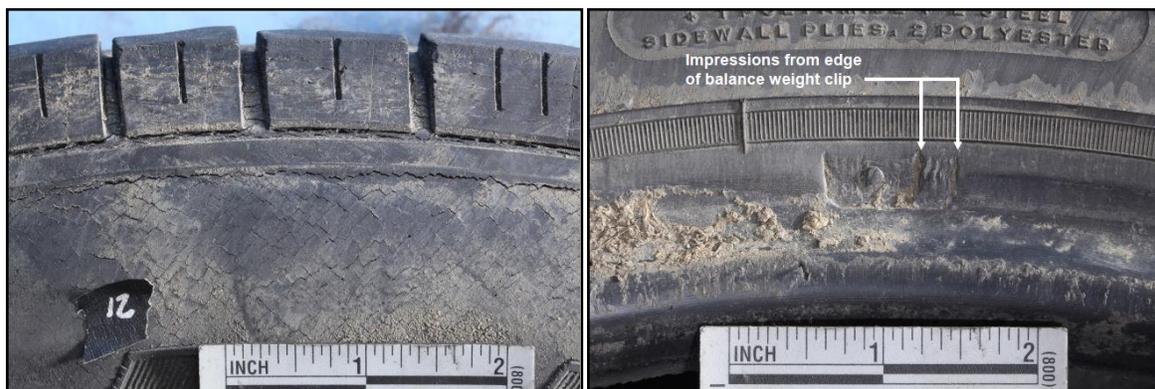
Additionally, there were compression set marks on the outboard sidewall and cracking along the sidewall and shoulder area (see figure 6, left image). Cracking can occur due to overdeflection, the presence of foreign materials, ozone deterioration, loss of rubber elasticity over time, and high operating temperatures.¹² A wheel weight clip, which is a device used to balance the tire, left multiple impression marks near the bead on the inboard side of the tire (see figure 6, right image); this suggests that the tire had been operated in an underinflated condition during its lifetime, thereby allowing the weight to shift.

Figure 6. Centerville SUV tire; at left is the inboard sidewall exhibiting cracking on the sidewall, buttress, and shoulder; at right are the impressions left by the wheel weight clip near the bead on the inboard side of the tire.

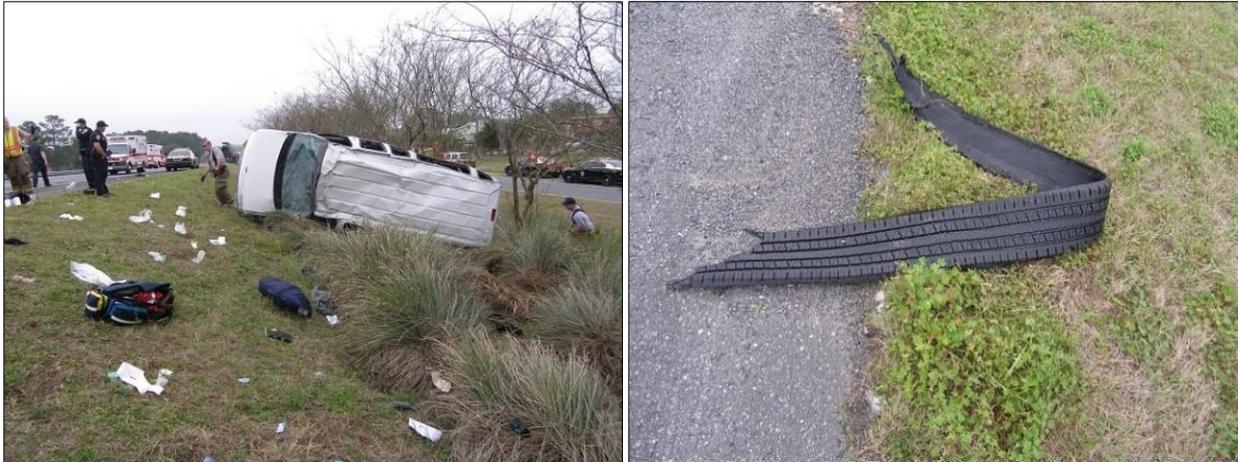
Figure 7. Lake City vehicle and tire; at left is a postcrash view of the 2002 Ford 15-passenger van at final rest on its left side, and, at right is the delaminated tire tread. (Source: Florida Highway Patrol)

Based on the evidence, the NTSB established that the probable cause of the Lake City, Florida, crash was the failure of the left rear tire due to a tread separation, which led to the loss of vehicle control. Contributing to the crash were the failure of the tire merchant to adhere to its training material and provide the purchaser with a tire registration form as required, and record-keeping discrepancies that inadvertently allowed an outdated address to be used in the recall notification process. Contributing to the severity of the injuries was the nonuse of available seat belts.

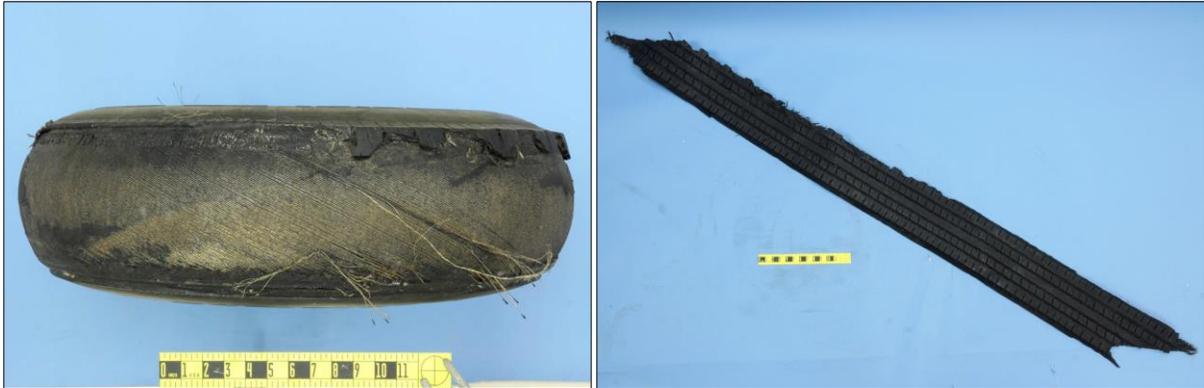
The subject tire was a BFGoodrich Commercial T/A all-season tire manufactured in the 47th week of 2011, making it about 2 years old at the time of the crash. (See figure 8.) The tire was among those recalled by Michelin, the parent company of BFGoodrich, on July 25, 2012. An examination of the tire showed that the tread separation initiated at a spot along its outer shoulder and developed into a thumbnail-shaped pocket between the inner and outer steel belts. As the initial separation grew in size, a second separation formed along the inner shoulder and expanded until it joined the initial separation. The tread separated from the tire shortly thereafter. The tire was examined for features consistent with overdeflection/underinflation, impact damage, or abuse prior to the separation, but none were found.

Figure 8. Carcass of left rear tire from the Lake City vehicle (left) and its delaminated tread (right).

The driver's perception of a vibration coming from one of the vehicle's tires shortly before the tire failure is consistent with the tread being pulled away from the tire and then being compressed between the tire and the road with each wheel revolution. Because the pocket was within the tire, the driver would not have seen any indication of it when he pulled over to inspect the tires. A postcrash inspection of the van revealed no damage within the left rear wheel well or to the surrounding fender panel that would have been consistent with repeated impacts by the separating tire tread.

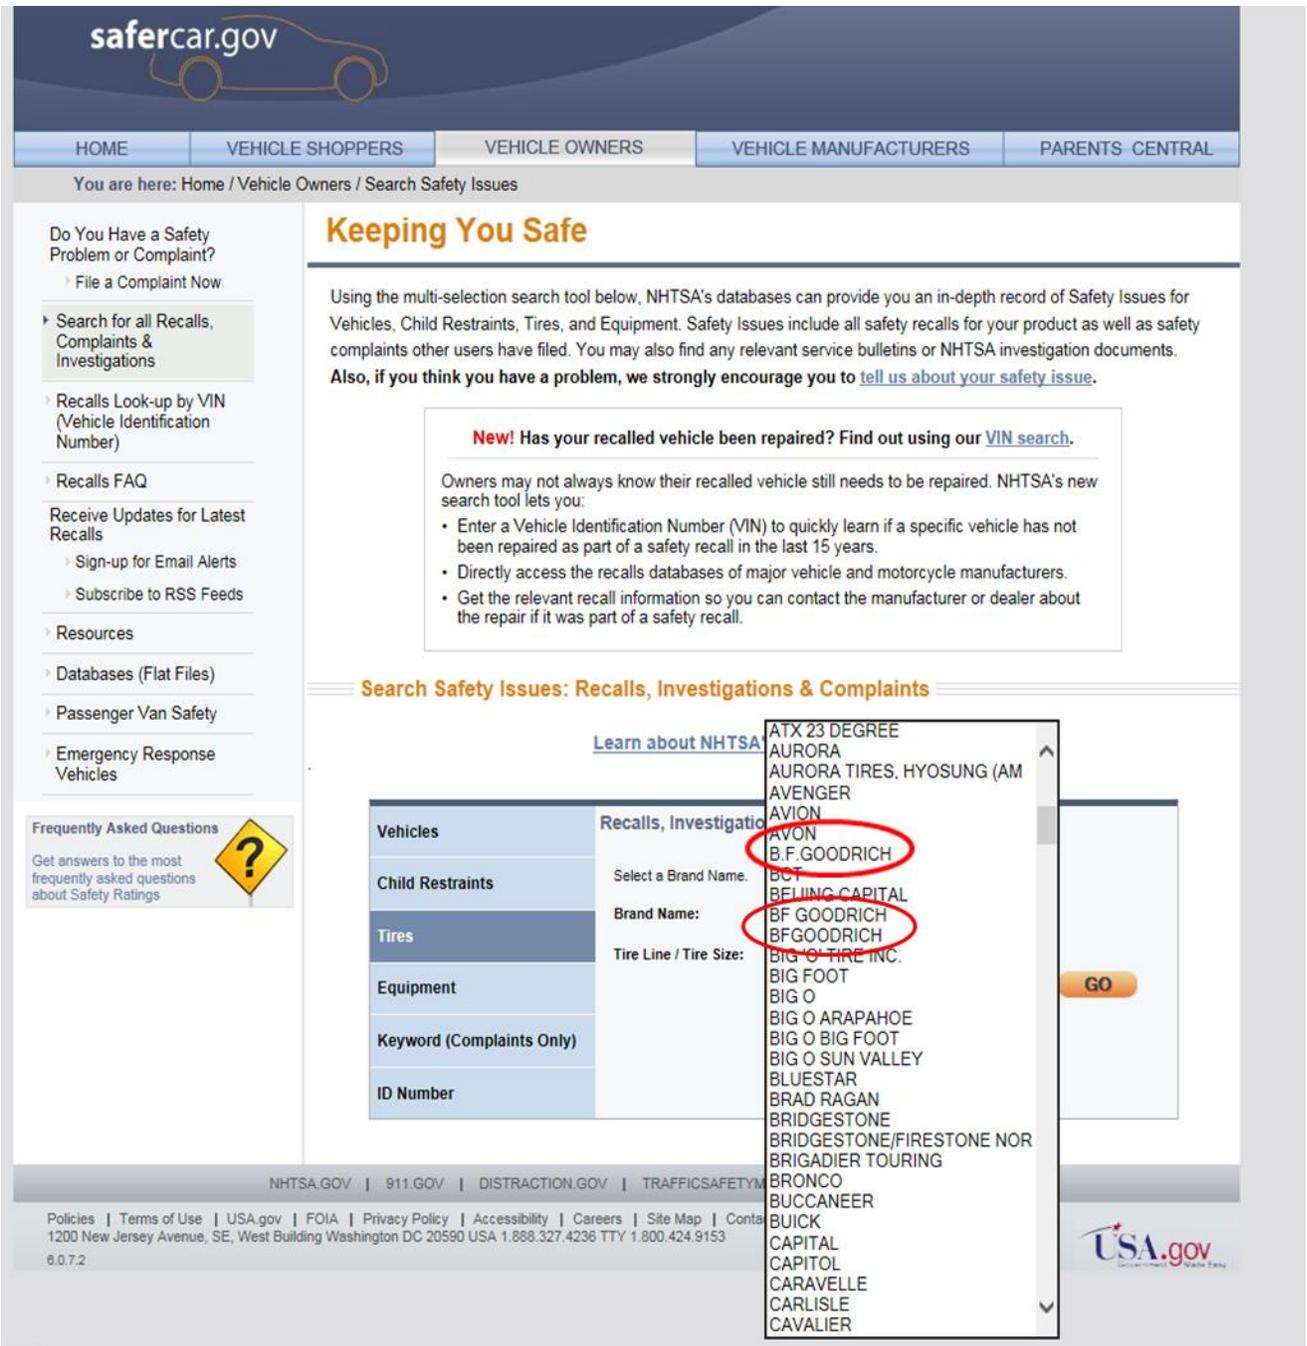
Figure 10. Tire manufacturer or brand name pull-down menu on the NHTSA recall search page, depicting multiple name stylings/spellings for one tire manufacturer.

For instance, a basic search by brand may return multiple results, depending on how the tire name appears in the NHTSA database. Although searches conducted through the NHTSA website provide access to all recalls, the consumer would need to recognize the tire description as provided in the defect information report, including the brand name, tire line, tire size, or other information that may have been used by the reporting manufacturer to describe the product. Although in most cases it is relatively simple to identify a tire brand on the NHTSA website, some manufacturers are listed multiple times due to variations in the spelling and styling of their names. Links from the differently provided names often return different search results (see figures 10 and 11), which reduces the effectiveness of the search tool. The NTSB concludes that the tool for conducting tire recall searches on the NHTSA website is confusing and could cause consumers to erroneously determine that their tires are not among those being recalled.

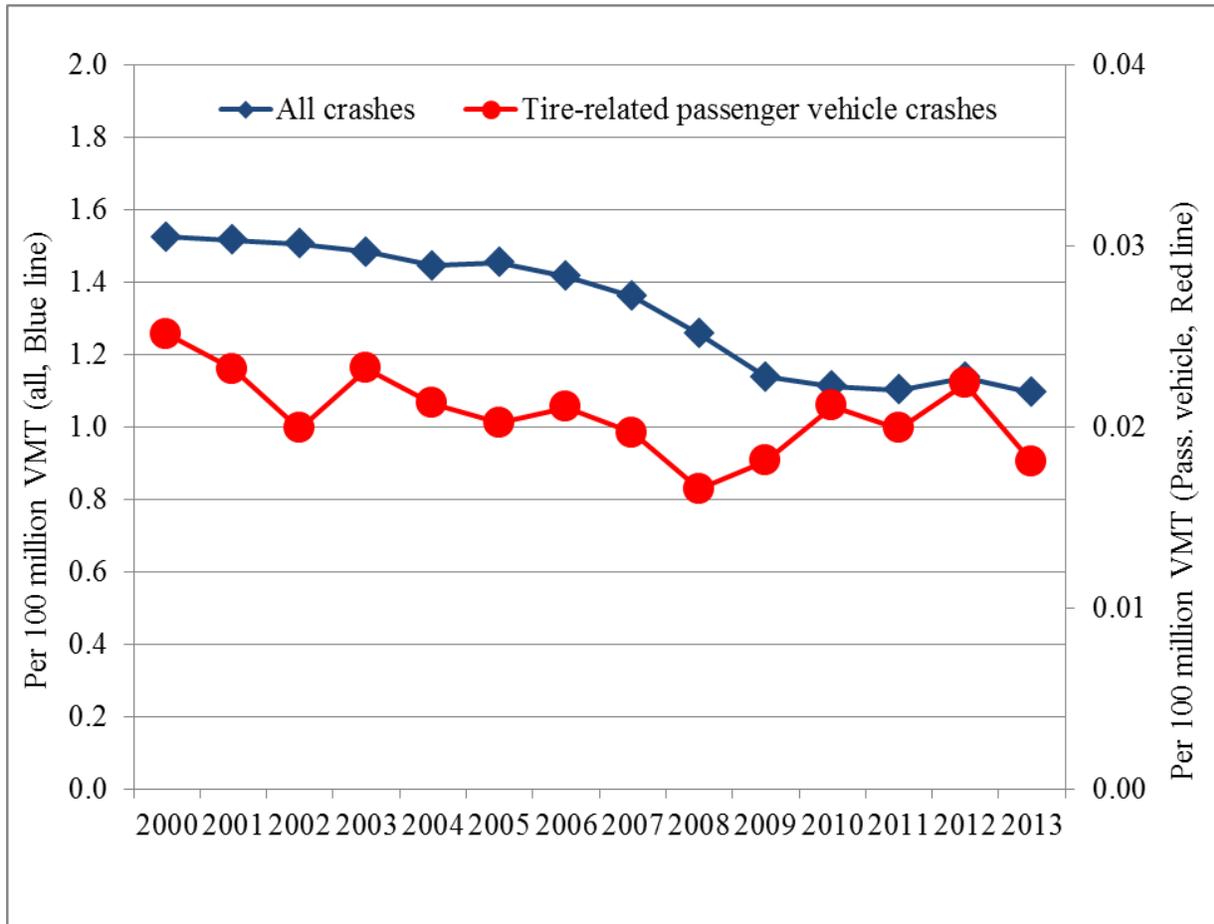
As shown by the blue line in figure B-1, all fatal crashes in the United States gradually declined throughout the period 2000–2013. The decline was most pronounced between 2007 and 2009, which coincided with a recession in the United States.⁴ The red line in figure B-1 represents the rate of tire-related fatalities during the same period. It shows that the rate of tire-related fatalities began to rise in 2007 and continued to do so until 2013.⁵ Thus, the overall rate of decline in US highway fatalities was not mirrored by a similar rate of decline in tire-related fatalities involving passenger vehicles, especially during the 2007–2013 period.

Figure B-1. Comparison of fatality rates for all highway vehicle crashes with tire-related passenger vehicle crashes, based on FARS data and Federal Highway Administration (FHWA) VMT data for 2000–2013.

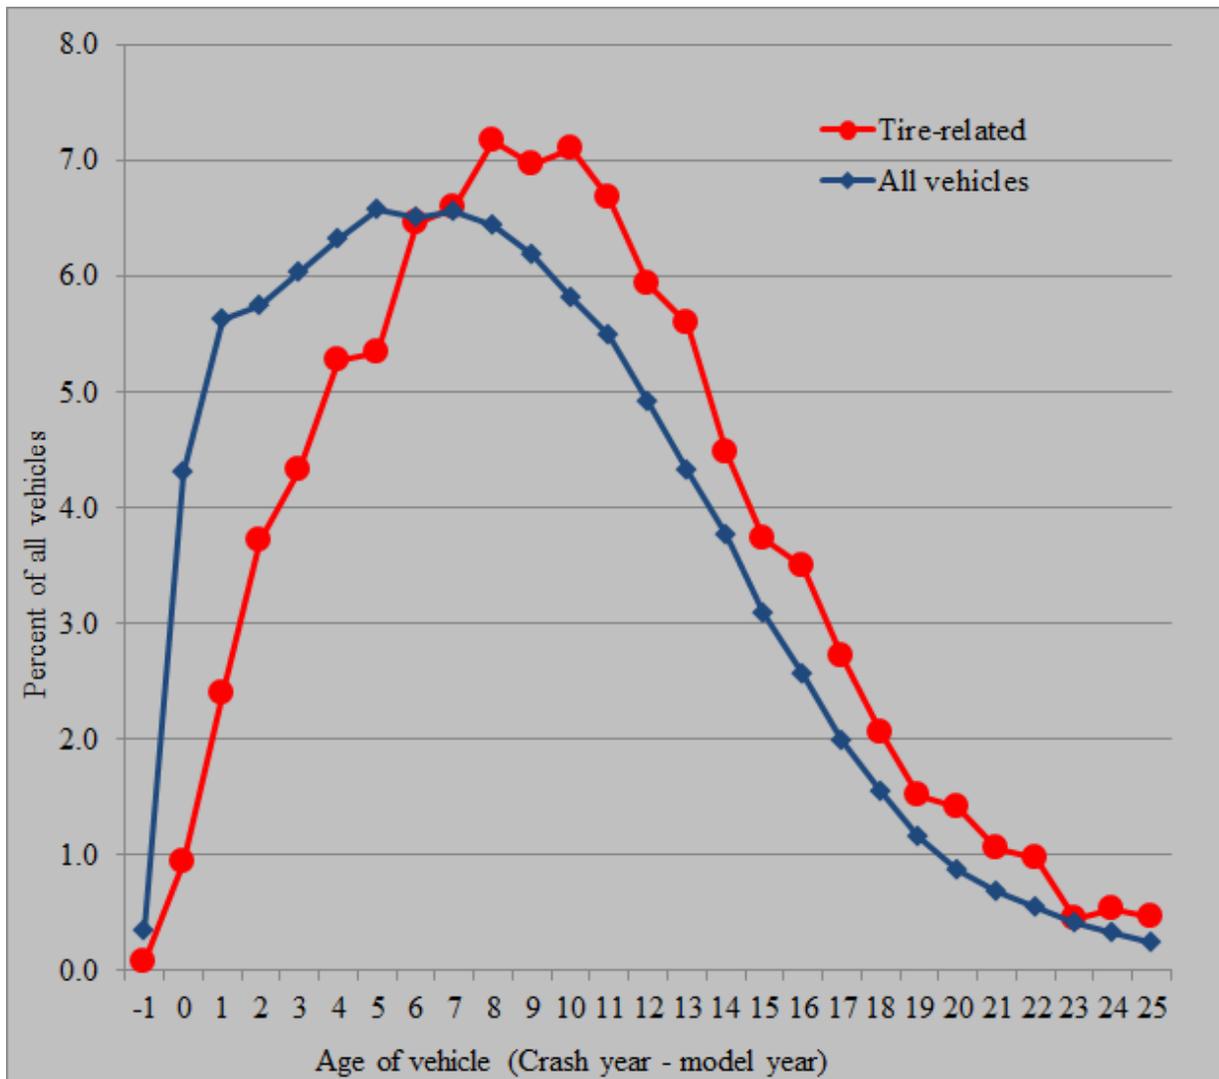
When the data were limited to passenger vehicles involved in a tire-related fatal crash, the results indicate that a large portion of these vehicles were between 8 and 10 years old. About 7.2 percent of all tire-related passenger vehicle crashes occurred at 8 years, followed closely by 10 and 9 years (7.1 percent and 7.0 percent, respectively). This suggests that the service life of passenger vehicle tires roughly corresponds with the replacement schedule recommended by vehicle and tire manufacturers.

Figure B-2. Relative frequency distribution of vehicles involved in fatal crashes by age of vehicle, FARS 2000–2013.

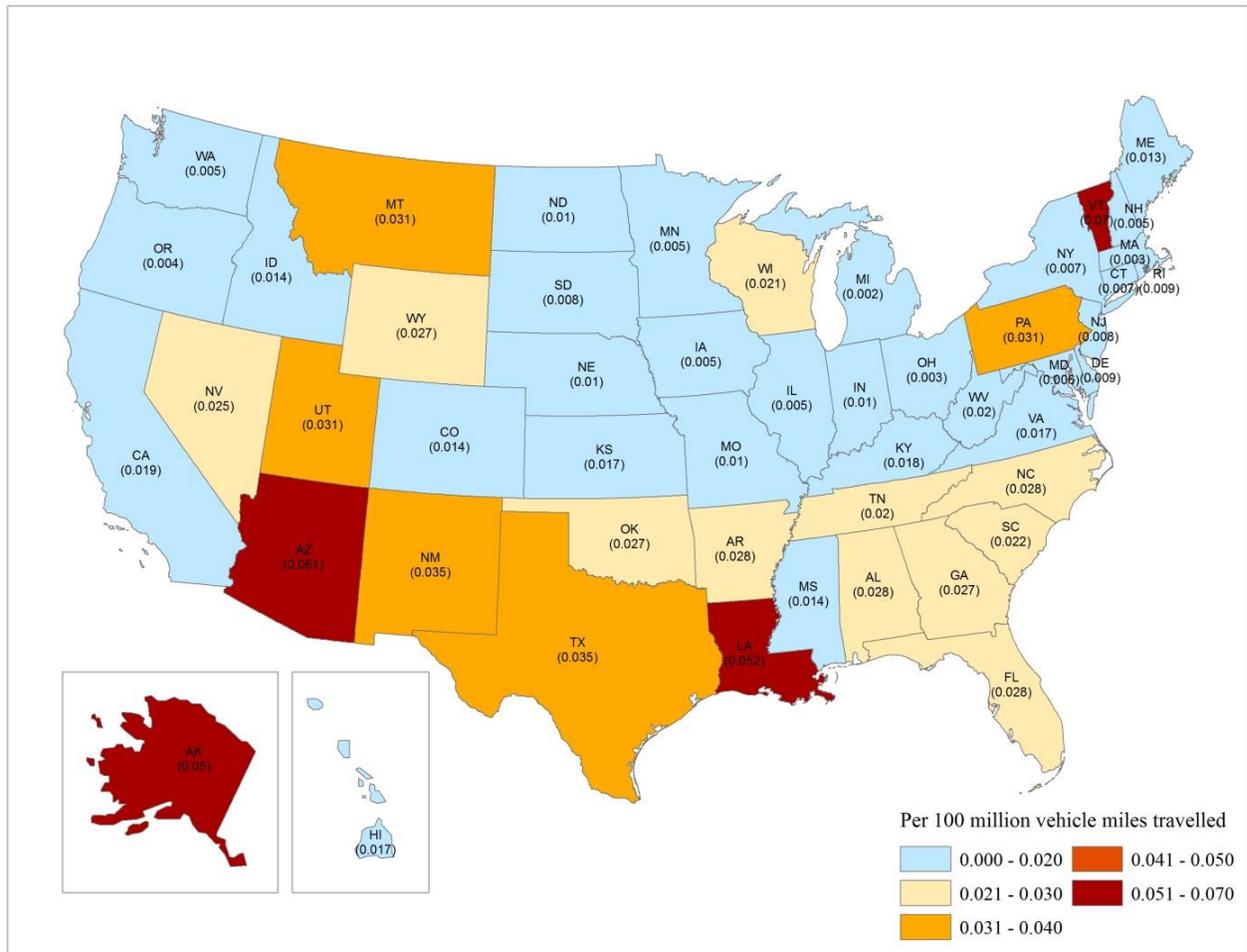
high fatality rates), a general north–south division can be seen in the map.⁸ Two of the top three states with the highest tire-related fatality rates (Arizona and Louisiana) are considered Sun Belt states. In fact, with the exception of Mississippi, all the Sun Belt states (including California and Nevada, of which only their southern halves are considered to be within the Sun Belt) had tire-related fatality rates at or higher than the US average. In figure B-3, those states in blue have tire-related fatality rates below the average tire-related fatality rate for the United States.

Figure B-3. Fatality rates of tire-related passenger vehicle crashes by state per 100 million VMT, per FARS and FHWA data for 2007–2013.

⁸ Vermont and Alaska are outliers in the overall pattern, with both having very high tire-related fatality rates. Although the reasons why these two states have such high rates were not examined, it should be noted that the VMTs in these two states are small when compared to most states. Only the District of Columbia has a lower VMT value, but it also has no tire-related fatalities.

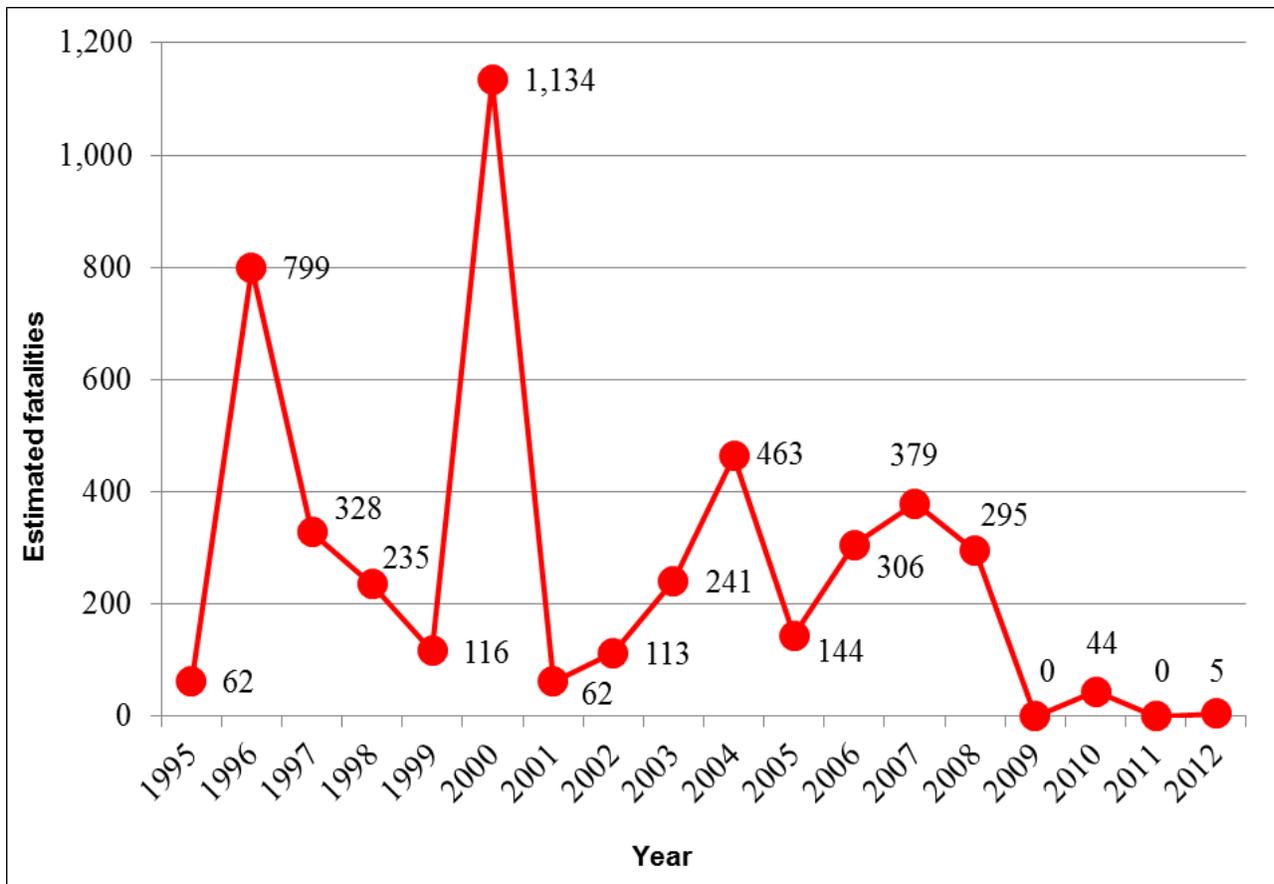
Figure B-4. Tire-related crash fatality estimates for 1995–2012, based on NASS/CDS representative sample data.

When compared to the estimates in NASS/GES and FARS data, the NASS/CDS data appear to underestimate the number of tire-related crashes, injuries, and fatalities. Additionally, the relatively small sample produced annual estimates that were based on very few actual crashes, resulting in unreliable estimates and trends that were more likely due to statistical noise rather than to true yearly difference. Finally, a vast majority of the fatal tire-related crashes in NASS/CDS during the period 1995–2012 were located in Arizona (41 of 64 fatal crashes), which suggests that for this particular factor, NASS/CDS did not provide a representative distribution of tire-related crashes across the United States.¹⁰
