Selective Issues in School Bus Transportation Safety: Crashes in Baltimore, Maryland, and Chattanooga, Tennessee

Special Investigation Report

NTSB/SIR-18/02
PB2018-100932

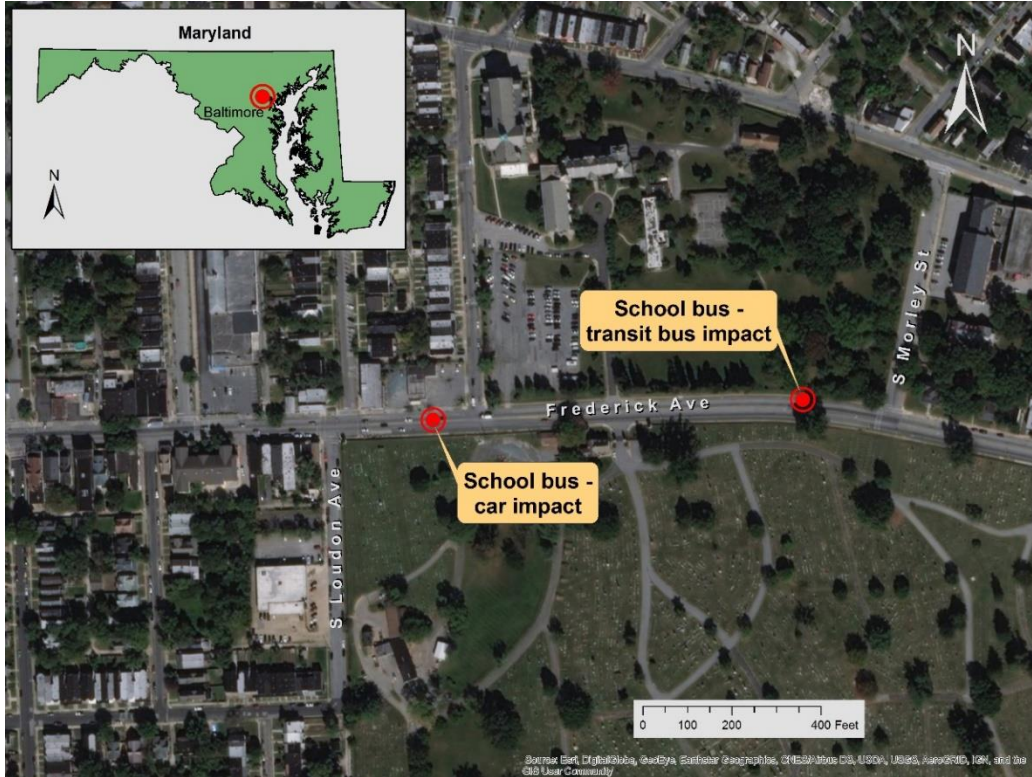
Figure 1. Overhead view of Frederick Avenue crash locations for eastbound school bus and car and for school bus and westbound transit bus. (Source: USDA FSA NAIP 2015, July 24, 2015)

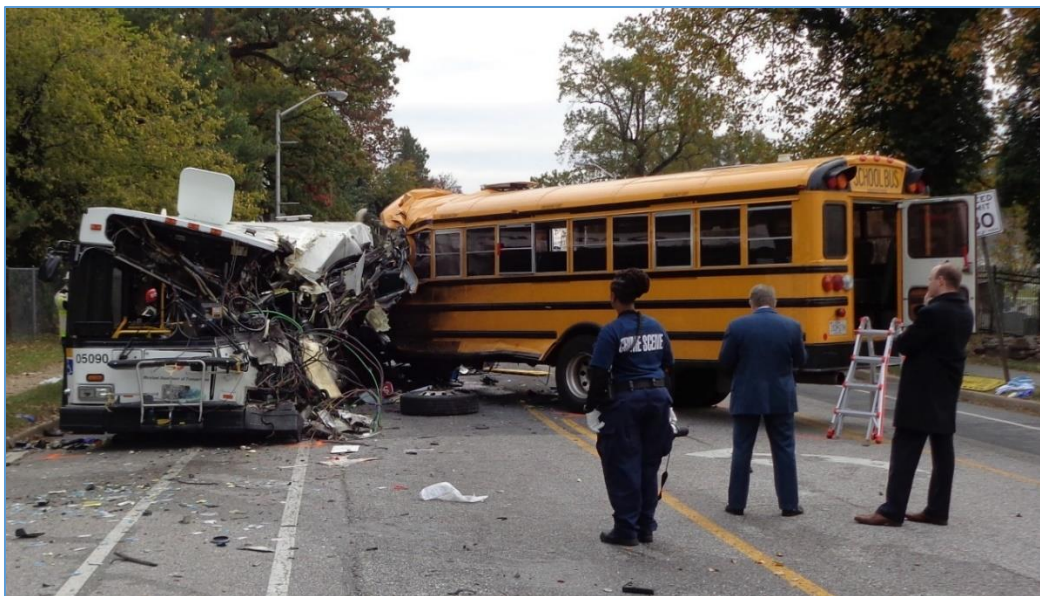
Figure 2. Crash scene on Frederick Avenue. (Source: Maryland Transit Administration)

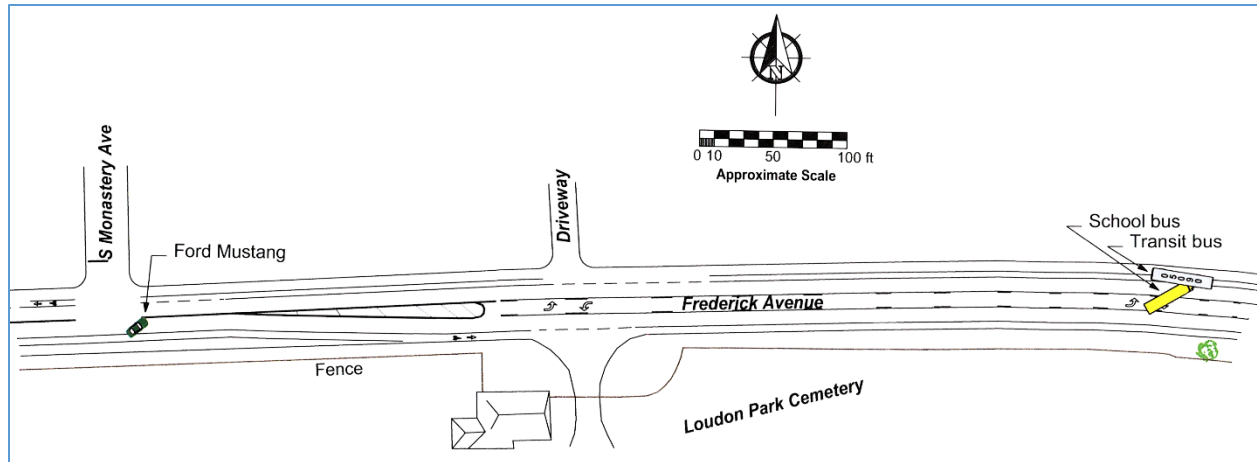
Figure 3. Crash scene diagram, Frederick Avenue, Baltimore.

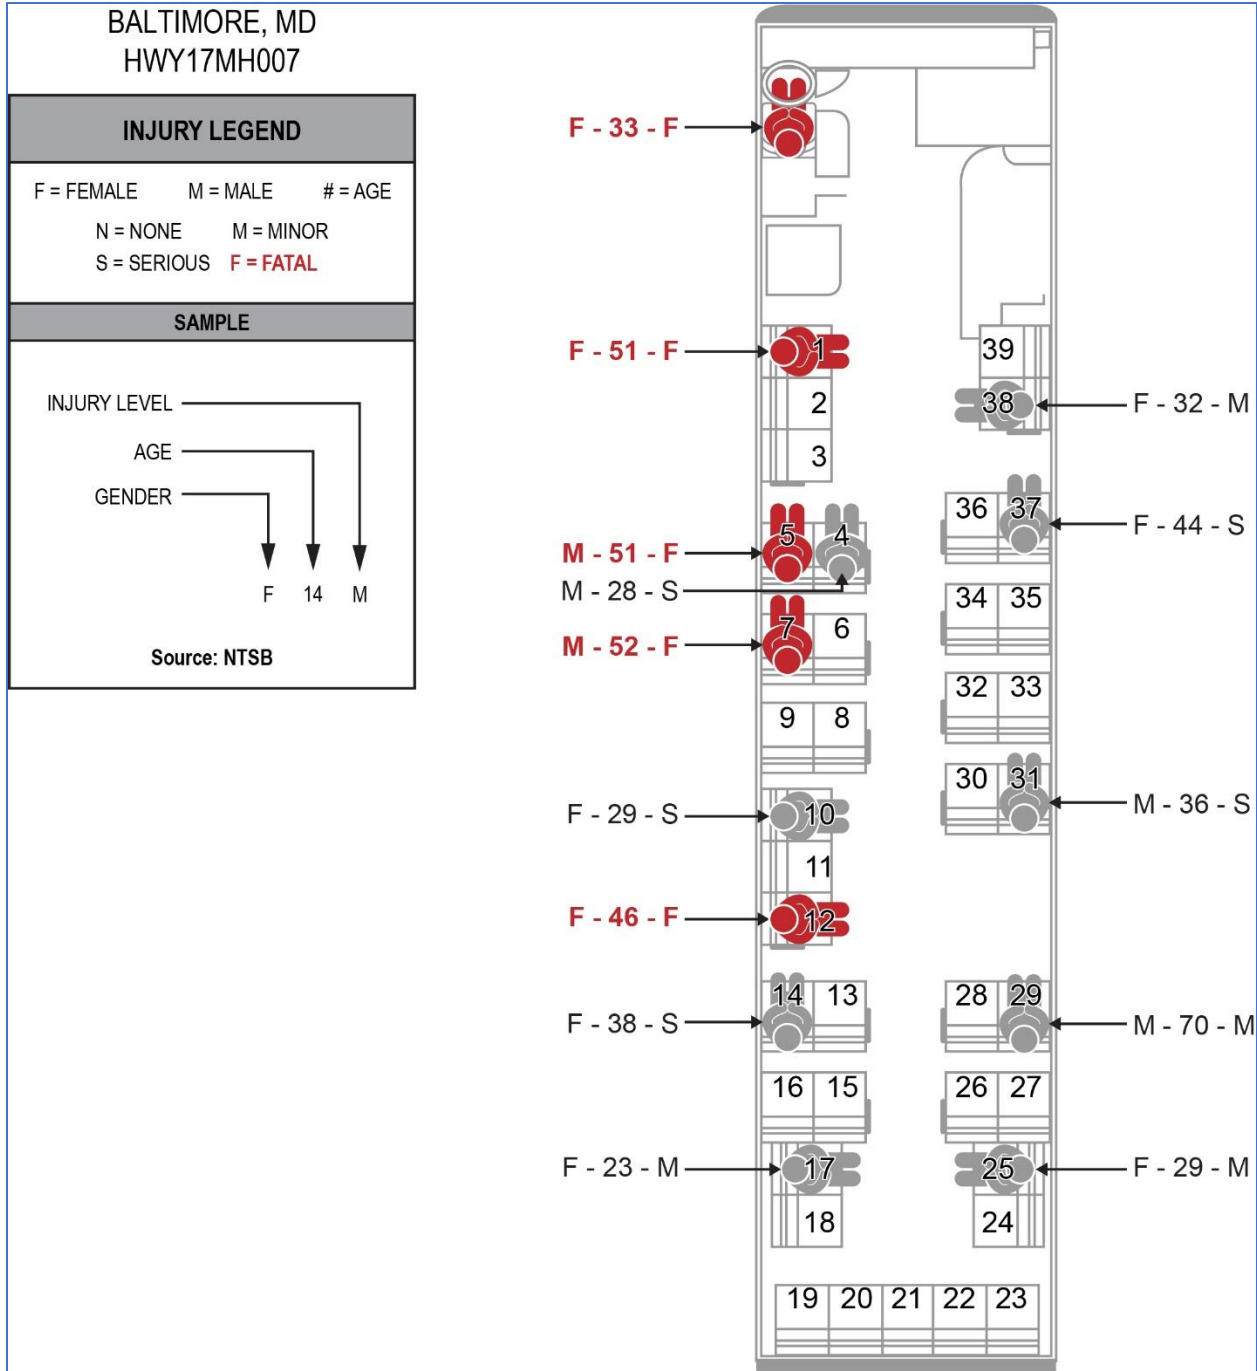
Figure 4. Transit bus occupant seating chart with injury and demographic information.

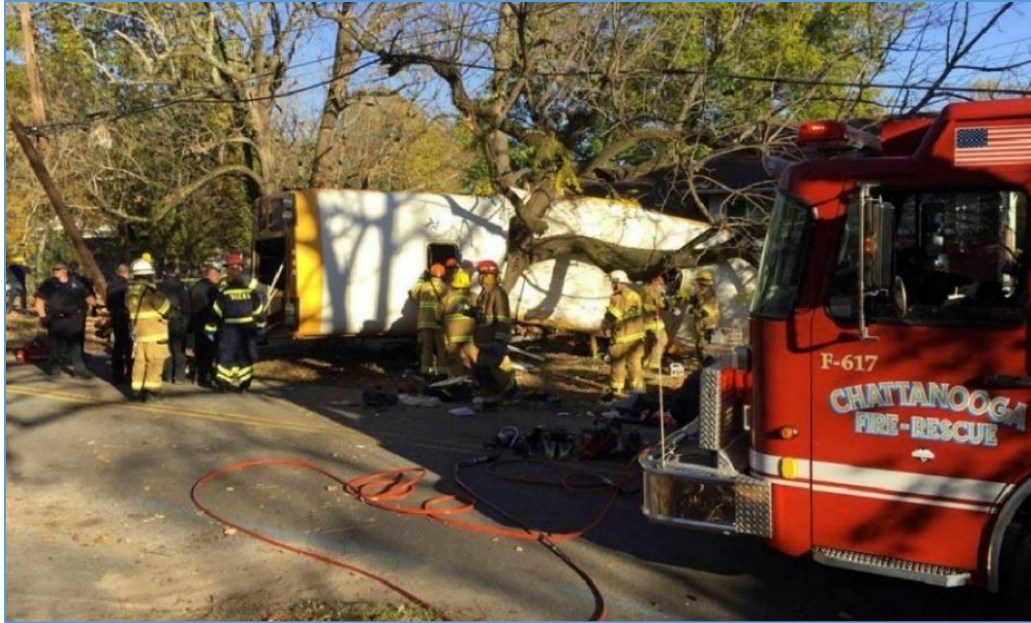
Figure 6. Crash scene off Talley Road, showing school bus on its passenger (right) side against tree. (Source: Chattanooga Fire Department)

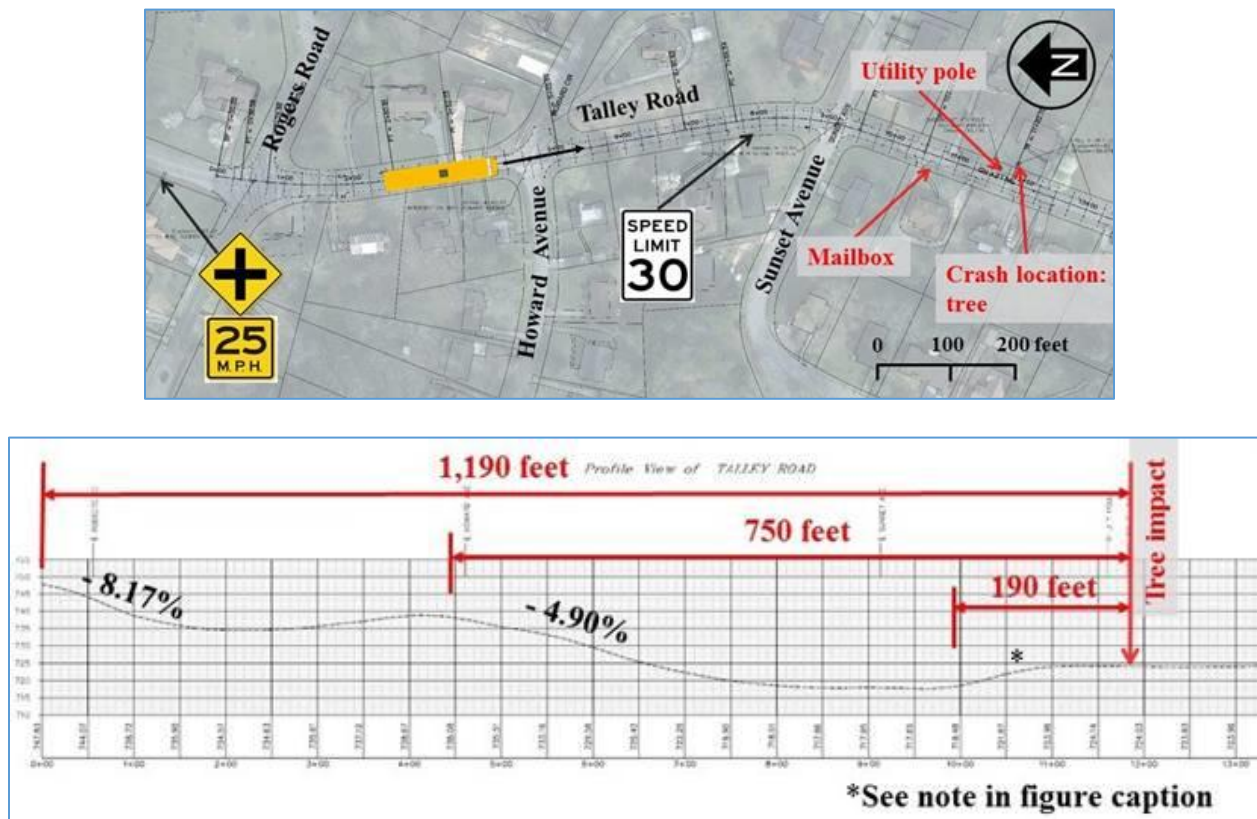
essentially level for 120 feet, at which point it begins to ascend for 150 feet, crests, and remains essentially level again (see figure 7).

Figure 7. Graphic showing plan view and signage of Talley Road (top) and profile view (bottom). (Source: city of Chattanooga, modified)

Note: 6.9 percent upgrade maximum slope (4.3 percent overall average slope).

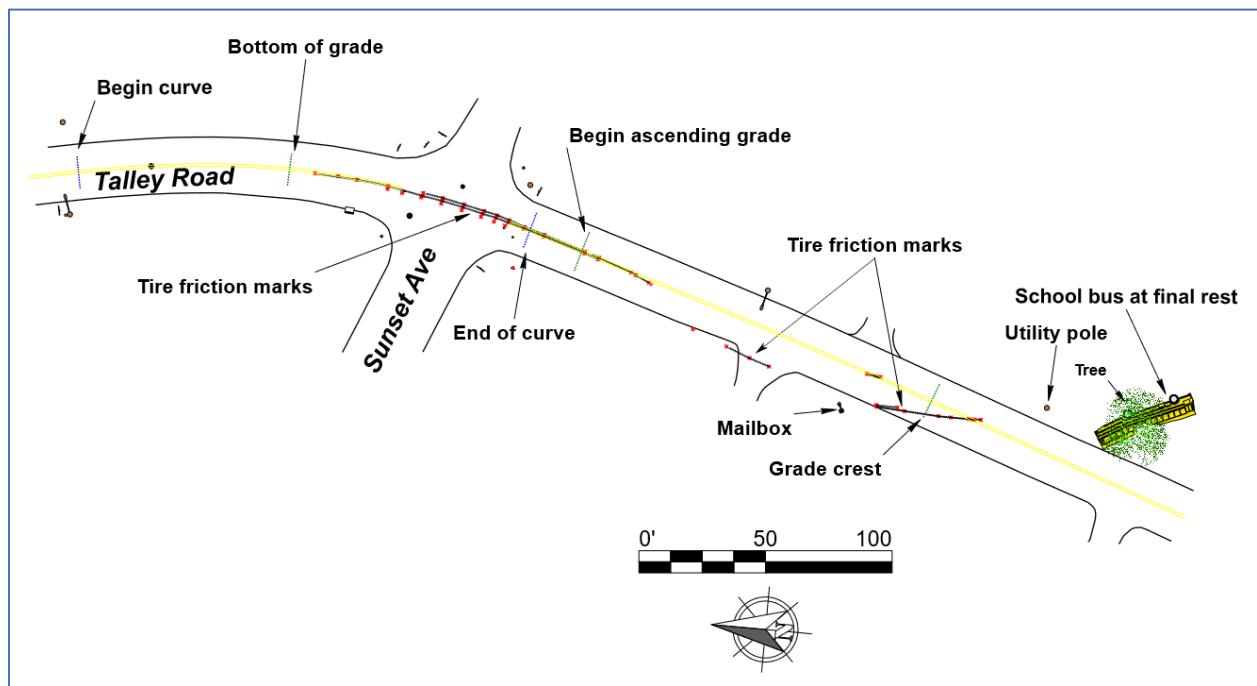
Figure 8. Crash scene diagram, Talley Road, Chattanooga.

Postcrash roadway evidence—consisting of tire friction marks, which tracked atop the pavement along the double yellow centerline or were slightly offset into the northbound travel lane—indicates that the bus driver began to lose control of the vehicle as he drove through the right curve near the intersection with Sunset Avenue. Twenty-five feet past the first set of tire marks, tire impressions parallel to the roadway were documented close to 2.4 feet off the southbound pavement edge to the right (past Sunset Avenue), as shown in figure 8.

As the right-side tires of the school bus traveled across a paved driveway, they created curvilinear friction marks, and the bus struck a roadside mailbox, which was anchored in concrete (figure 9). Tire friction marks on the pavement appeared again 15 feet beyond the mailbox, in a south-southwesterly direction (at a 24-degree angle), toward the northbound side of Talley Road, as shown in figure 8. The longest tire mark terminated in the northbound lane about 26 feet from the utility pole (shown in the figure 8 scene diagram).

³⁸ The tire marks shown in figure 8 near the mailbox are from the right-side tires of the school bus.

side and come to rest in a yard alongside Talley Road. Figure 8 presents a diagram of the crash scene.³⁸

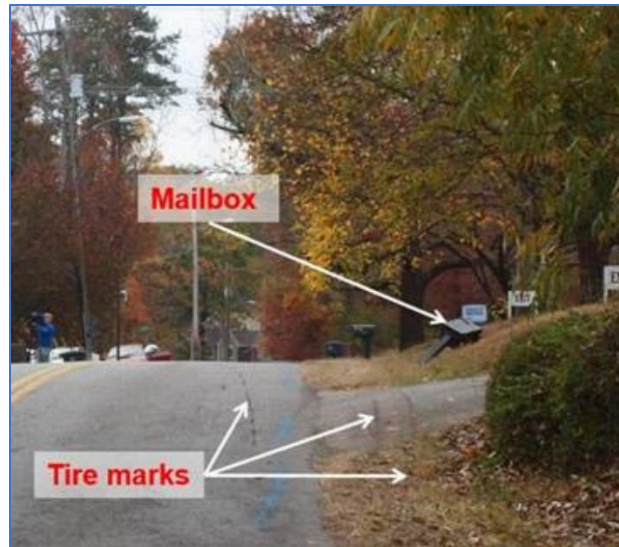
Figure 9. Tire marks on southbound Talley Road and damaged mailbox.

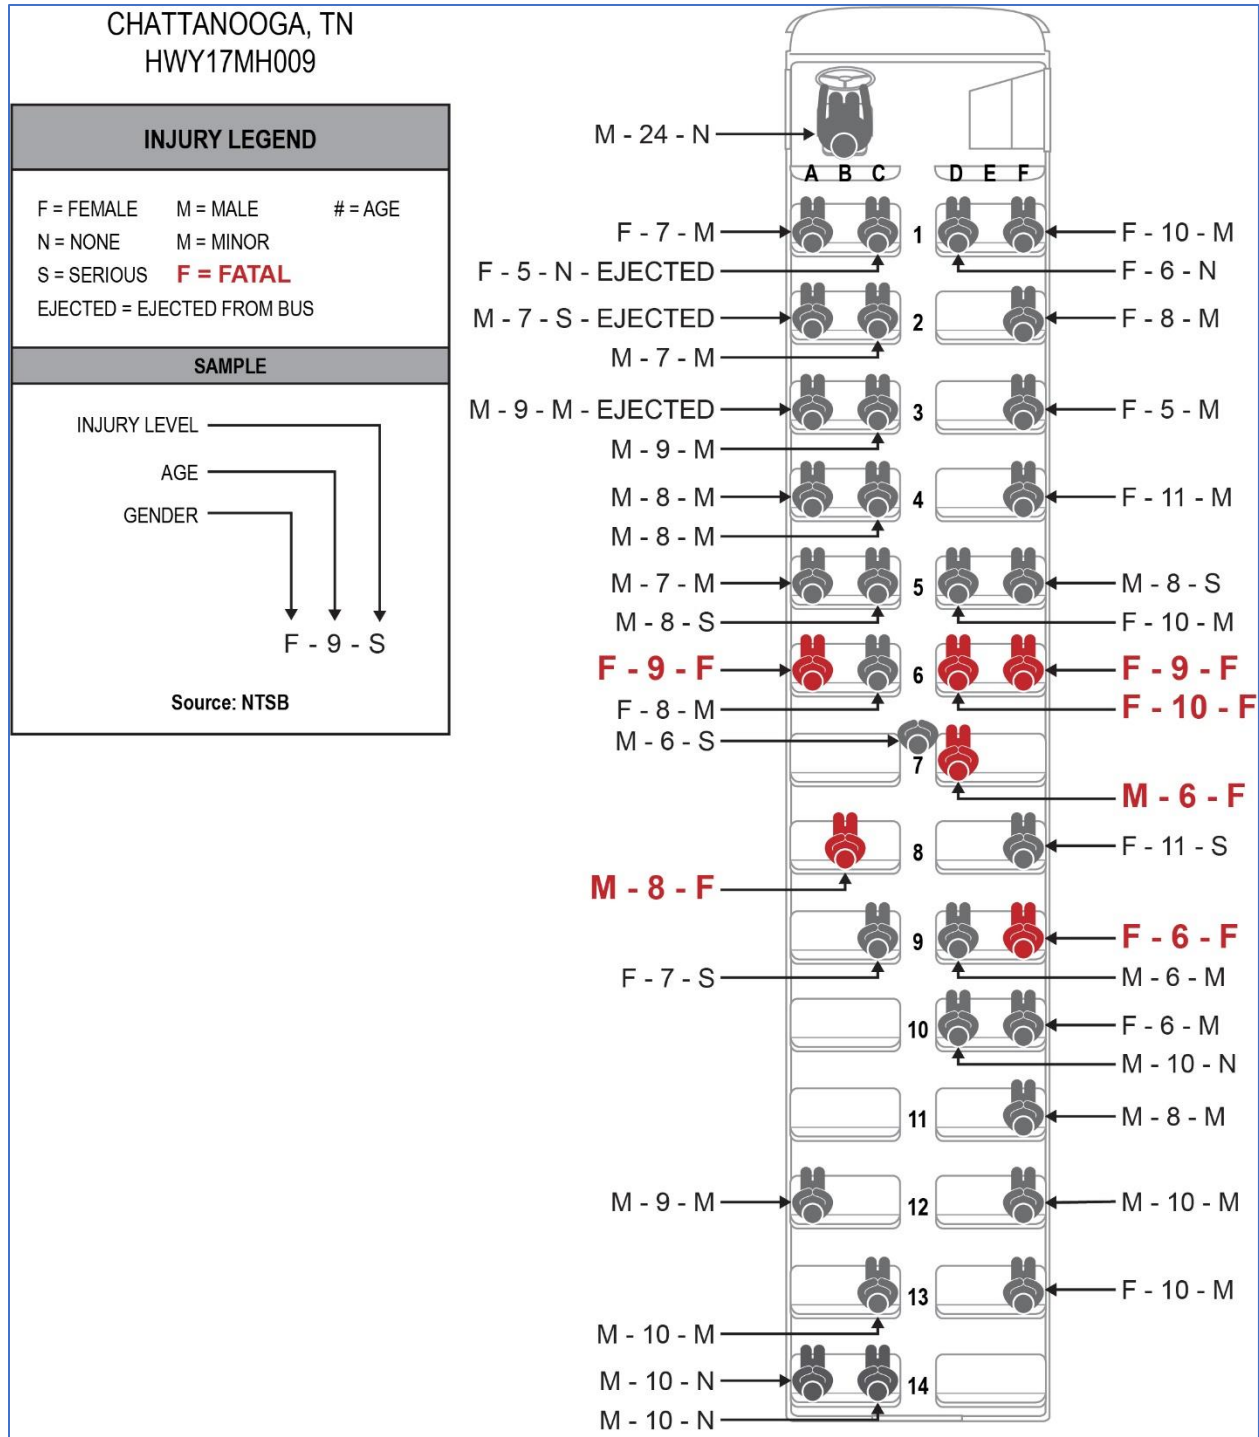
Figure 10. Durham school bus occupant seating chart with injury and demographic information.

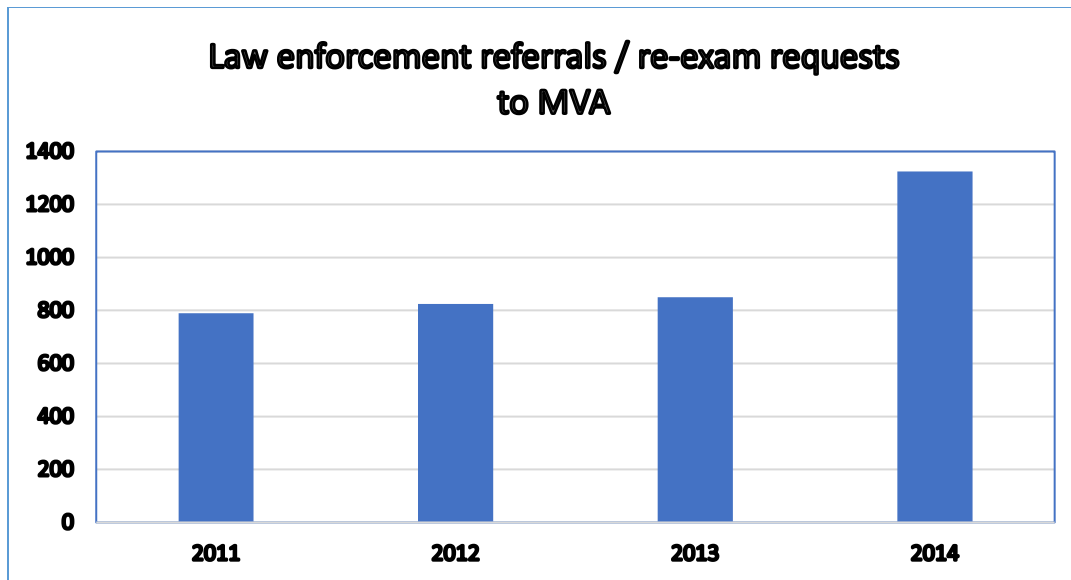
Figure 11. MVA data showing increase in law enforcement referrals of medically at-risk drivers. (Source: Maryland Department of Transportation)

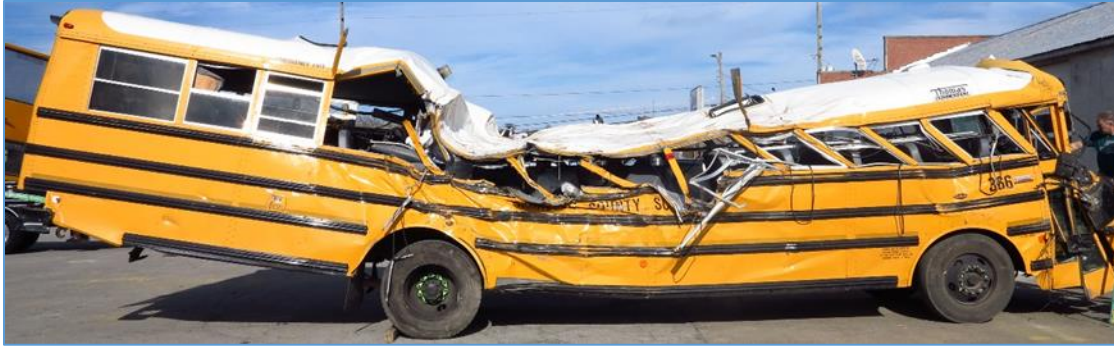
¹²³ Tree impacts often challenge the crashworthiness of a vehicle because the impact forces are localized to a small area. However, because the Chattanooga school bus rolled over and struck the tree, roof strength was determined not to be a safety issue.

Figure 12. Passenger (right) side of Chattanooga school bus postcrash.

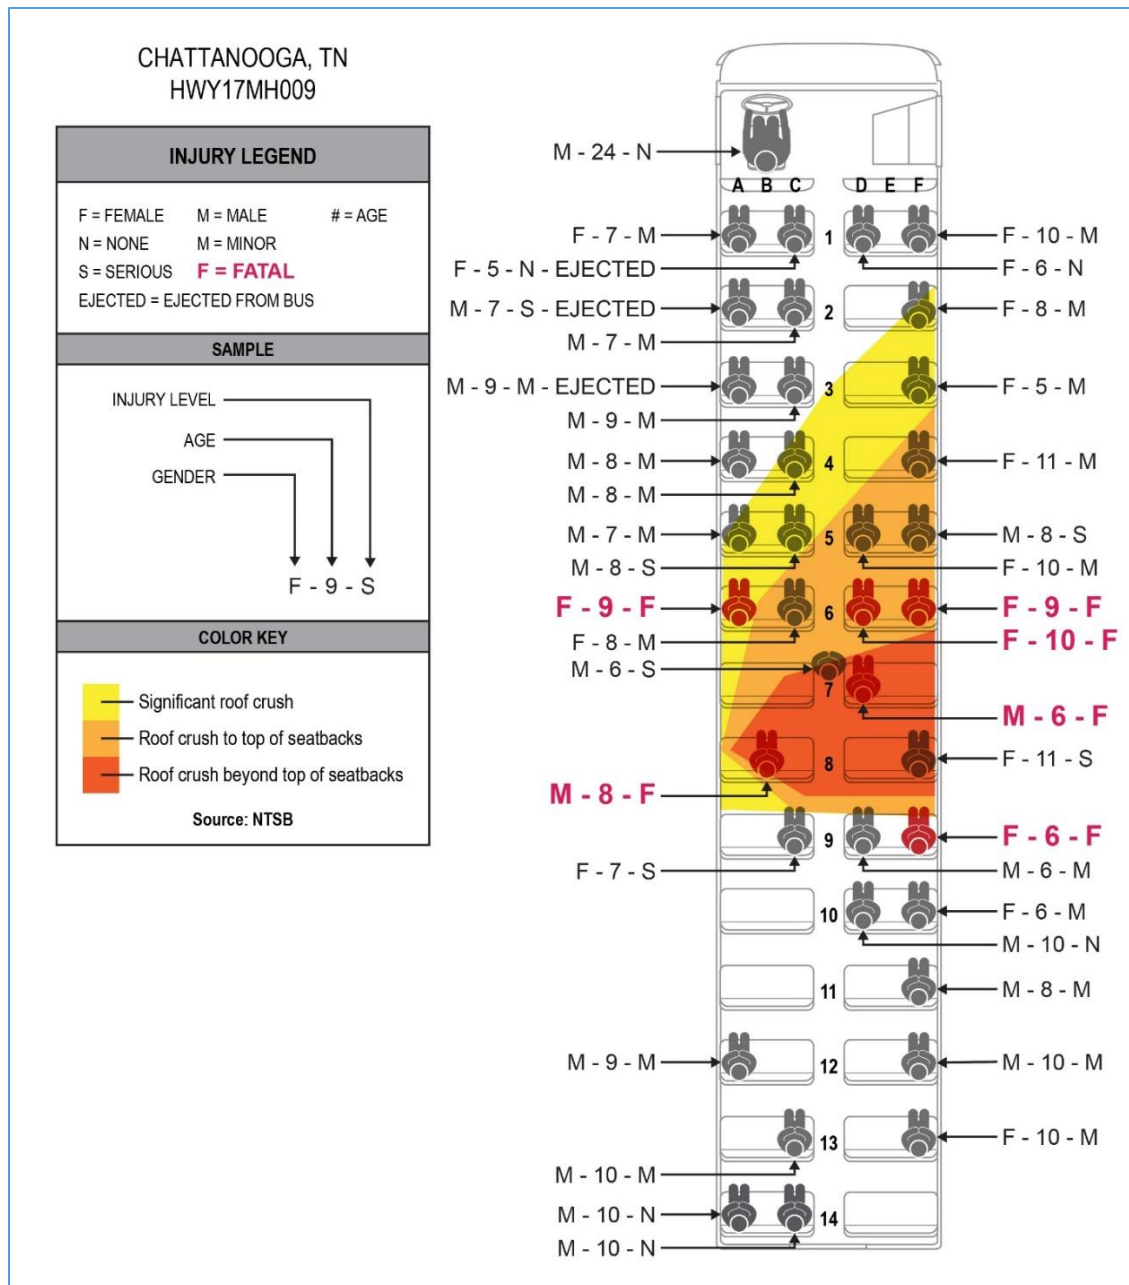
The deformation of the vehicle frame around the tree, along with severe roofline intrusion, reduced the survival space for many of the Chattanooga school bus passengers. The vertical intrusion into the passenger compartment covered the region of rows 2–8 on the passenger side and rows 4–8 on the driver side. The intrusion was most severe in rows 7 and 8. Figure 13 shows the roof crush from the tree impact overlaid onto the school bus occupant seating chart.¹²⁴

¹²⁴ (a) Figure 13 shows the seating positions of the bus occupants before lateral forces displaced many of them from their seating compartments just preceding the tree impact and resulting roof crush. (b) The roof crush described represents residual roof crush. Typically, during a crash, the vehicle will crush to a maximum extent and then the metal will “spring back.” Residual crush is always less than maximum crush.

Figure 13. Overlay of postcrash tree-intrusion zones on Durham school bus occupant seating chart.

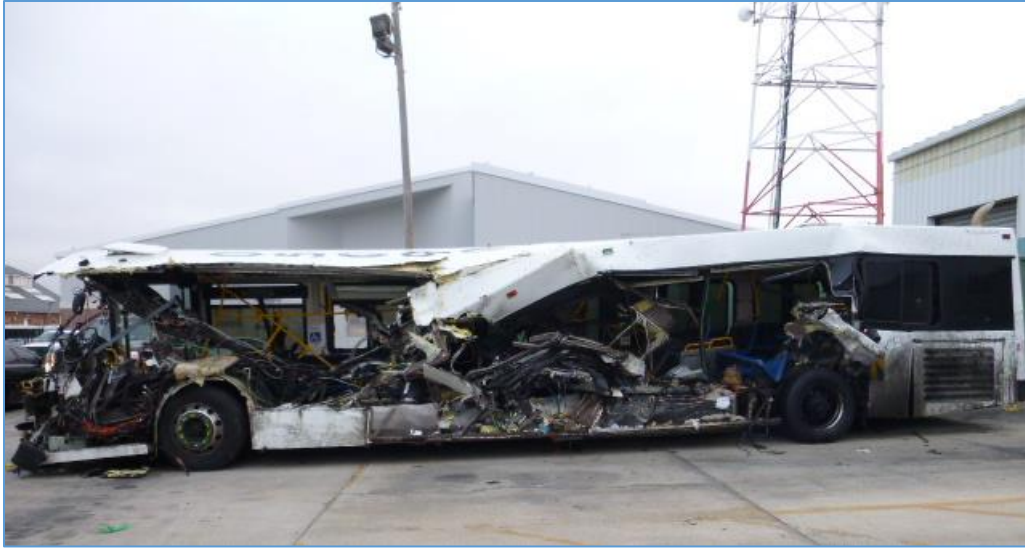
The New Flyer transit bus had 39 passenger seats and capacity for 15 standees. The driver seat was equipped with a lap/shoulder belt. All 39 seats were constructed of the same molded fiberglass shell and high-strength thermoplastic back. Passenger seats were not equipped with restraints.¹⁴⁶ The transit bus sustained extensive impact damage that started at the front left bumper corner and extended vertically to the windshield header and down the driver side—tearing away the windows, sheet metal, and fiberglass, resulting in an approximate 6-foot-tall opening (see figure B-1).

Figure B-1. Driver-side postcrash view of 2005 New Flyer transit bus.

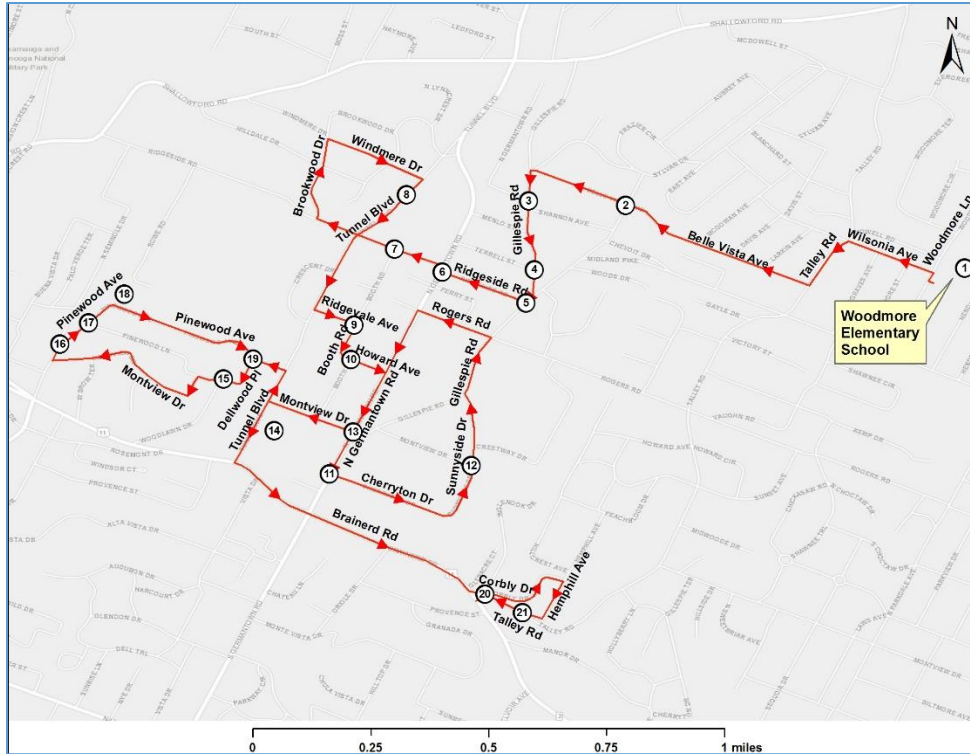
Figure C-2 shows the route the driver should have taken when departing the elementary school in the afternoon. The route is plotted on a map, with red arrows showing the direction of travel; the stops are numbered as listed in table C-1.

Figure C-2. Scheduled afternoon route for Chattanooga school bus driver.

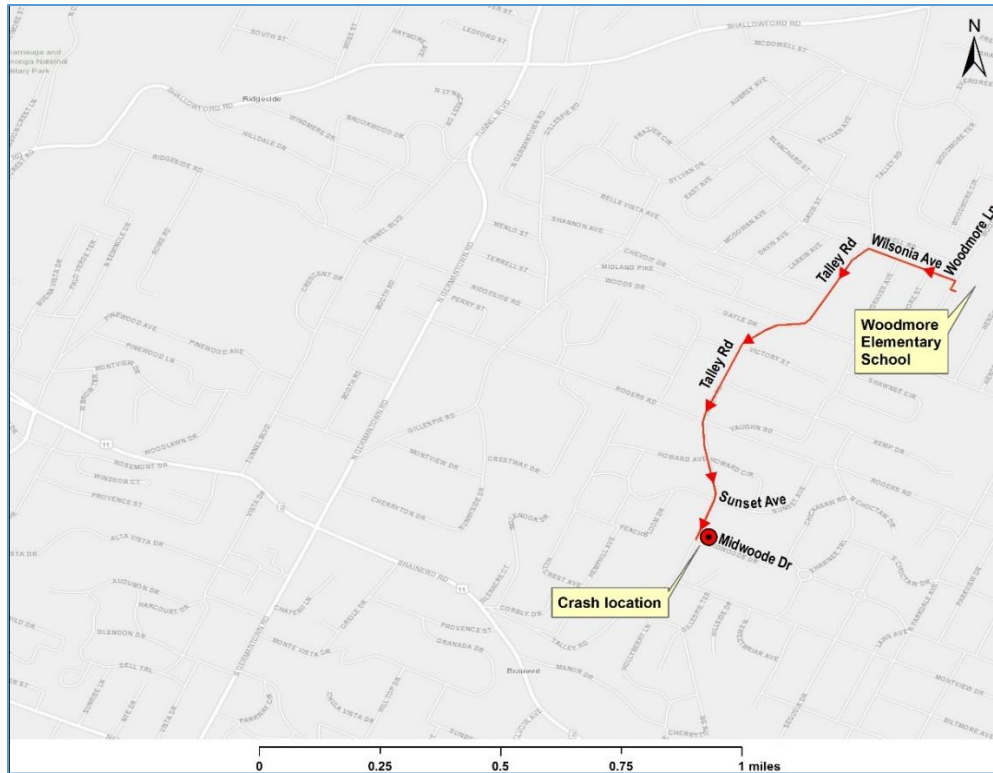
Figure C-3 shows the actual route the driver took for the afternoon shift on November 21. At the time of the crash, he had not reached any of his scheduled drop-off locations. This map was developed using Zonar data from the bus. Durham used Zonar to assist with global positioning system tracking.

Figure C-3. Actual route traveled by Chattanooga school bus driver on day of crash.

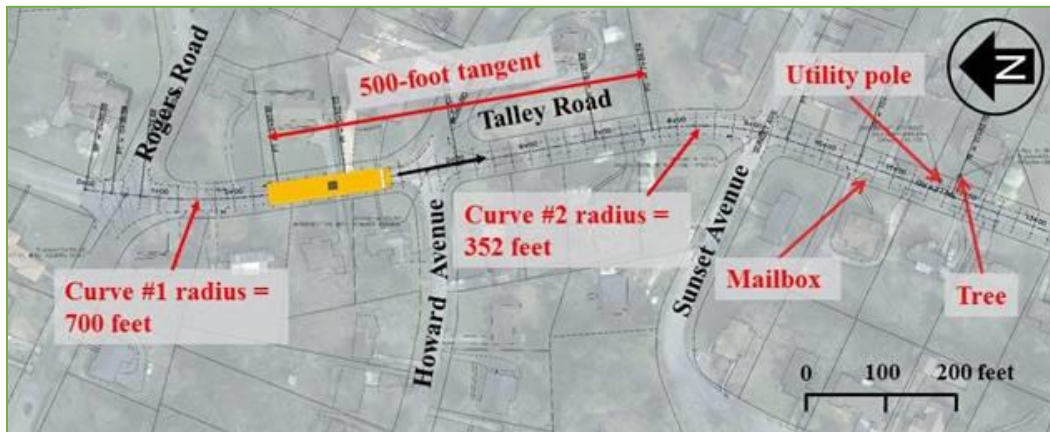
Talley Road is functionally classified as a local urban street. Figure C-4 shows the horizontal curves immediately preceding the crash location. On December 1, 2016, the city of Chattanooga conducted a 24-hour vehicle classification study in the 318 block of Talley Road southbound. Passenger vehicles accounted for 58 percent of the total classified vehicles; vans and pickups, 33 percent; buses and trucks, 4 percent; and other vehicles, 5 percent.

Figure C-4. Horizontal curves immediately preceding Talley Road crash location (Source: city of Chattanooga, modified)

Horizontal curve #1 turns to the left for motorists traveling south on Talley Road and has a radius of 700 feet. Horizontal curve #2 turns to the right for motorists traveling south on Talley Road and has a radius of 352 feet. A tangent distance of 500 feet separates the horizontal curves. The vertical grades for Talley Road in the southbound direction of travel consist of a -8.17 percent downgrade slope located 1,190 feet from the tree; a -4.9 percent downgrade slope located 750 feet from the tree; and a +6.9 percent upgrade maximum slope (4.3 percent overall average slope) located 190 feet from the tree.
